Dear Council Members,

Due to an error at Fed-Ex I had only given you the first half of the Historic Structures report, so here is the second half. The Second half does include important chapters such as approaches to rehabilitation and possible uses. If you have any questions please feel free to call or email me. I am working on showing that there is deep support, especially in the African American community for the acquisition and rehabilitation of this building.

Carver Nursery School / William Thomas Post 129, Alexandria, Virginia
Historic Structure Report

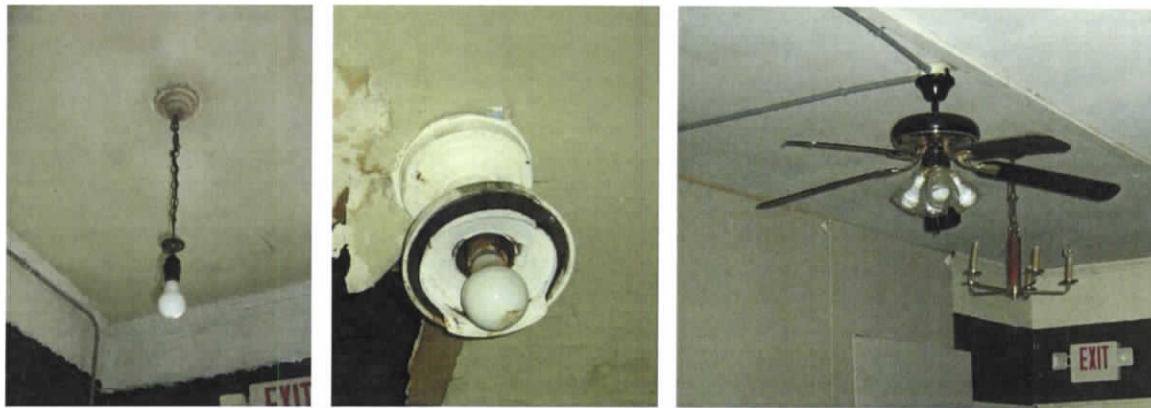
The chain hung fixture on the left may be original to the construction, or something remade from lamp parts that have always been in the building. The center image shows a fixture that appears to be a remake of an original schoolhouse fixture, altered by removing the vertical rod that would have originally been found between the escutcheon and the shade holder. The ceiling fan and chandelier fixture on the right are post 1980.

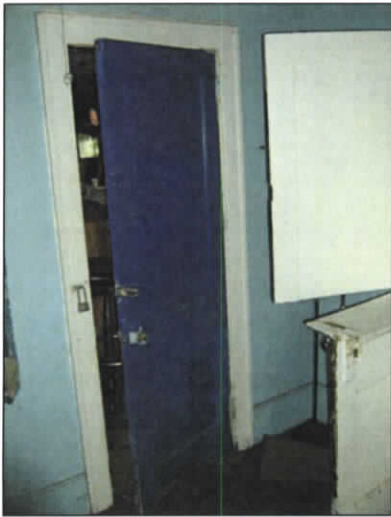
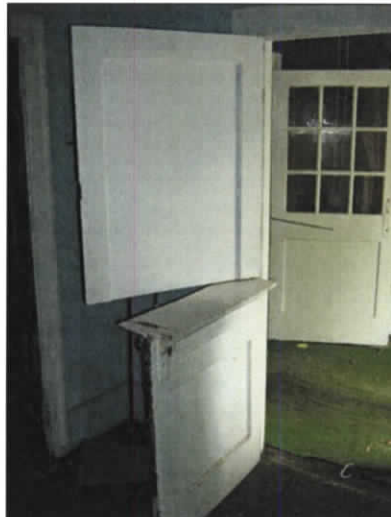
Southeast Room

The southeast room was labeled as an “Isolation Room” on the original plans. It is accessed from the center hall by what appears to be an original two-panel door; however, the door has been cut at the top edge of the lock-rail to make it a dutch door. A small shelf was added at the top of the lock-rail as part of this alteration. The bottom edge of the upper panel has no rail or other finish element as a result of the cut. In the west stile in line with the lock-rail is a doorknob set with escutcheon and box lock that appears to be original. A similar two-panel door, but without the cut, is found at the west side of this room. A door is not shown at this location on the plans (suggesting that this door was relocated after the American Legion post began using the building). Both doors are cased in sanitary casing with a rounded backband. The casing is mitered as is the backband. The room has simple baseboard with an applied quarter-round top edge. At the edge of the ceiling is picture rail trim used throughout the building. The room has the baseboard used elsewhere, a transfer grill in the wall, and the remnant of a ceiling fixture. A section of the gypsum wallboard ceiling is missing as a result of water damage; some mildew is present at the edges of the damaged area.

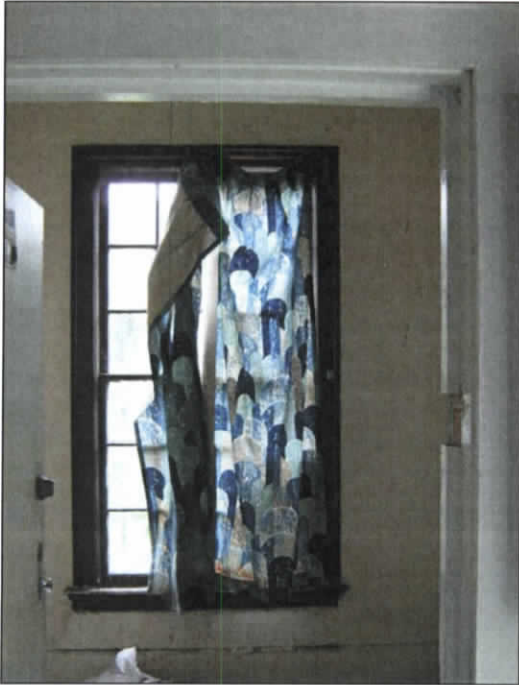
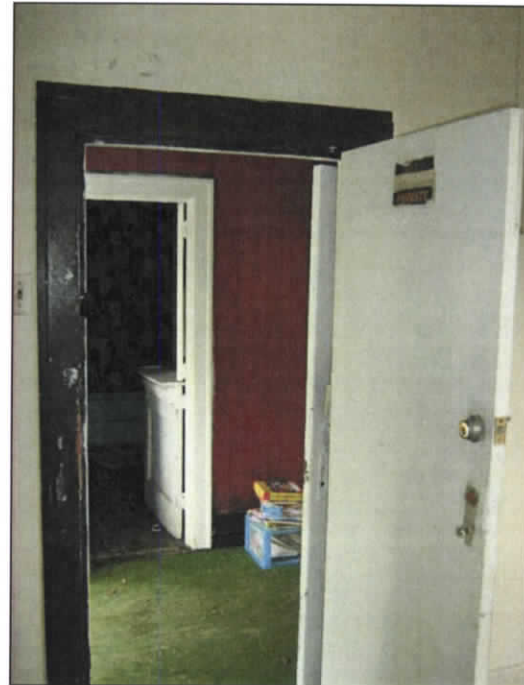
Northeast Room

The northeast room is similar in plan and finish to the southeast room. However, it has a flush door leading in from the corridor. The door is cased in sanitary casing, as is the window in the room's north wall. Like the southeast room, it has original baseboard, picture rail, and sanitary casing at one door opening and one window opening, as well as a transfer grill to let heat in from the adjoining larger space. The gypsum wallboard is almost entirely intact in this room. The ceiling fixture is a ca.1990 fanlight.

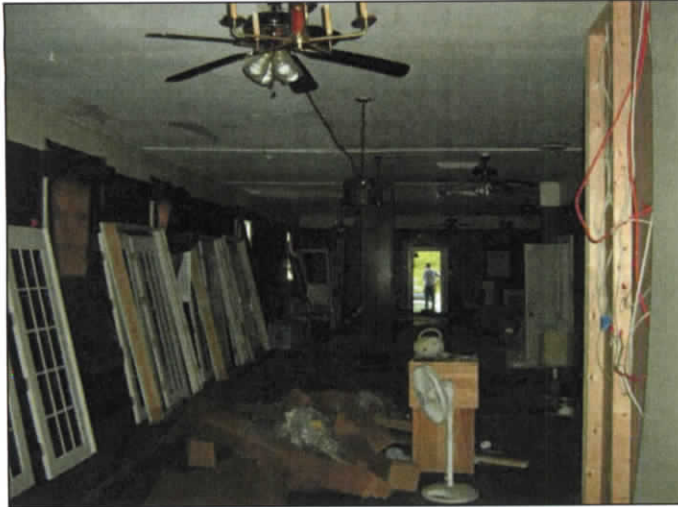
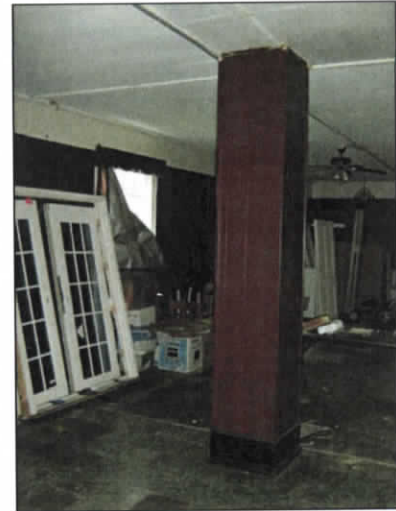
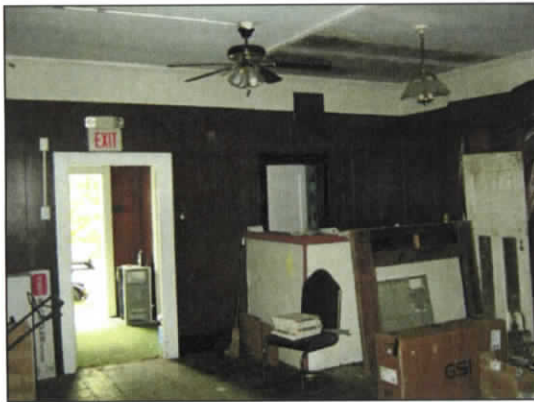
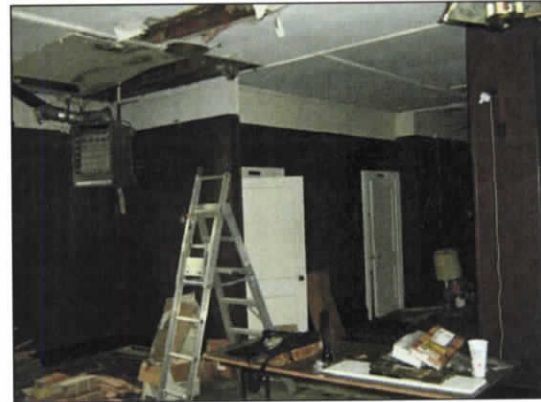
Center Space

The building now has a large center space that represents about 75% of the interior area. The space was originally two classrooms with a small kitchen and cloakroom between them. Two rest rooms were placed to one side of the cloakroom, and they are still in place. A third similar-sized room was built next to them as a place to relocate the kitchen. A small storage was also built at the building's southwest corner at some point, and someone began adding another partition between the new kitchen and storage room in what appears to have been the most recent project started in the building, but the project remains unfinished. The large center space is the area between these smaller rooms.

The gypsum wallboard is covered at the walls in all areas, up to eight feet above the floor, by simulated wood paneling that has been painted or stained. At the top of the paneling is a narrow scalloped edge. Most of the paneling is in good condition, but it should be removed in any recommended treatment of the building. It covers areas where there were originally bookcases, blackboards, bulletin boards, work benches, and similar features. Although these were original, most were removed apparently when the city began renting the space to the American Legion, and the wall surfaces behind them were in suitable condition to be painted and serve as the interior finish, as is apparent in the

various photographs in the Legion's archives. Above the eight foot line, the gypsum wallboard of the remaining wall (approximately one foot to the ceiling) is in good condition in nearly all areas. The gypsum wallboard of the ceiling is also apparently in good condition across about 70% of its area; however, the remaining 30% represents serious damage from holes in the roof and possibly other kinds of problems. Where damage has occurred, the wallboard is damaged beyond repair or completely missing over 80%-90% of each problem area, with mildew and water-damaged wallboard in the edges of the hole. The main problem areas are the southeast corner of the center space (water-damaged wallboard), the southwest corner of the east classroom (hole above the ceiling-mounted heating unit), and the southwest corner of the center space (hole over the partially enclosed area in center part of west classroom, west of the current kitchen area, where the ceiling hole is the direct result of a hole in the roof). To repair the damage, following the original design, or a modified version thereof, new wallboard material will need to be patched into the current holes.

The resilient tile on the floor of the center space is heavily worn, splattered with paint, and otherwise damaged in several areas. The drawings show that the nursery school was designed to have exposed wood floors, and it is clear in some American Legion photographs that the floor remained wood for a time after the bookcases and other wall units had been removed and after Legion began using the building. It is also apparent that the tile was installed when the kitchen was still located with partition walls between the two classrooms, as the kitchen area is now filled in with a newer patch using a different shade of green resilient tile. The condition of the current tile is too poor to plan to repair it, and, in any event, under virtually all scenarios, it would be more appropriate to restore the original exposed wood design at the floors.

The windows are all original, and very little work is needed beyond replacement of missing panes and repair of some water-damaged wood where the paint has worn away.

The center space has a few fixtures, or remnants of fixtures, that appear to be original or at least from an early date. This includes two or three remnants of ceiling fixtures. Together with the photographic evidence, these can now be used as a basis for choosing replacement fixtures. Some of the other electrical fixtures, such as outlets and switches, also may be early and could be used as a basis for selecting new historic-style items. The ceiling-mounted heaters are from an early date, or may be replacements of similar ones installed to replace the original oil-fired heaters. It appears that both the original oil-fired heaters and the first ceiling-mounted units are visible in the photographs in the Legion archives. No remnant is still in place of the two drinking fountains, but they can be seen in the photographs. Minor fixtures not shown on the drawings are generally later changes and not known to be either of aesthetic or historical value at this writing. This would include things like the electrical circuit boxes and any remnants of the dictograph security system (*including the sign*). The historic door closers and spring-loaded hinges might be examples of minor but early (or original) fixtures that should be kept because they are part of the character of the space and appear in some of the Legion's photo archives. The historic doorknobs and escutcheons should be kept. Hasps and screen-door-type hook-and-eye latches should be removed and replaced with more appropriate hardware.

The ropes need to be replaced at most openings to reattach the counterweights in the jambs. In some cases, the pulleys are likely to need replacement as well. The loss of the window ropes and some pulleys may be due to their having been painted over the years.

The chimney at the center of the central open space should be left in place even if the partition walls that originally abutted it are not restored. The brick should not be exposed on the east and south sides where there were always walls. The north and west sides, however, may have been exposed in the original design (this subject should be researched further before a decision to expose or cover the brick on these two sides, west and north, is finalized). This possibility should be investigated, and the bricks may be left exposed only on those two sides if they were exposed historically.

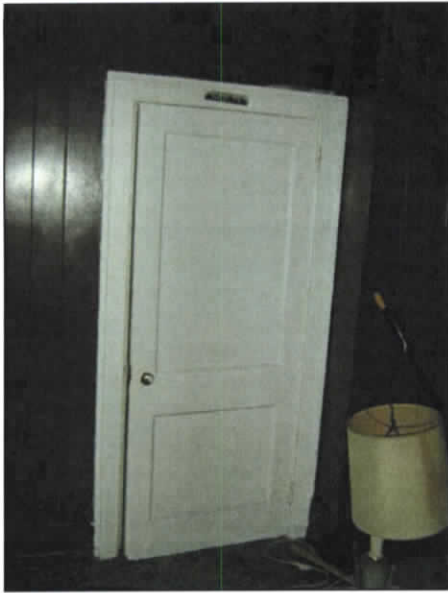
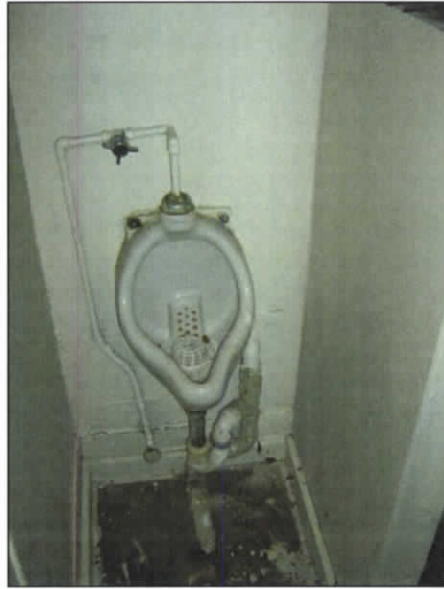
Rest Rooms — Men's and Women's

The two rest rooms are now labeled men and women. Both were designed to have two toilet fixtures. The men's room currently contains a urinal and a toilet. The fixtures are not the originals. There is some water damage in this area of the building, but their conditions were not surveyed in great detail because the rest rooms contain very little original material and because they are small enough that restoration of original wall and trim finishes would not be costly (they were also very difficult to photograph). Nearly everything in these two spaces can be assumed to be appropriate for removal and replacement in either a restoration or a rehabilitation project.

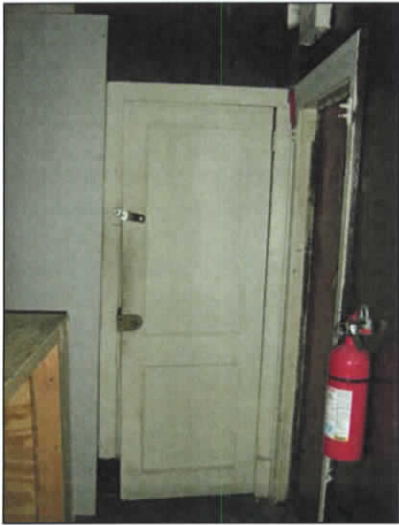
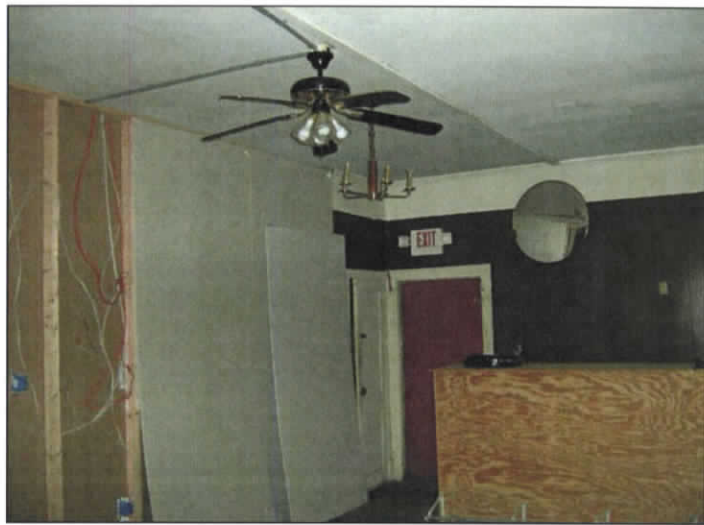
Storage Room

The storage room in the building's southwest corner is not believed to be original. The two partition walls that define it, constructed as gypsum wallboard on wood studs, were erected with wallboard on only one side of the studs. The room is not part of the original plan and is not believed at this writing to be of an early date. It is expected that the room would be removed and the original surfaces of the older walls (south and west sides) would be restored in virtually any new use of the building. Adjoining this room, to the east, is an unfinished project of erecting one more partition of wallboard on studs in line with the north wall of the storage space and extending toward the location of the current kitchen. This wall likewise is only finished on one side and is likely to be removed in any restoration or rehabilitation of the building. Over these two adjoining spaces is the section of the roof that has failed the most. The roofing has developed holes. It has also been patched, but the patch now appears to be failing, and the surface of the roof has become concave under the new shingles, suggesting that the sheathing and some of the truss members have rotted in this area. As a result, a sizable section of the ceiling is missing. These materials will need to be replaced, and some adjoining studs and wallboard may need to be replaced, reinforced, or otherwise repaired.

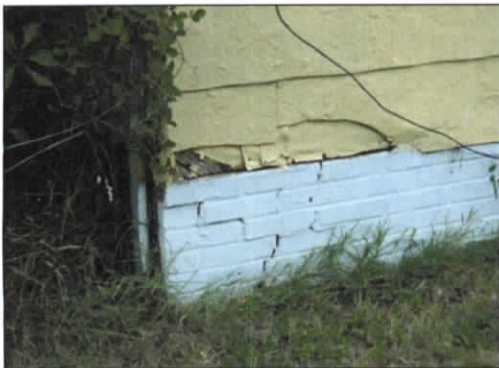
The bricks are slightly out of alignment at the building's southeast corner. They have broken free from the mortar, which resulted in only a few individual bricks breaking. Breaks appear near the center line of two or three bricks, and the alignment is out of plane only about 1/4" in the spot where it is most apparent. The siding is also broken in the same area, exposing a small portion of the sheathing at the edge. The sheathing has begun to deteriorate as a result. The problem most likely began as a minor shift in the alignment of the overall building, but became localized at a weak spot as a result of the "J" bolt fasteners holding the assembly tight in most other locations.

The building has moved slightly out of alignment at the southeast corner, resulting in a crack that runs through several courses of brick, mostly at mortar joints, but also cutting through at least two or three bricks that have broken at their centers. The bricks along this crack are out of plane, at the worst spot, by about 1/4" (or less). The movement may have occurred in the soils beneath the building, and/or it could be a sign of moisture problems. However, the movement appears to be limited, is probably not a sign of greater structural problems, and it is something that could be easily repaired, to return the wall to plumb and structural uniformity, as well as to correct the aesthetic aspect of the defect. The structural engineering report prepared for the current owner (see copy in the appendix to the current report) makes reference to cracks in the west end of the foundation, but not the southeast corner. Since cracks in the west end of the foundation were not observed in the survey for the current report, this is taken as possibly a compass direction error. The structural engineering report also raises concerns about the chimneys leaning. This may be the case, but, once again, the brick of this era behaves monolithically. The chimneys were not felt to be dangerously out of plumb when the survey for the present report was undertaken (the survey was conducted several days after an earthquake struck the Alexandria area, causing dozens of other chimneys to fall; repairs were underway at many locations in the city the day of the survey in anticipation of a hurricane that occurred the day after the survey was conducted; neither these events nor the hurricane that occurred in October 2012 caused the chimneys to fall).

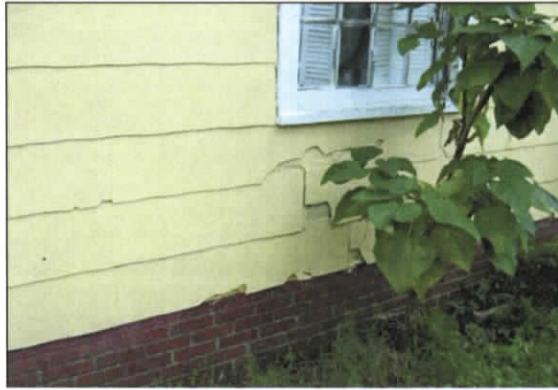
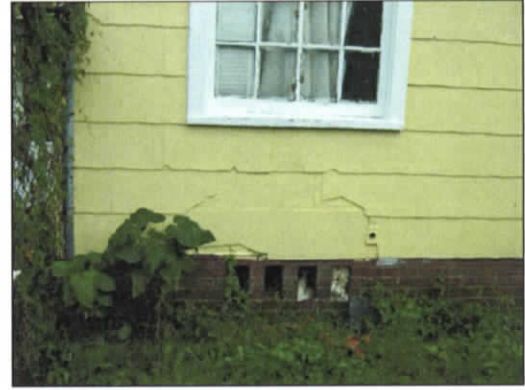
Frame Walls and Exterior Asbestos-Cement Siding

The frame walls are composed of typical wood studs on 16" centers. There is no indication of problems in the wall framing/construction over approximately 80-90% of the exterior. The main potential exception, though, is the area below where the roof has failed along the south wall near the southwest corner (see the bottom left photo on page 68, above, and the photo on page 92, below), where chronic moisture infiltration over an extended period of time may have compromised a small portion of the stud wall framing. This was the least visible part of the building during the survey, both one of the most overgrown parts of the exterior and an area where the interior walls were not fully accessible because of an incomplete remodeling project, floor problems, and material stored there. Otherwise, the exterior surface of the walls appears to be reasonably watertight, despite a few broken tiles in the asbestos cement siding.

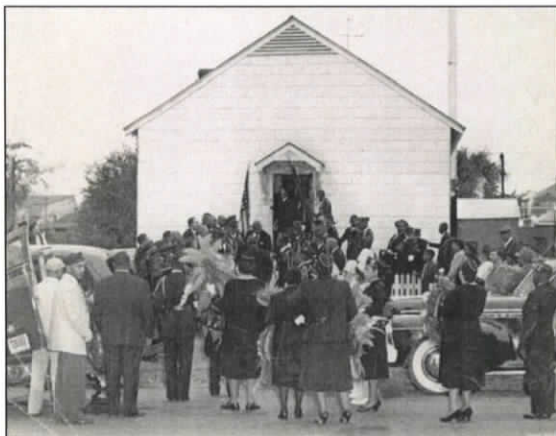
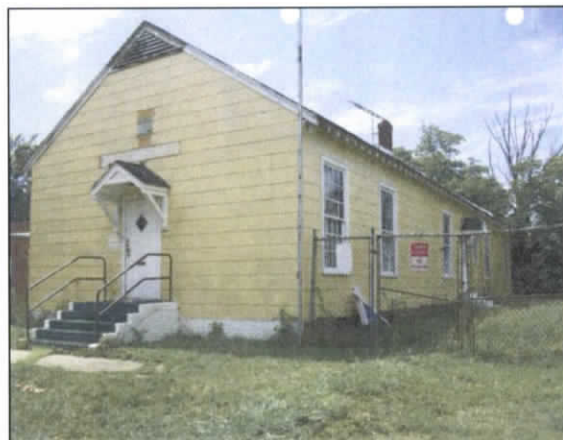
The gable end facing North Fayette Street was painted white and had a simpler appearance in the image on the left. The post later added signs, which were removed when it relocated, leaving scars in the current yellow paint.

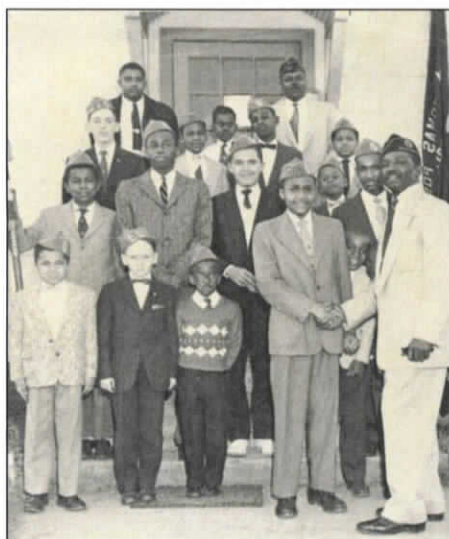
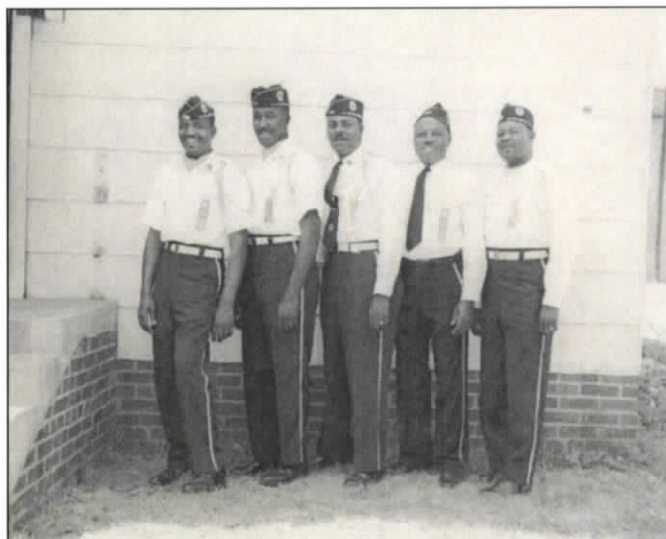
The canopy and door once had a dark paint scheme against the white asbestos shingles (above left). The brick base of the building, however, was not painted (above right). Note the scars in the asbestos shingles where the original wood handrail had been fastened. Though still present, these marks are now filled with a filler material and painted over.
