The Campagna Center

Window Survey

Location: 418 S Washington

Date: 2/17/2002, 12PM-2:15PM

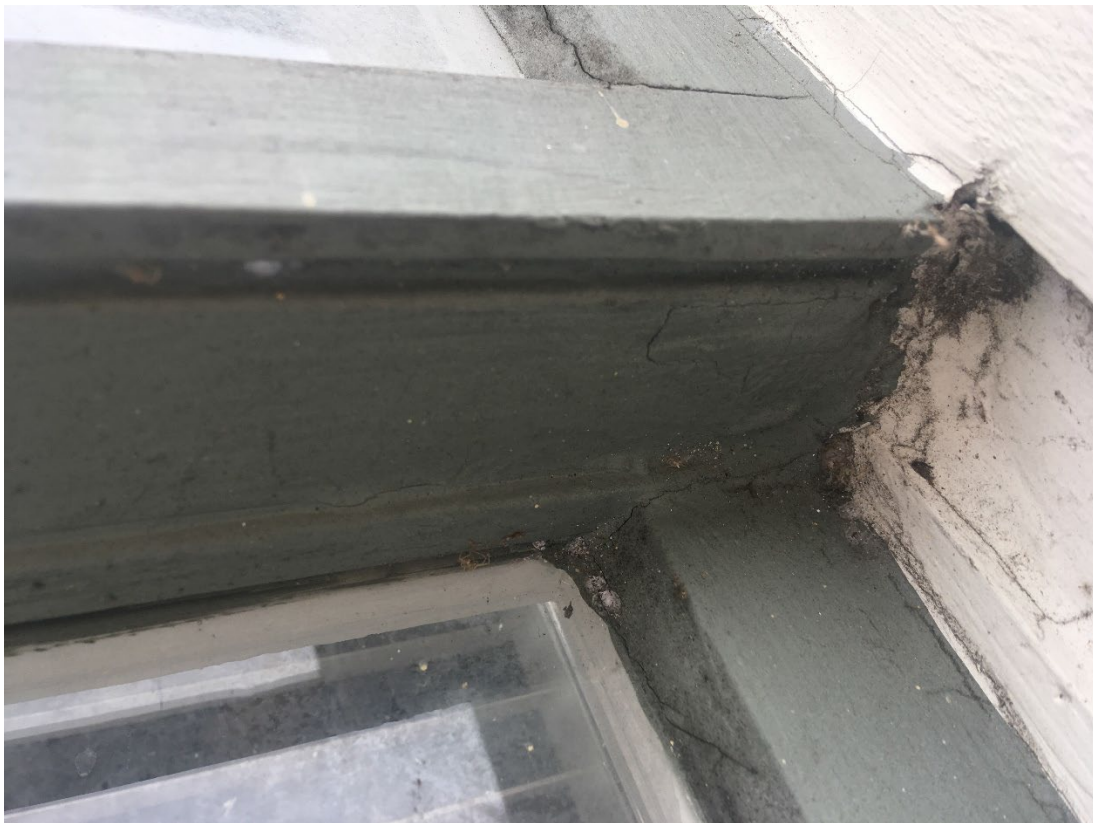
Figure 1: Image showing drip edge routed in the upper sash, typical throughout. This is not a common feature of Victorian period window sash.

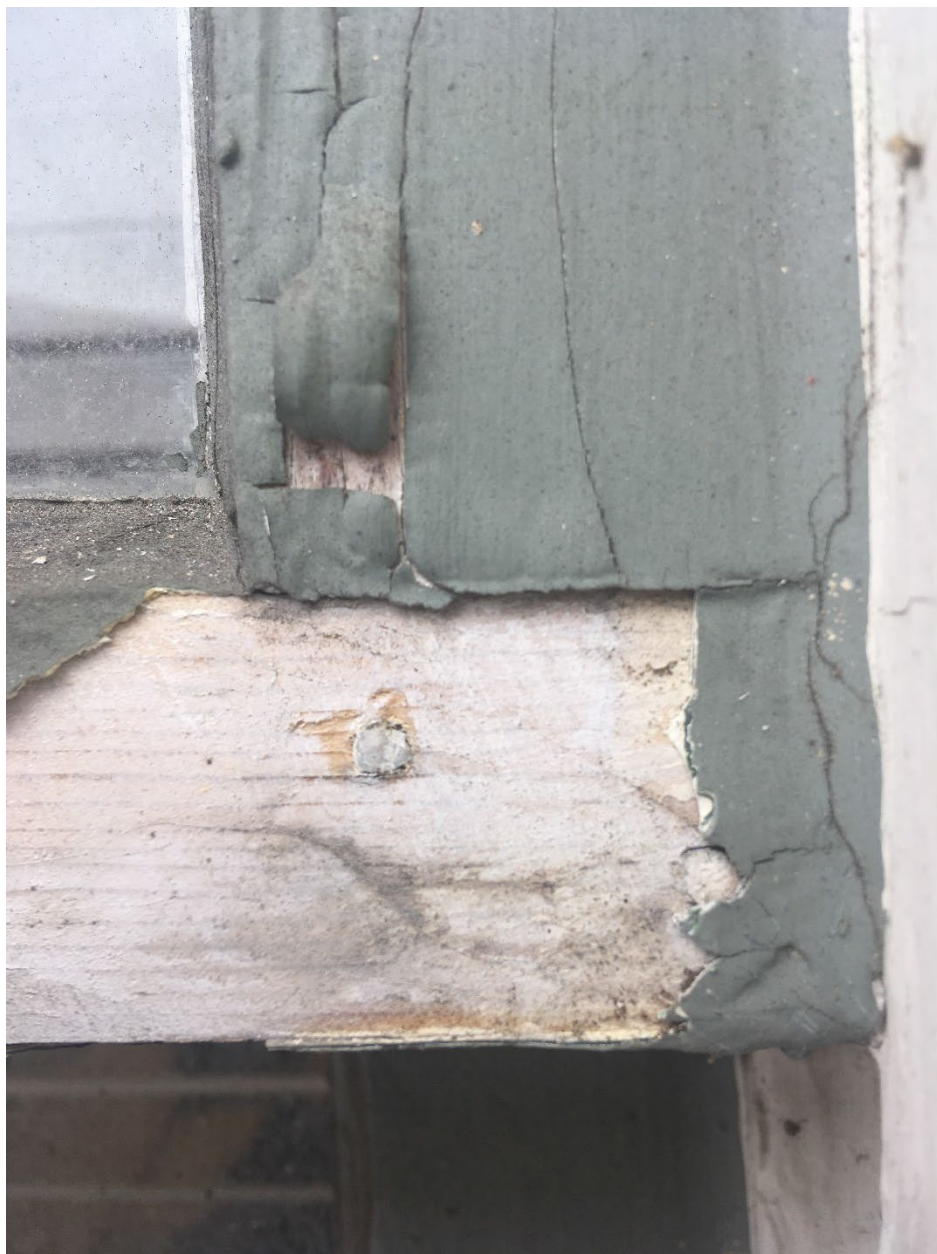
10. No intact Victorian period sash with wood pegs were found anywhere in the building. All of the rail and stile joints in the window sash were nailed, though the rusting finish-nail heads sometimes give the appearance of wood historic pegs through the paint. Several locations were scraped with a knife to confirm the presence of nails below. (see photos)

Figure 2: Iron finish nails at stile and rail joint, typ.
