MEMORANDUM

RE: WARWICK POOL - FACILITY ASSESSMENT
3301 LANDOVER STREET, ALEXANDRIA, VA

SUBJECT: DEPARTMENT OF GENERAL SERVICES FACILITY ASSESSMENT, WARWICK POOL- 3301 LANDOVER STREET, ALEXANDRIA, VA

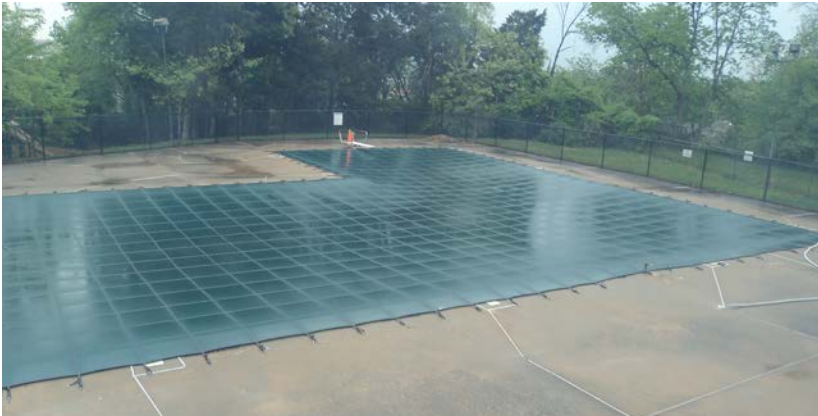
MAIN POOL DECK

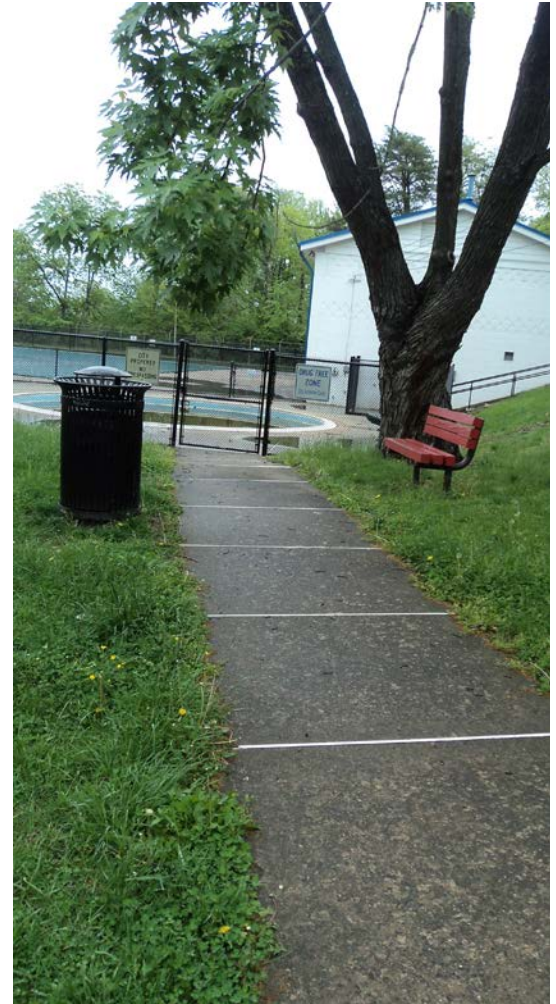
- Remove and Replace Concrete Sidewalk Including Re-grading to Meet ADA Standards from Landover Street to the children's wading pool
- Drainage System Cleaning - Clogged Drains - Damaged Drain Caps & Misc. Equipment Replacement
- Interim Pool Deck Concrete Inspection, Maintenance and Repair of Joints and Failing Concrete Areas
- Remove and Replace Concrete Stair - The existing concrete stairs and handrail appear to be shifting and settling. Cracking exists and slopes of up to 5.5% were observed.

CONCRETE SIDEWALK (T-I-A)

TIER I ITEM DESCRIPTION	LOW COST	HIGH COST
A. REPLACE CONCRETE ACCESS PATH		
Demolish Existing Concrete Path - Rebuild and Regrade per ADA Standards - Adjust slope and tripping hazards - Approx. 70' in Length	10,000.00	20,000.00
Total: includes additional General Conditions 12%, Design 10%, Contingency 20%	14,200	28,400

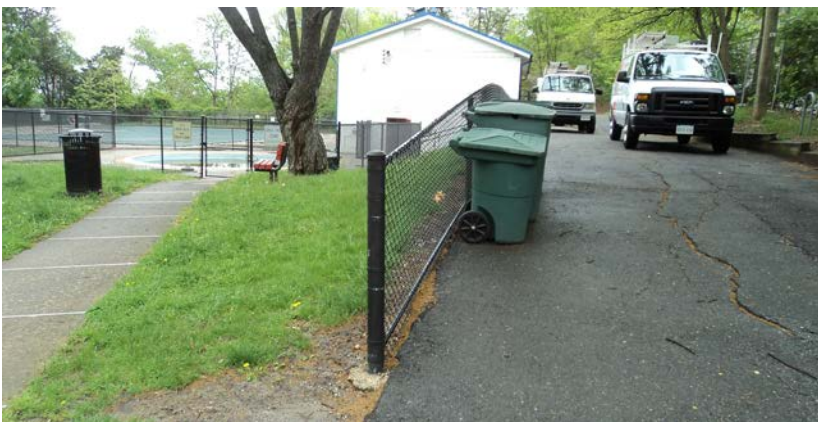
- Repair Asphalt Drive and Entrance Areas - The asphalt entrance shows severe damage. Sinking and heaving was evident near the street as well as consistent cracking throughout. Steep slopes of up to 6.5% were observed at the upper level entrance.

ASPHALT ENTRANCE DRIVE (T-II-C) AND CONCRETE SIDEWALK (T-I-A)

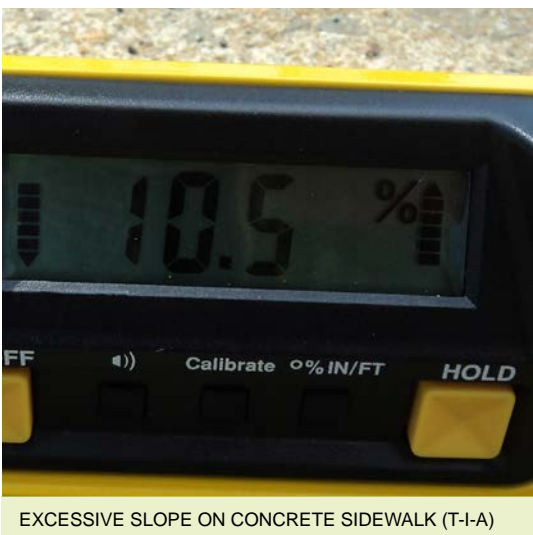
EXCESSIVE SLOPE ON CONCRETE SIDEWALK (T-I-A)

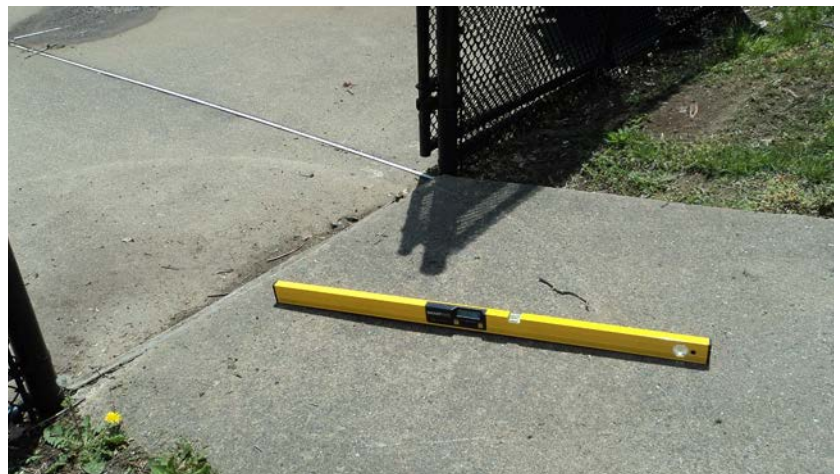
CONCRETE SIDEWALK TRIPPING HAZARD AND EXCESSIVE SLOPE AT WADING POOL ENTRANCE AND CONNECTION (T-I-A)

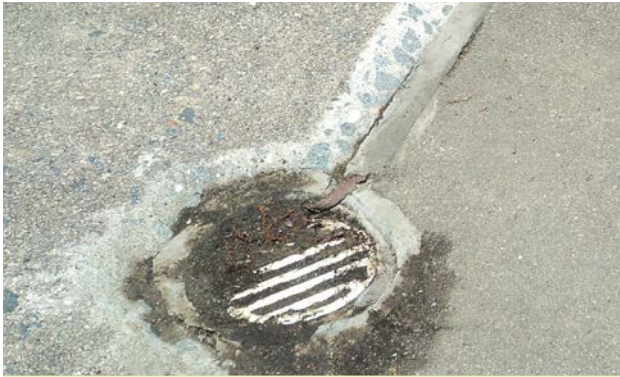
The majority of the pool deck drains were clogged during site observations. A new drainage system with larger diameter piping is recommended along with pool deck replacement to provide proper slope and drainage.

CLOGGED POOL DECK DRAINS (T-I-B)

B. POOL DECK DRAIN INSPECTION / CLEANING		
Clean and Flush Existing Drain System - Replace Damaged Surface Equip.	2,000.00	5,000.00
Total: includes additional General Conditions 12%, Design 10%, Contingency 20%	2,840	7,100

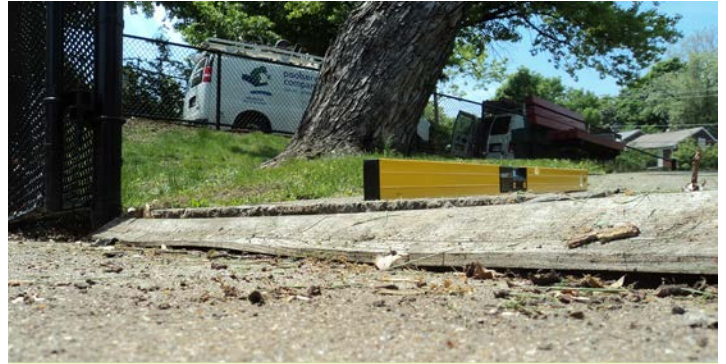
TRIPPING HAZARD AT CONCRETE SIDEWALK ENTRANCE TO WADING POOL (T-I-A)

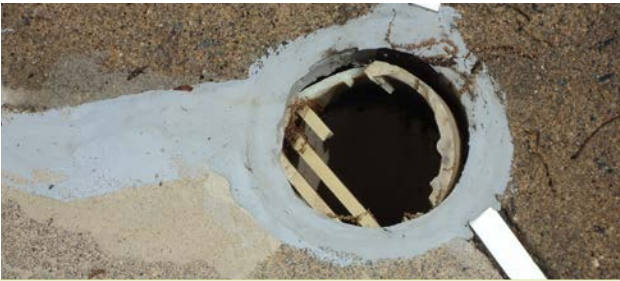
DAMAGED POOL DECK DRAIN (T-I-B AND T-II-B)

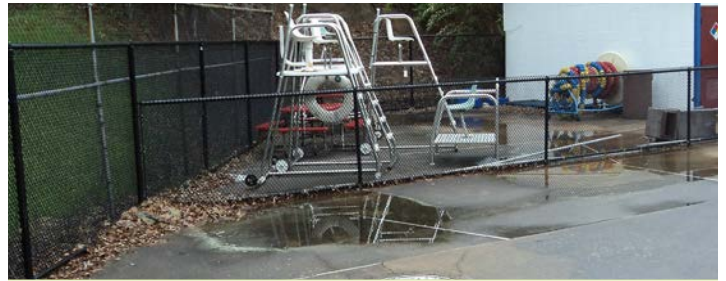
STANDING WATER - CLOGGED POOL DECK DRAINS (T-I-B)

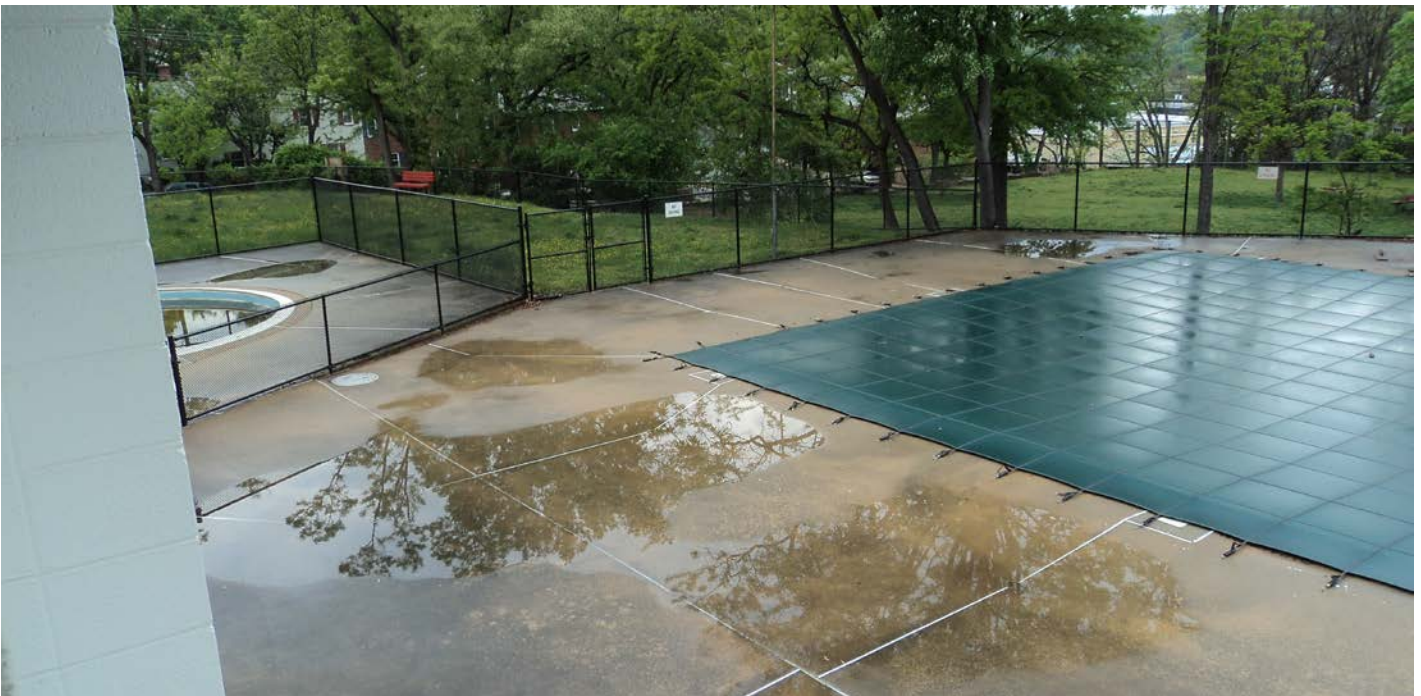
STANDING WATER - CLOGGED POOL DECK DRAINS (T-I-B, T-I-D, AND T-II-A, T-II-B)

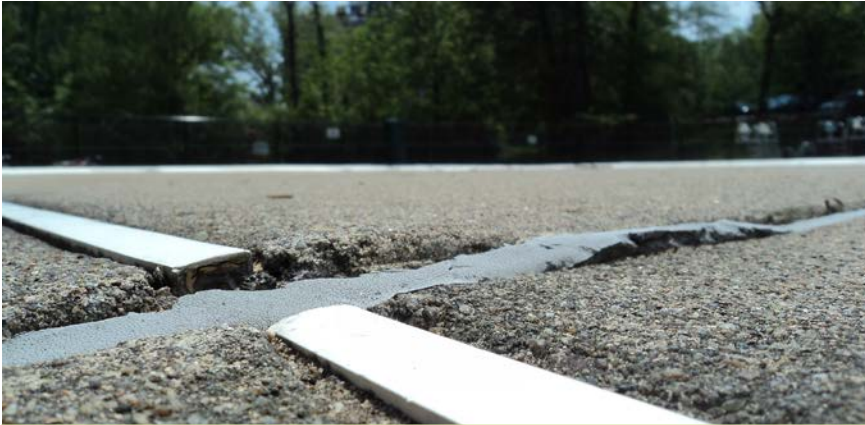
Previous repairs to the concrete pool deck have been made (2009 Poolservice Company), mainly near the diving board area. Other areas of failing concrete exist that have not been patched which need immediate attention. Tripping hazards were also observed at failing concrete joints. Limited areas within the pool deck will need patching, sealing or replacement prior to full replacement of the entire pool deck.

FAILING AND DAMAGED CONCRETE JOINTS (T-I-D)

D. INTERIM POOL DECK CONCRETE AND POOL INSPECTION / PATCHING		
Replace Damaged and Failing Areas of Concrete to Minimize Tripping Hazards, Re caulk Coping and Expansion Joints, Stabilize Eroding Concrete Slab Sections, Replace Broken Pool Tiles and Grout as Necessary	20,000.00	30,000.00
Total: includes additional General Conditions 12%, Design 10%, Contingency 20%	28,400	42,600
Totals for Tier I Items (Soft Costs Included):	65,320	105,080

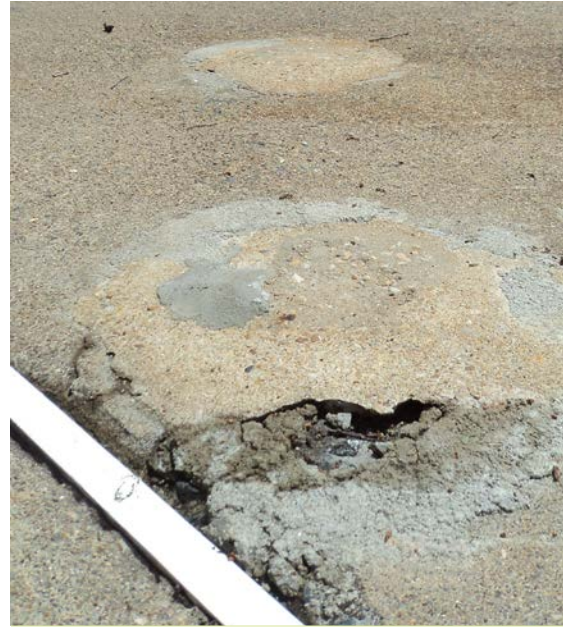
FAILING AND DAMAGED CONCRETE AND JOINTS (T-I-D)

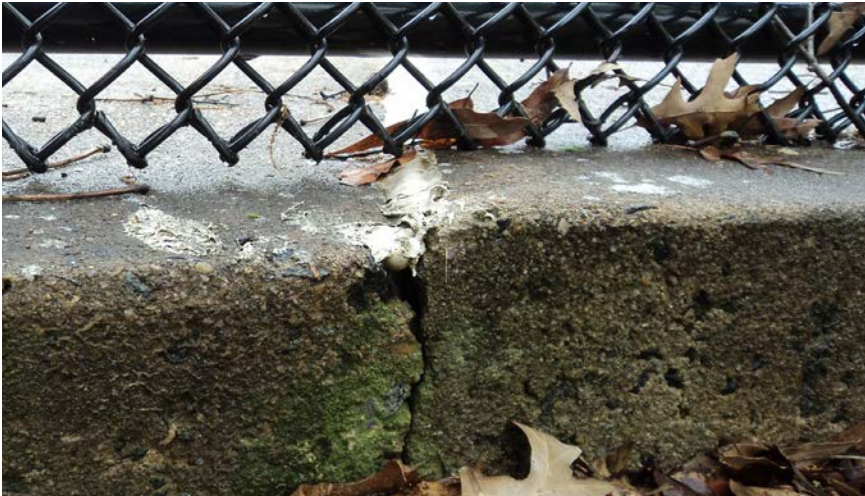
- Replace Concrete Pool Decking - The concrete pool decking's surface was observed to have slopes in the range of 1%-5.5% with an average of 3.5% slope at the drains, exceeding general pool deck slope standards. Tripping hazards were evident at joints and material changes. Full concrete deck replacement will be necessary after interim repairs have been made.

FAILING CONCRETE POOL DECK (T-II-A)

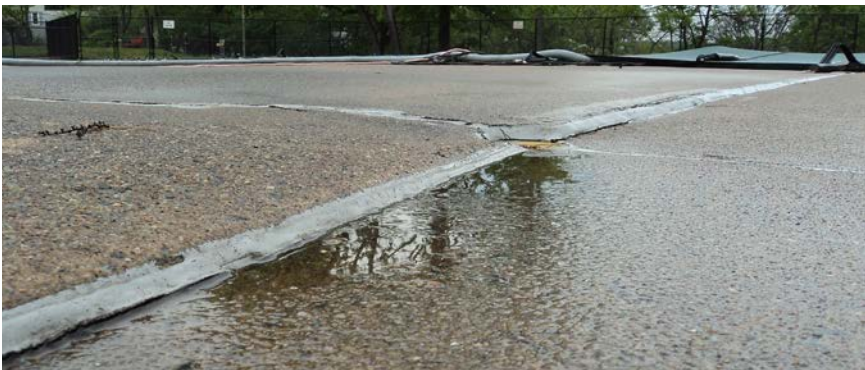
FAILING AND DAMAGED CONCRETE JOINTS (T-I-D)

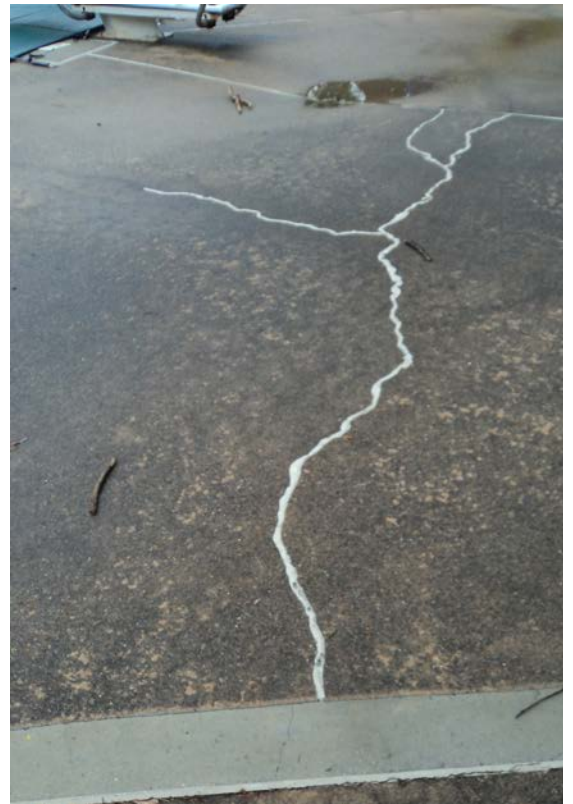
FAILING CONCRETE POOL DECK (T-I-D AND T-II-A)

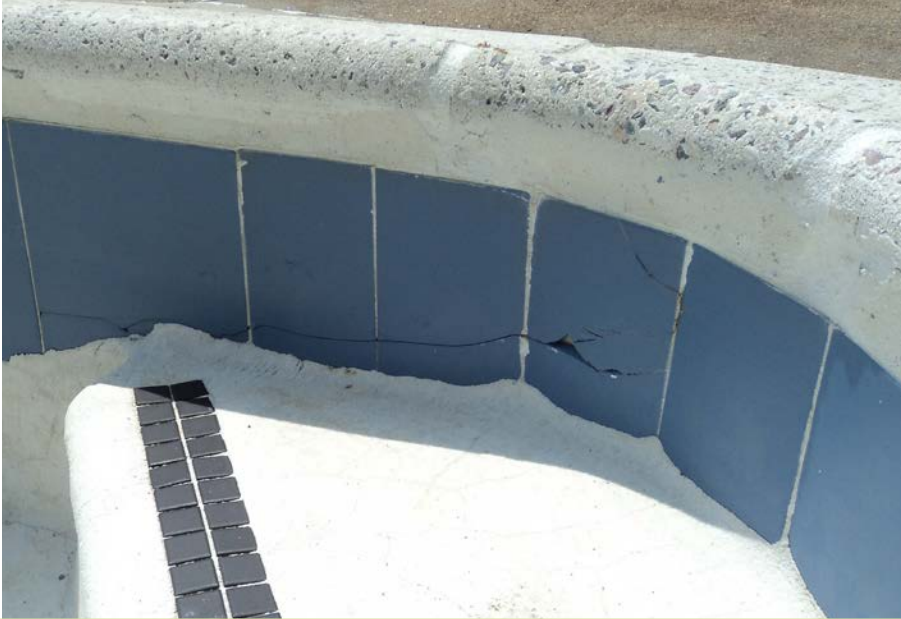
The sealant around the coping in some areas of the main pool and wading pool was noticed to be deteriorating. Cracks were evident in some of the tiles below the coping in both the main pool and the wading pool. The wading pool shows consistent cracking around the wall. Poolservice company has noted this consistent crack on the wading pool during pool servicing since 2009.

CRACKING POOL TILE (T-I-D AND T-III-A)

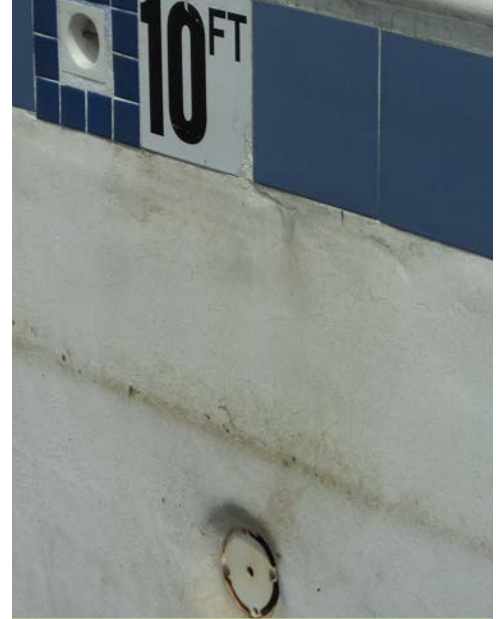
CRACKING POOL TILE (T-I-D AND T-III-A)

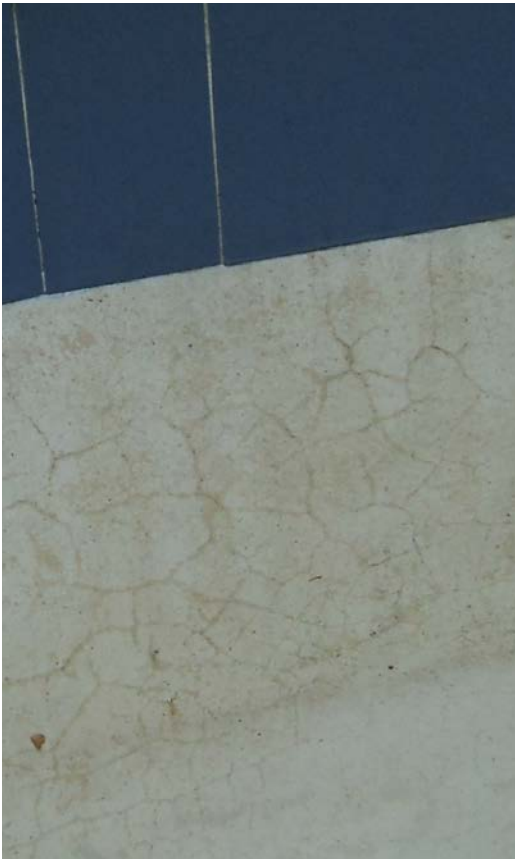
The current outer surface of the main pool walls appear to be in usable condition. Poolservice Company reported re-plastering of the main pool in 2009. Light cracking and crazing exists in the top 3-4 ft portions of the wall. The Camp Dresser & McKee report (CMD, 2001) noted these areas to have cracking and significant structural deterioration at the time of their inspection due to the probable penetration of water through the wall layers. The report found that multiple pool walls exist and that replacement of the liner would not be a permanent or recommended solution.

CRACKING / CRAZING IN POOL WALL (T-III-A)

Demolish and Replace Existing Pool Walls / Liner / Coping and Equipment (Pool Deck and Drain System Not Included)	350,000.00	450,000.00
---	------------	------------

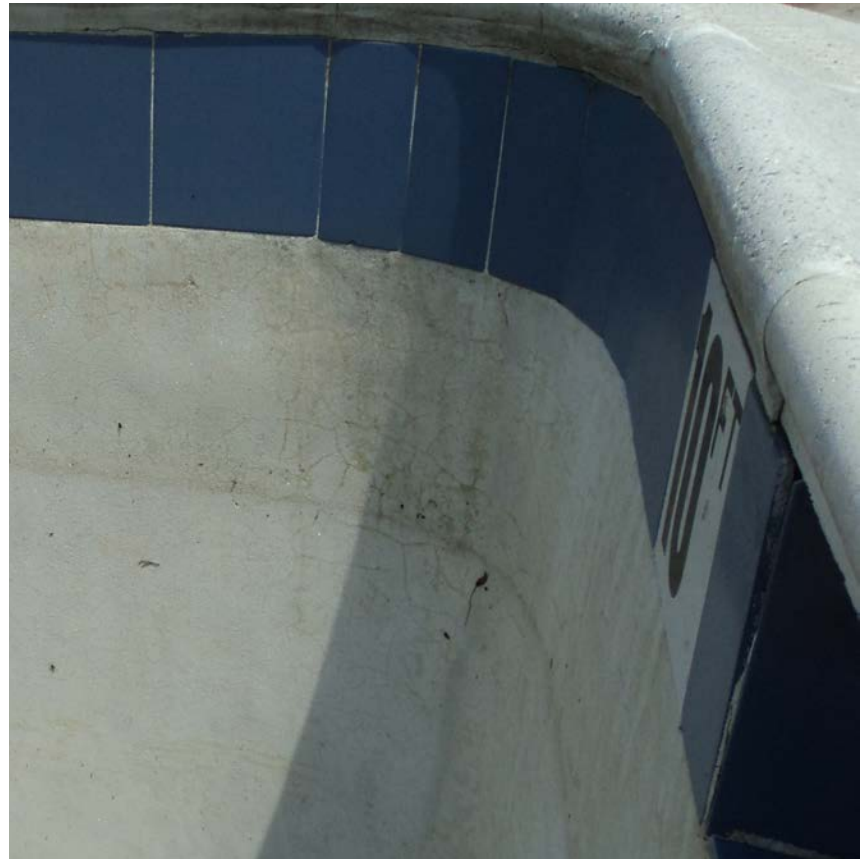
CRACKING / CRAZING IN POOL WALL (T-III-A)

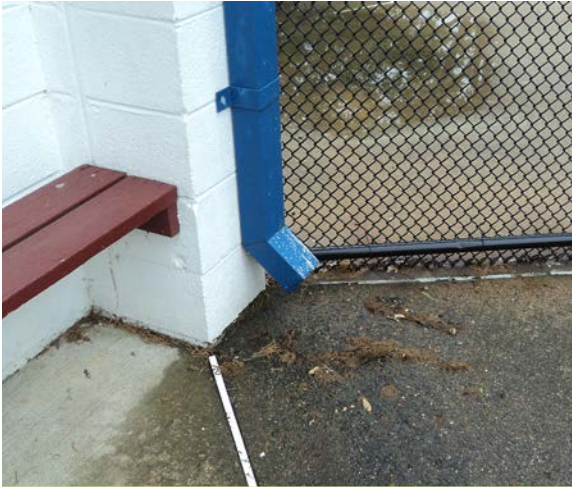
- Replace Pool Drainage System and Incorporate New Foundation Drains / Roof Connections - The clogged drains will need to be upgraded to handle a larger capacity. The existing roof leaders direct water onto the pool deck and back into the buildings foundation. Drains need to be installed to direct water away from the building.

ROOF LEADERS AT POOL DECK WITH NO GROUND LEVEL CONNECTIONS (T-II-B)

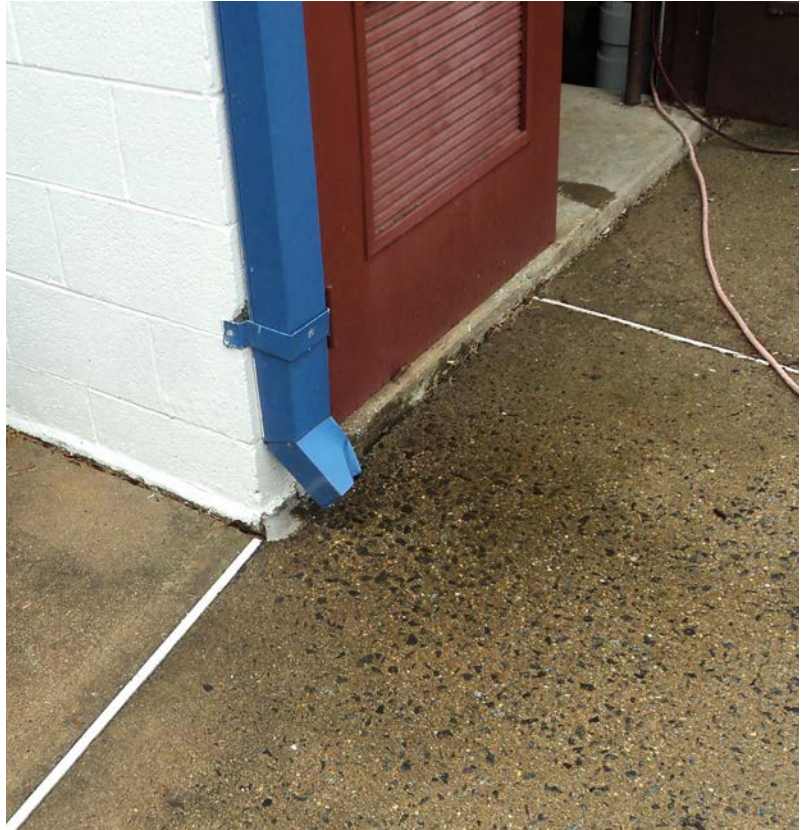
ROOF LEADERS AT POOL DECK WITH NO GROUND LEVEL CONNECTIONS (T-II-B)

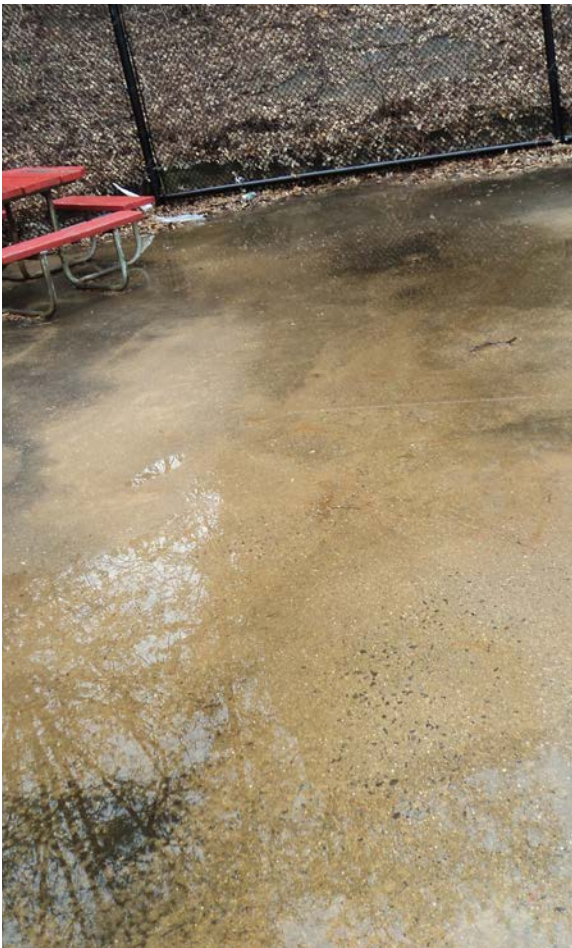
STANDING WATER - CLOGGED POOL DECK DRAINS (T-I-B)

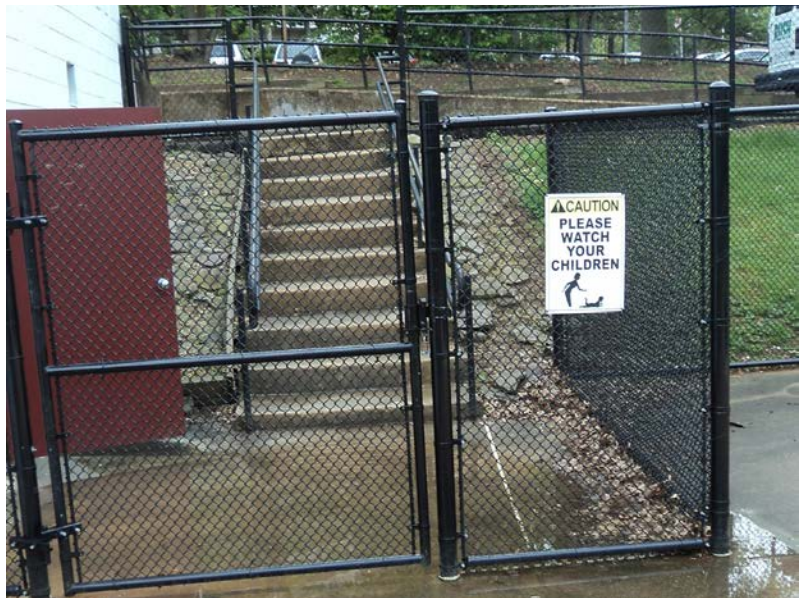
STANDING WATER - CLOGGED POOL DECK DRAINS (T-I-B) AND IMPROPER SLOPE CONDITIONS OF POOL DECK (T-I-D AND T-II-A)

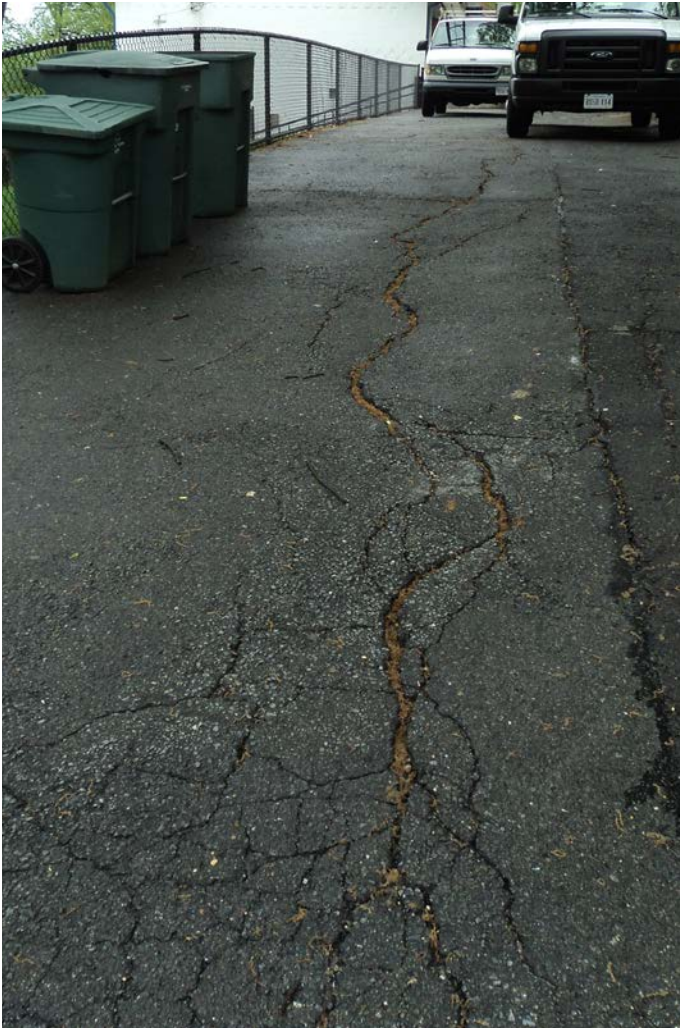
FAILING ASPHALT ENTRANCE (T-II-C)

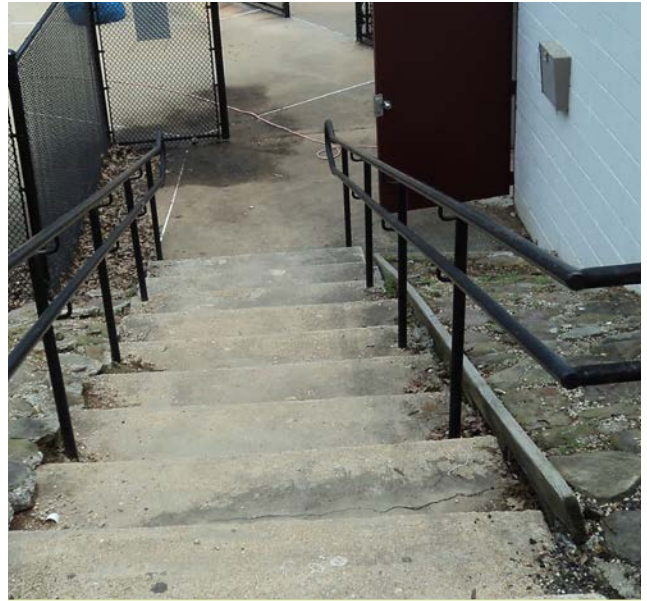
FAILING CONCRETE STAIRS (T-I-C AND RECOMMENDED T-III-C)

C. CONCRETE STAIR AND HANDRAIL REPLACEMENT		
Remove and Replace Existing Concrete Stairs and Handrail	14,000.00	19,000.00
Total: includes additional General Conditions 12%, Design 10%, Contingency 20%	19,880	26,980

Regrade & Construct new multi platformed ramp in addition to concrete stairs	55,000.00	75,000.00
--	-----------	-----------

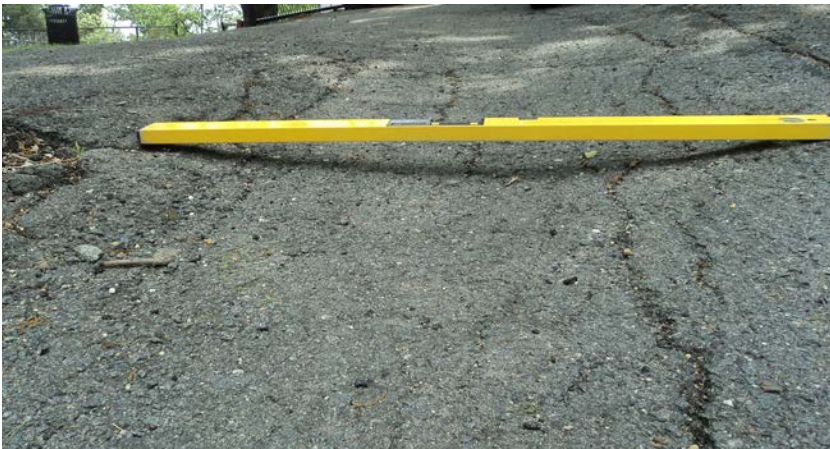
FAILING ASPHALT ENTRANCE (T-II-C). SEVERE SETTLING AND SHIFTING

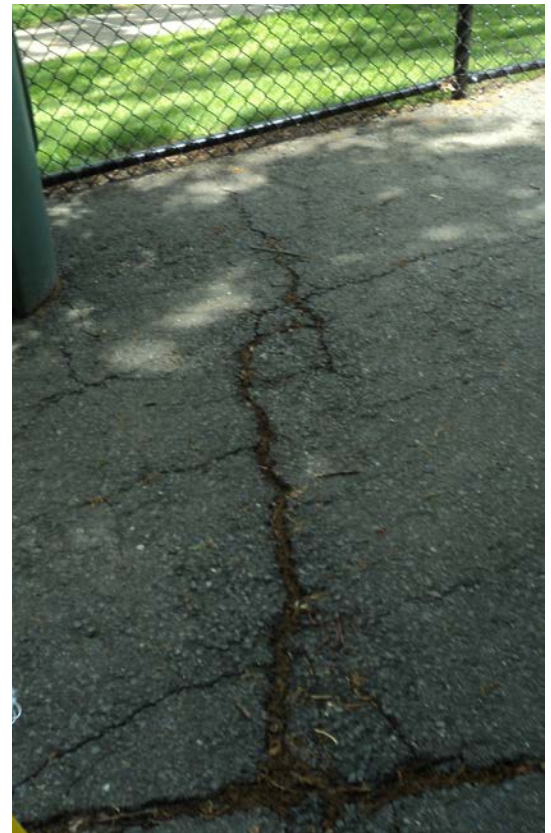
FAILING ASPHALT ENTRANCE (T-II-C)

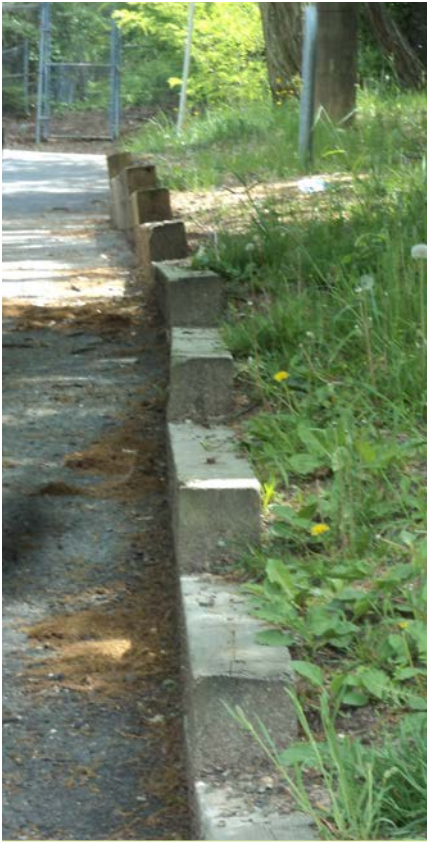
- Replace Concrete Stabilization and Timber Retaining Walls - The existing concrete stabilization wall is overgrown with vegetation and appears to direct water into the building. The timber retaining wall adjacent to the asphalt entrance is significantly warped and shows signs of damage.

TIMBER RETAINING WALL UNDER PRESSURE (T-II-D)

Demolish and Remove / Replace Existing Concrete Stabilization Wall and Timber Retaining Wall - Provide Proper Drainage and Backfill	100,000.00	140,000.00
---	------------	------------

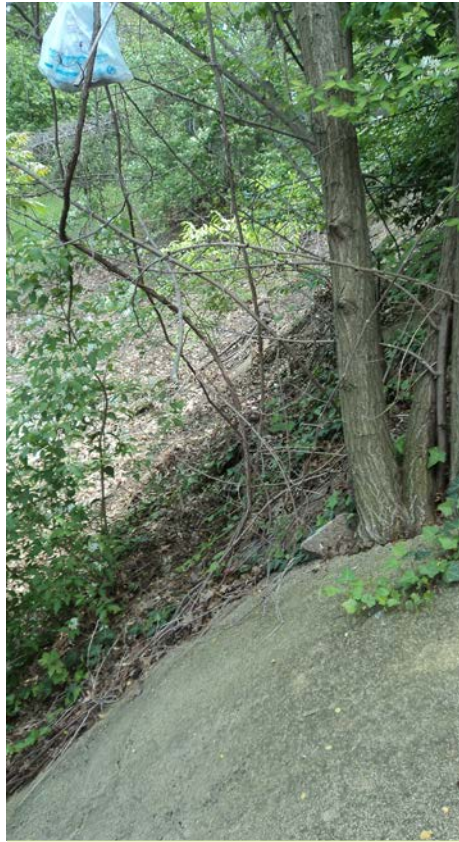
OVERGROWN CONCRETE WALL AT REAR OF BUILDING (T-II-D)

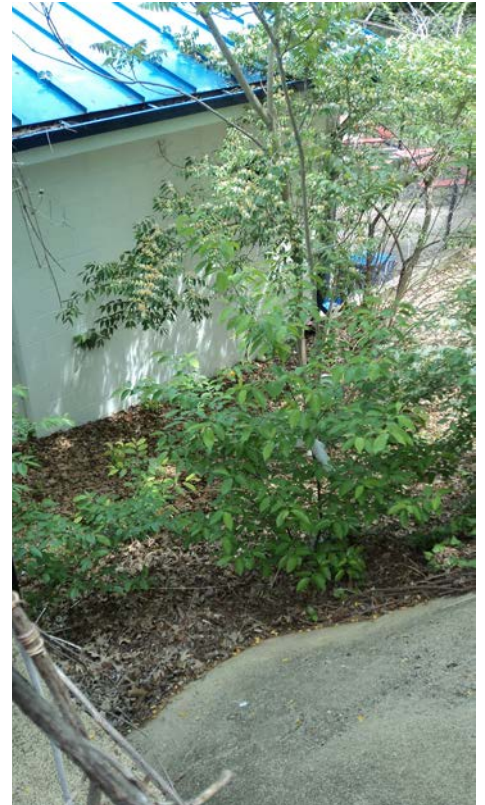
OVERGROWN CONCRETE WALL AT REAR OF BUILDING DIRECTING WATER TOWARDS BUILDING (T-II-D)

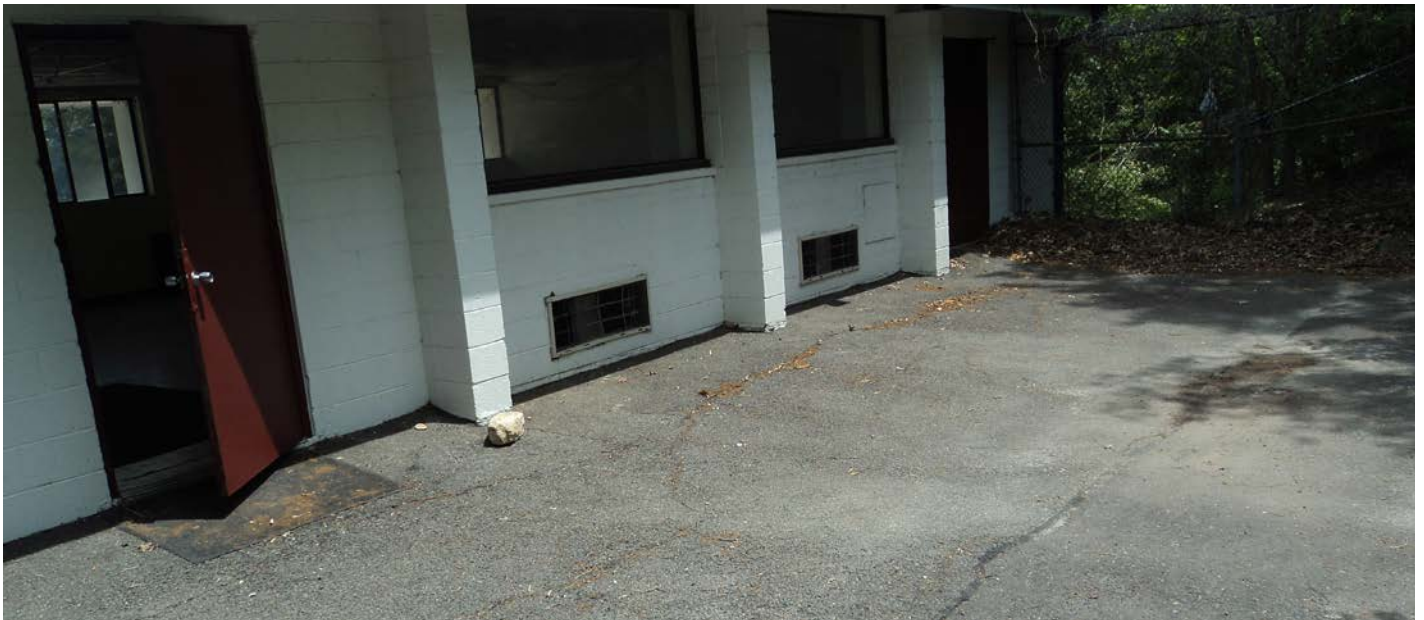
ASPHALT AT UPPER LEVEL ENTRANCE - CRACKING AND SLOPE ISSUES PRESENT (T-II-C)

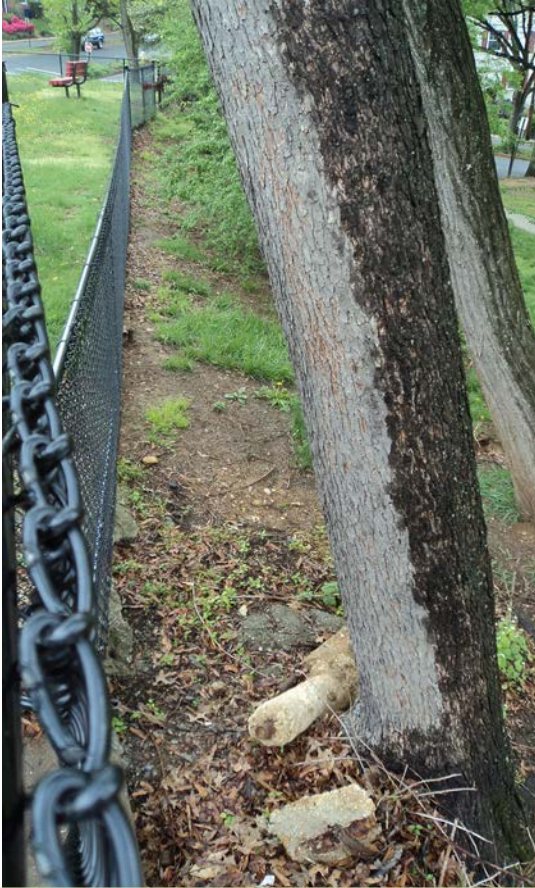
- Tree Removal Along Pool Fence - An existing Cherry along the NW pool fence corner encroaches on the pool deck area and is recommended to be removed.
- Replace Site Lighting - The site lighting was observed to be damaged. The northern pole was shifted and angled. Multiple electrical connections did not have proper weather proofing.

VEGETATION TO BE REMOVED AT NORTH FENCE LINE (T-II-E)

Remove Locust and Cherries Along Pool Fence	2,000.00	4,000.00
---	----------	----------

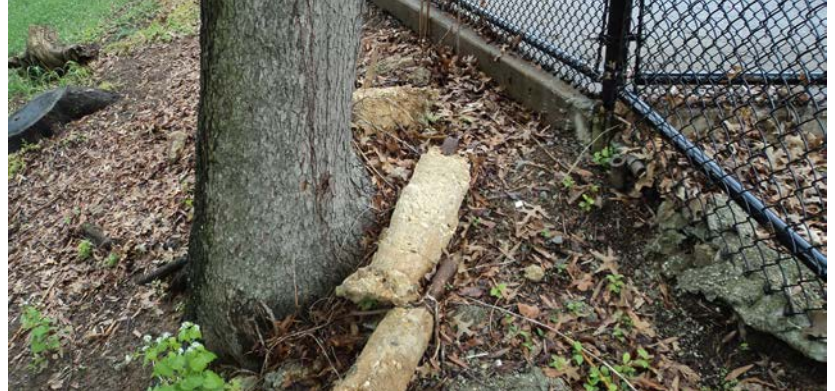
VEGETATION TO BE REMOVED AT NORTH FENCE LINE (T-II-E)

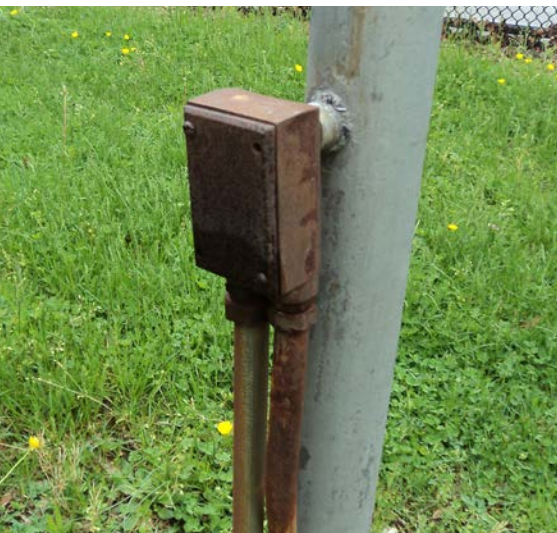
AGING LIGHTING EQUIPMENT - NO SEALS (T-II-F)

Remove and Replace Existing Site Lighting	18,000.00	26,000.00
---	-----------	-----------

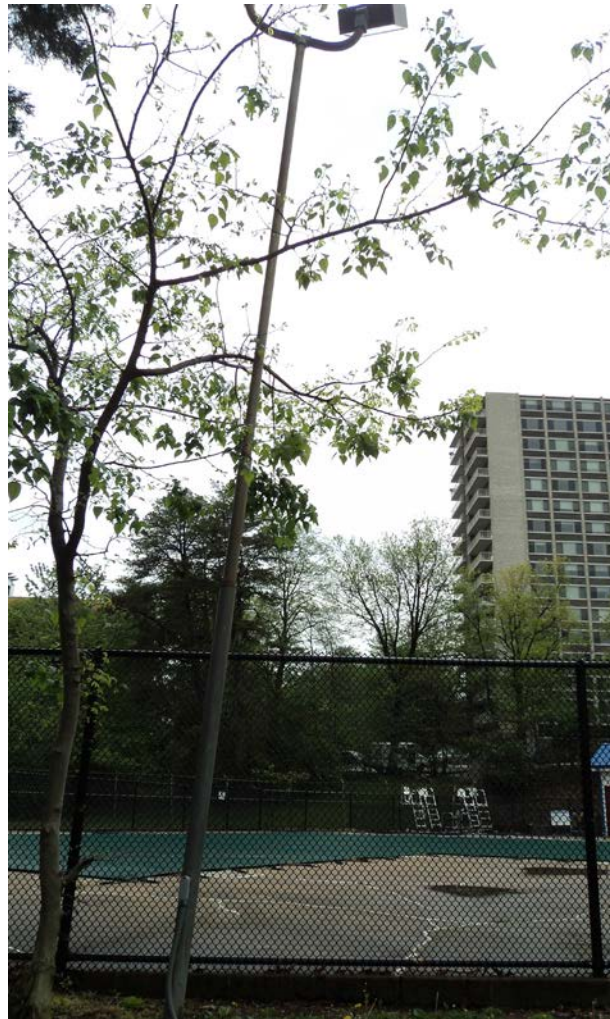
LEANING LIGHT POLE ALONG NORTH FENCE LINE (T-II-F)

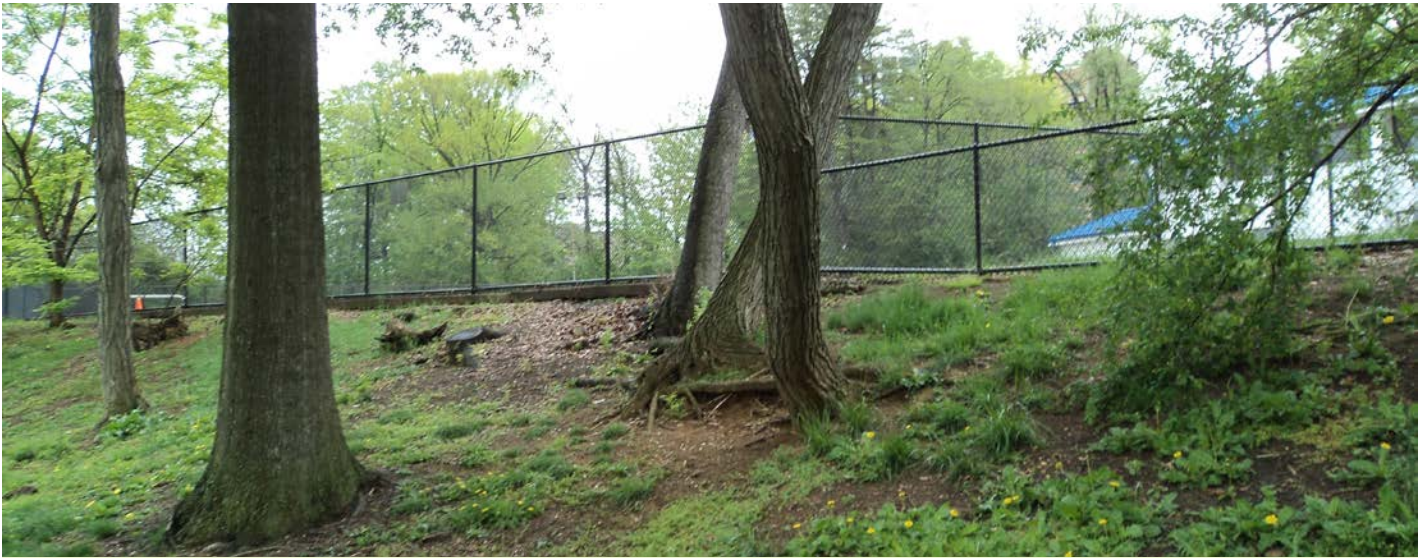
- Site Grading, Stabilization, and Drainage Improvements - The existing roof leader at the upper building entrance directs water down the asphalt drive, around the ramped retaining wall, and down the grassed bank towards the wading pool. Erosion was evident and no proper drainage system was in place. The northern side of the concrete pool deck facing the playground is situated on an eroding slope. The base is not stabilized below the edges of the concrete pool deck will need modification.

ERODING NORHERN SLOPE AT POOL DECK BASE (T-II-G)

Regrade Eroded Areas and Implement Drainage Systems	30,000.00	50,000.00
---	-----------	-----------

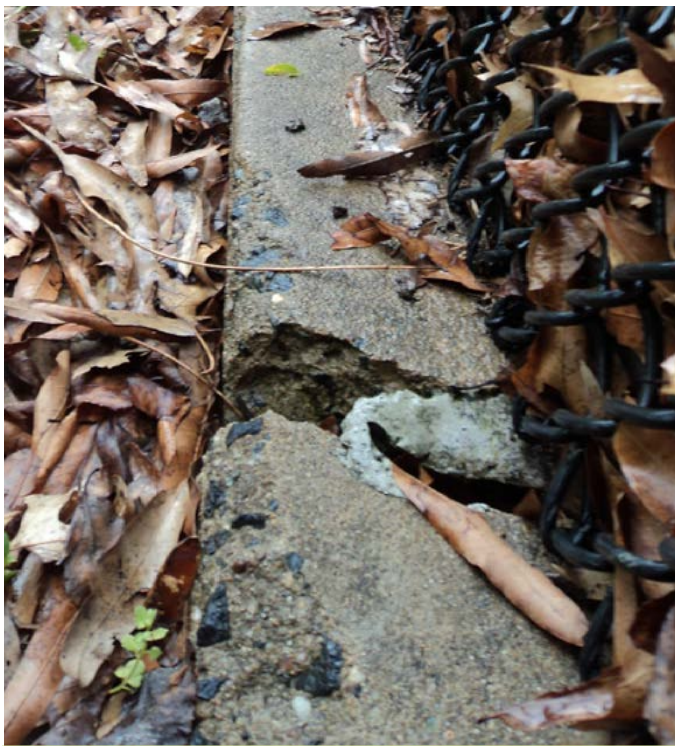
FAILING CONCRETE POOL DECK (T-II-A)

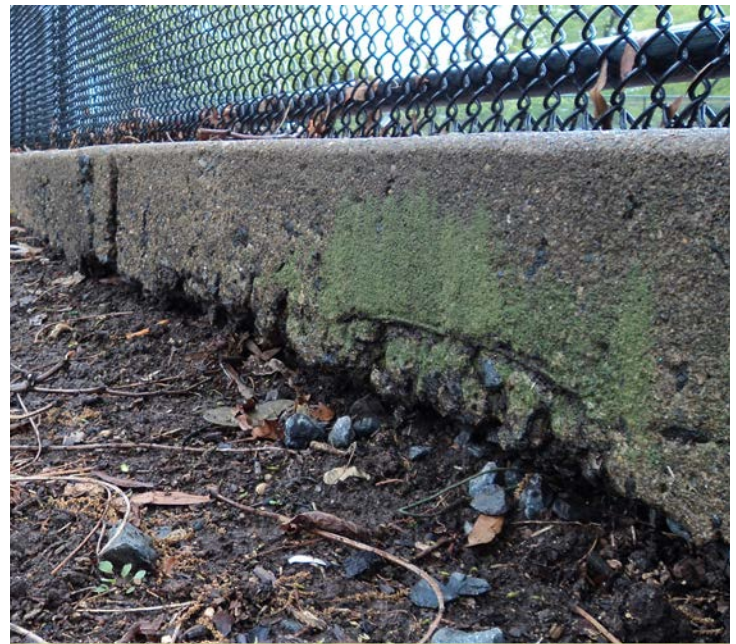
ERODING NORHERN SLOPE AT POOL DECK BASE (T-II-G)

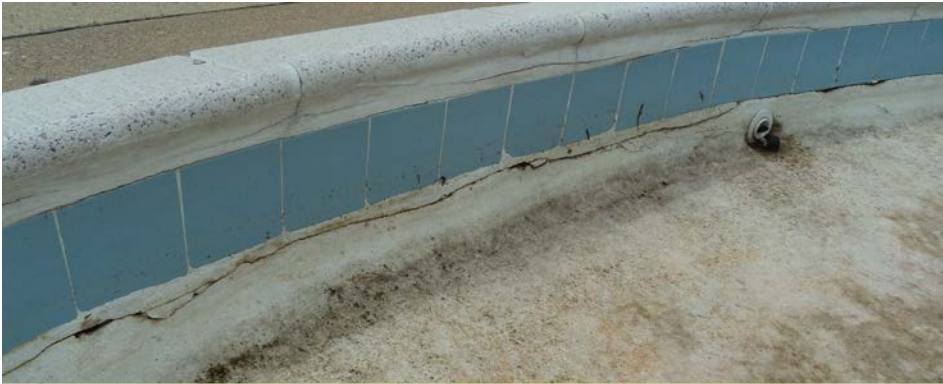
CONSISTENT CRACK AT WADING POOL (T-III-B)

Replace Existing Children's Pool and Concrete Deck	80,000.00	100,000.00
--	-----------	------------

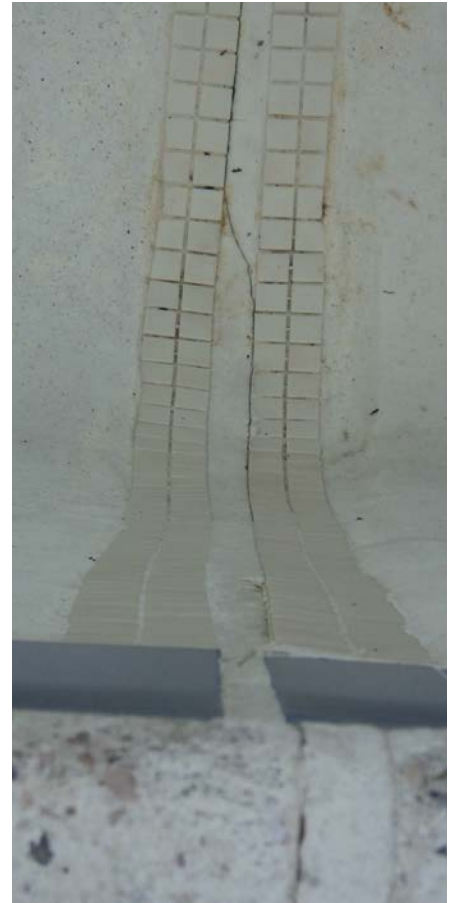
CRACKING ALONG POOL WALL AND FLOOR (T-III-A)

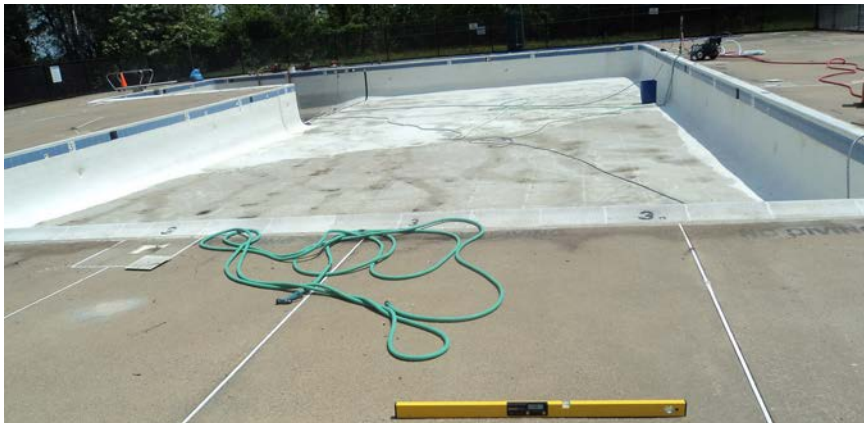
MAIN POOL (T-III-A)

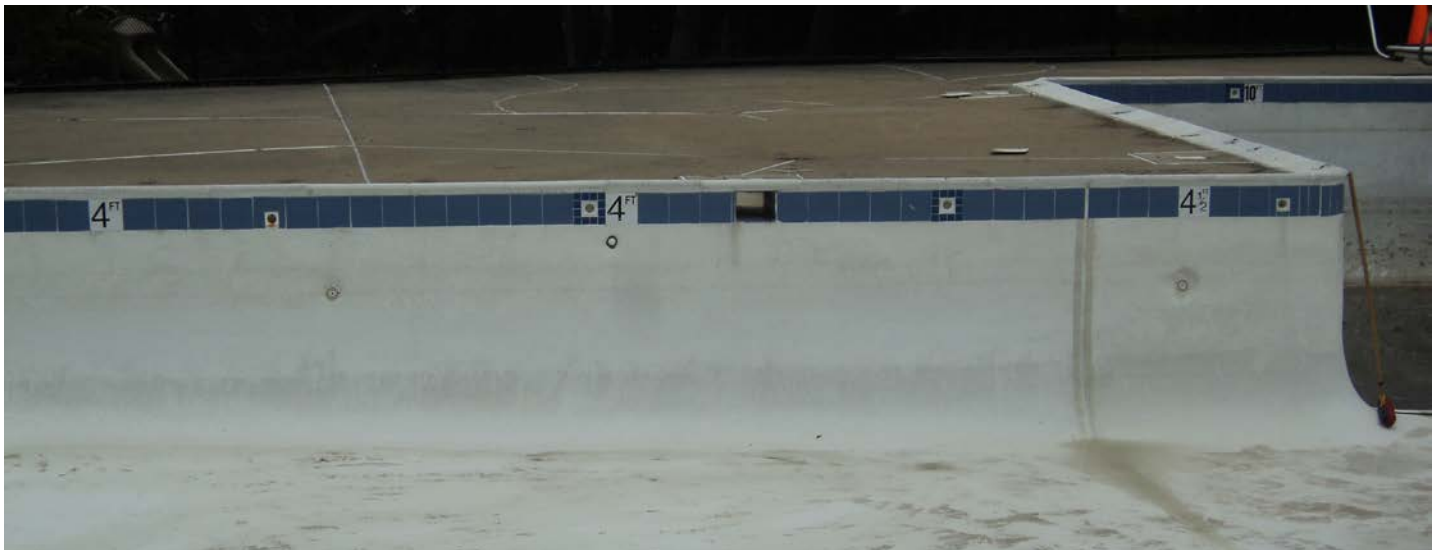
MAIN POOL (T-III-A)
