**City of Alexandria Recreation, Parks,  
and Cultural Activities  
Final Facility Assessment Report**

*November 2015*

Cardno, Inc.  
10988 Richardson Road  
Ashland, VA 23005  
[www.cardno.com](http://www.cardno.com)

Project COA320

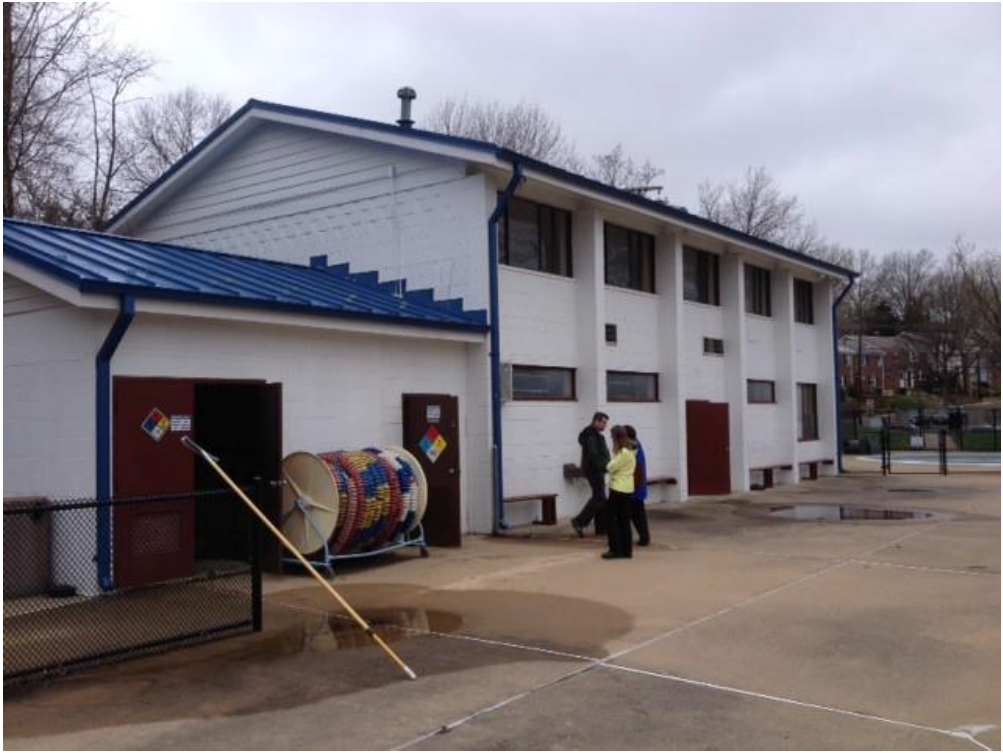
| <b>Date:</b><br>04/08/2015<br><br><b>Description:</b> Warwick Pool- Pool house as viewed from the pool deck looking west. Lower wing shown in the left foreground houses pool water filtration/treatment system; upper floor houses community room; and lower level houses pool bathhouse and office. | | <b>Photo 1</b> | |
