**City of Alexandria Recreation, Parks,
and Cultural Activities
Final Facility Assessment Report**

November 2015

Project COA320

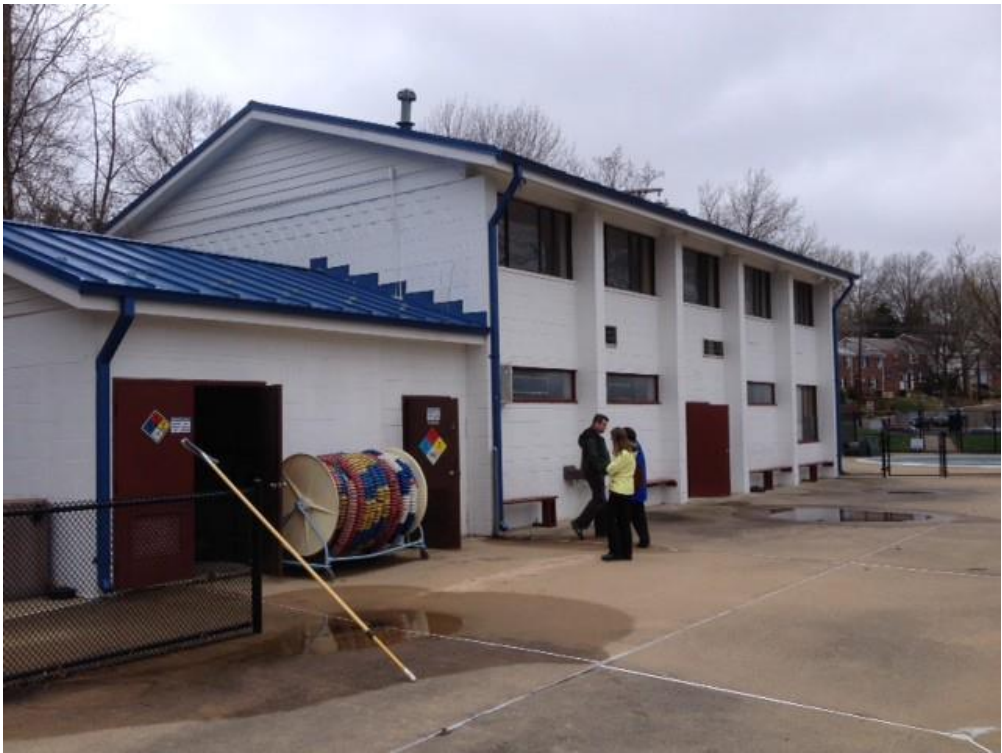
Client:	City of Alexandria	Site Location:	Warwick Pool
Site Name:	Warwick Pool	Project Number:	COA320
Date: 04/08/2015 Description: Warwick Pool- Pool house as viewed from the pool deck looking west. Lower wing shown in the left foreground houses pool water filtration/treatment system; upper floor houses community room; and lower level houses pool bathhouse and office.		Photo 1
