201 Gibbon Street
Alexandria, VA 22314

Request for Alterations:

- Replace two severely damaged, non-original windows on a portion of the building dating to the 1950s, with replacement windows that fully comply with BAR guidelines, as homeowners were previously told they could in written guidance from BAR Staff in July 2022.

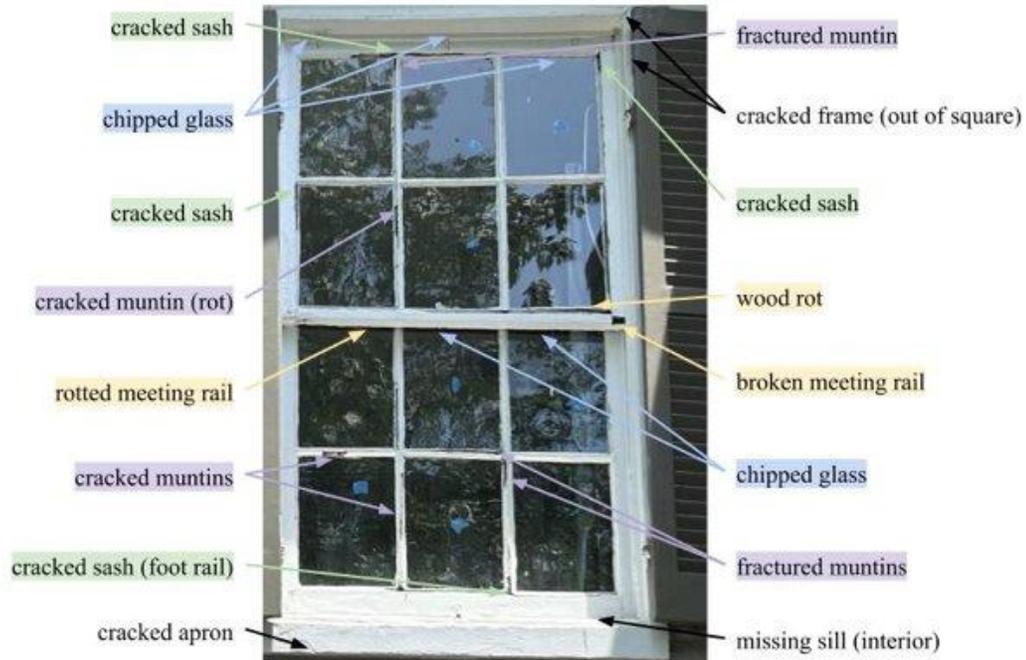
“Paint is about the only thing holding this window together.”

Lack of proper maintenance by the previous owners left these windows riddled with wood rot and completely non-functional. Paint hid the worst of it. But when hidden structural damage to the wall was discovered – requiring immediate remediation for safety concerns - the deterioration cascaded into cracks, splits, and fractures throughout both windows.

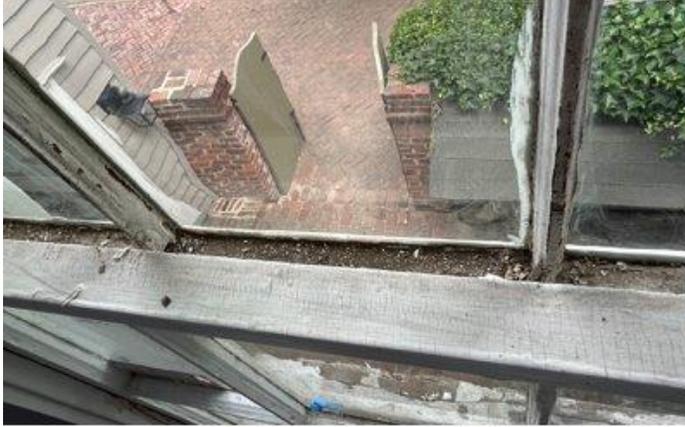
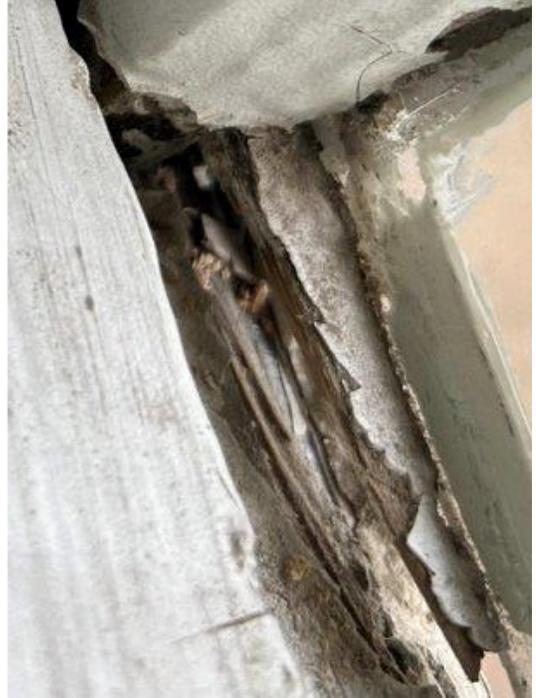
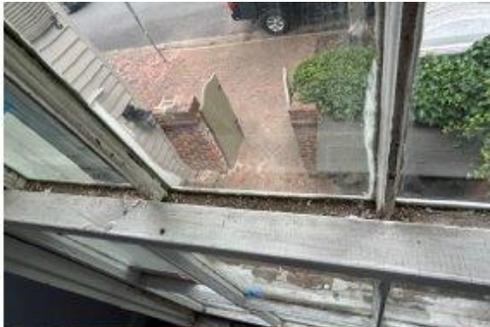
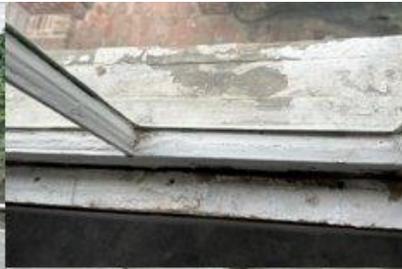
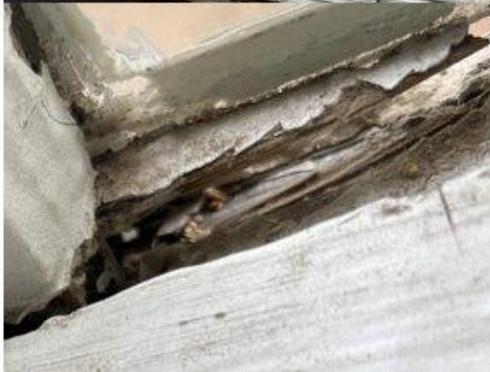
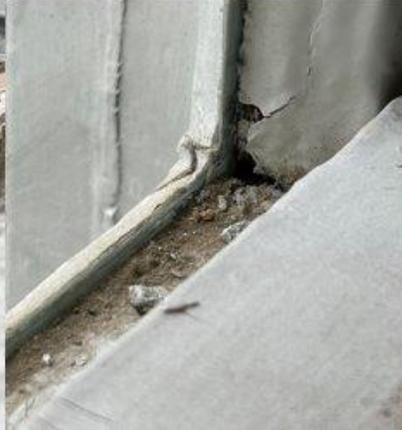
Wood Rot

We contacted seven different historic window restoration companies from MD, DC, VA and NC. Most local companies were too busy to help us, but all those willing to give us an assessment concluded that the windows would need to be rebuilt or replicated.
