Appeal to City Council

Request for Window Replacement at 201 Gibbon St.

December 2024

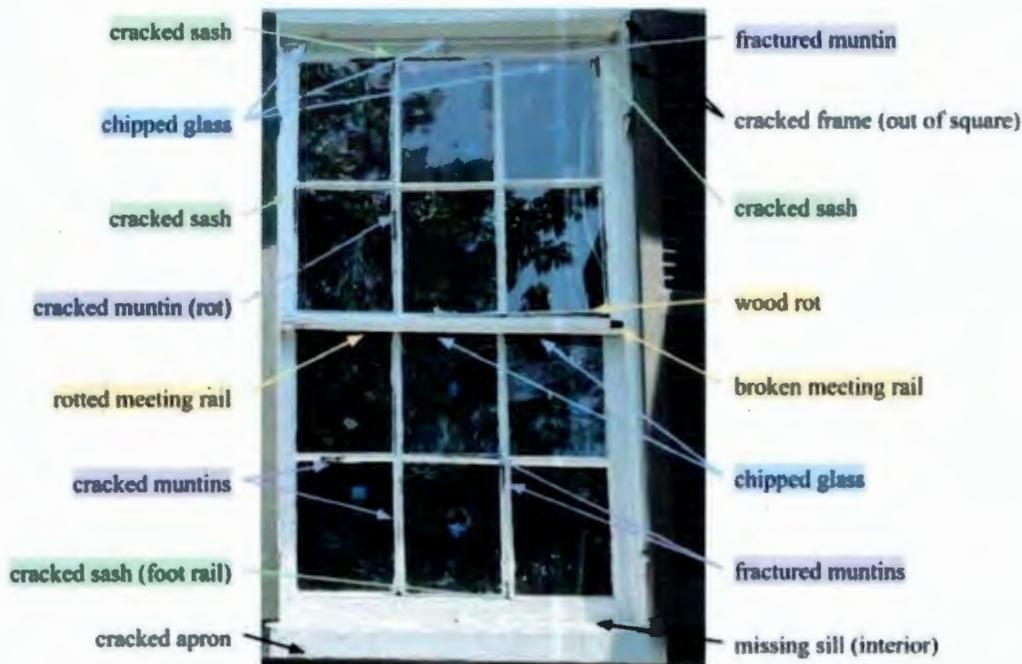
“Paint is about the only thing holding this window together.”

Contrary to the BAR Staff’s report that the windows are merely “painted shut,” this photo illustrates how nearly every piece of wood and joint is rotted, cracked, or splitting. Less visible are the numerous small cracks in the glass, especially along the glazing edges, which renders most of the panes unable to be reused.

Lack of proper maintenance by the previous owners left these windows riddled with wood rot and completely non-functional. Paint disguised the worst of it. But when hidden structural damage to the wall was discovered – requiring immediate remediation for safety concerns – the deterioration cascaded into cracks, splits, and fractures throughout both windows.
