MASONRY

PARKER-GRAY DISTRICT CITY OF ALEXANDRIA

ROOFING

SIDING+TRIM

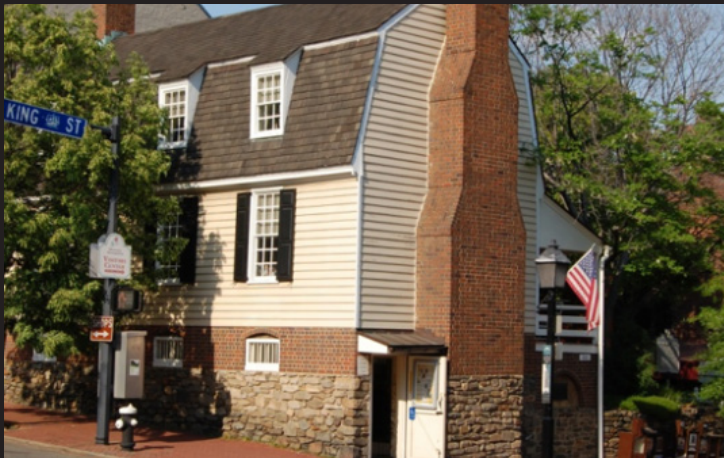
The Ramsay house was originally constructed in the 18th Century with a foundation of Potomac River granite fieldstone.

The foundations of 18th Century buildings in Alexandria were typically constructed with Potomac River granite fieldstone. With rare exception, this stone was always installed below grade. A notable example of these stone foundations can be seen on the Ramsay House. The Carlyle House is the only building in Alexandria that was originally constructed of Aquia Creek sandstone, although it was later refinished with Indiana limestone in the 1970s. Sandstone and limestone were commonly used for stoops throughout the 18th and 19th Centuries. Precast concrete was not used as a building material until the early 20th Century.

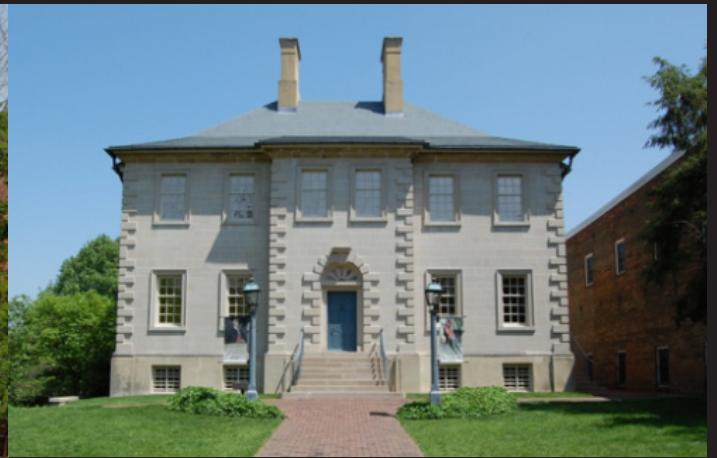
The Carlyle House was originally constructed in the 18th Century with Aquia Creek sandstone.

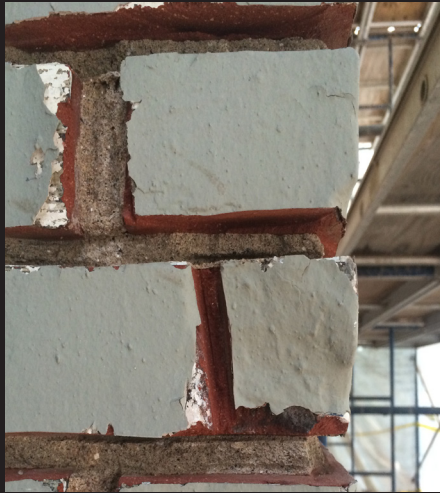
The result of using power tools on mortar joints - the grinders sliced off 1/4 inch sections of brick. The facade is irreversibly damaged, resulting in the loss of the original, handmade bricks. The aesthetic and historic character of the building is lost, as the joints are now twice the original width. In addition, the softer and more absorbant interior of the brick is exposed, leading to future deterioration.

Power tools should only be used to remove mortar from horizontal joints by scoring the middle of the joint and using hand tools to remove the remaining mortar. Only hand tools should be used on horizontal joints less than 3/8 inches tall and on all vertical joints. Mortar should be removed to a depth of 2 and 1/2 times the height of the joint. Masonry damaged by improper mortar removal is considered a demolition and both the homeowner and contractor are subject to penalties.

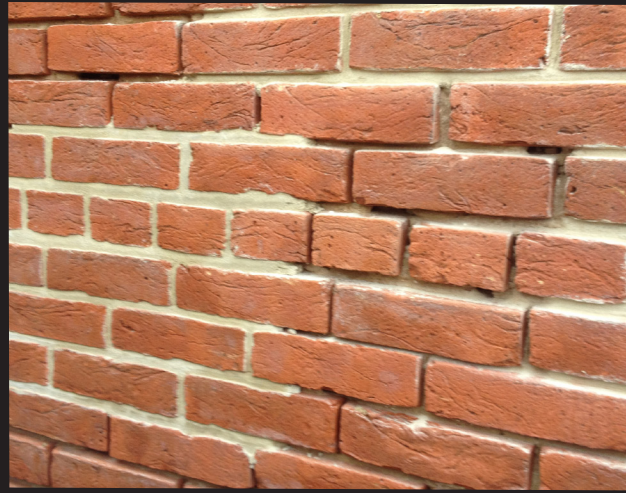
An example of appropriate mortar removal using hand chisels. The width of the original joint and the integrity of the brick are maintained.

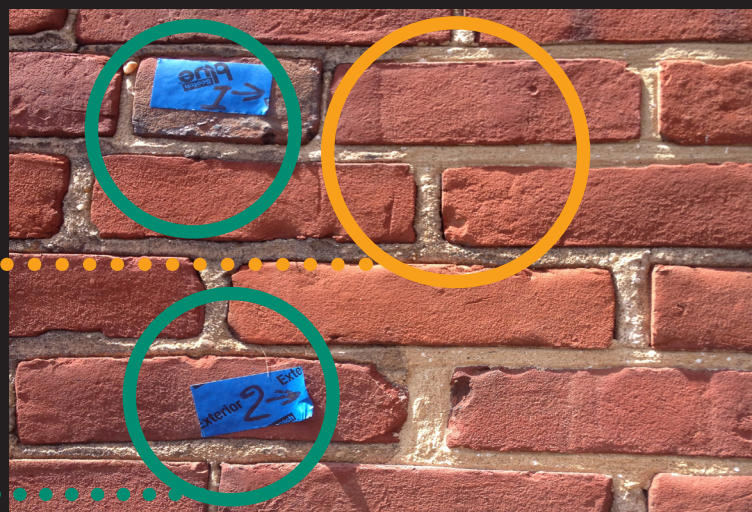
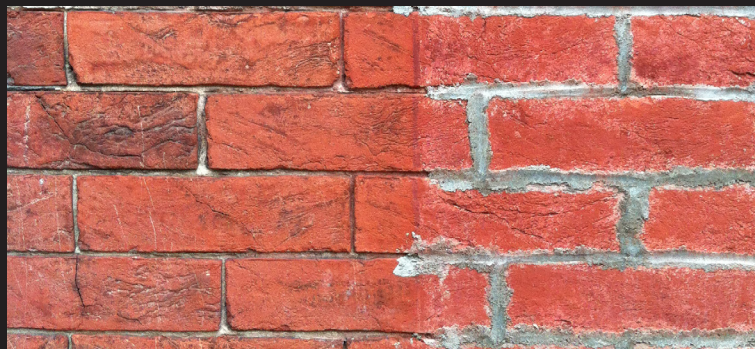
The exposed and soiled layer of mortar has been scraped away to reveal clean mortar for an accurate color match.

The samples have been clearly labeled with painter's tape so that they are easily identifiable for Staff.

The mortar on the right is the wrong color, incorrectly applied, and includes a high ratio of Portland cement, which is not appropriate for historic masonry. Both the historic and aesthetic characteristics are permanently lost.

New mortar should match the color and texture of the original historic mortar. It may be necessary to look in a protected area where the original mortar has not been repointed, such as behind a shutter or under a cornice. If the wall was previously repointed, it may be necessary to scrape off the outer layer of mortar to reveal the historic mortar's color and texture. Subsequent property owners often choose to remove paint and therefore it is important to color match mortar on painted buildings as well.

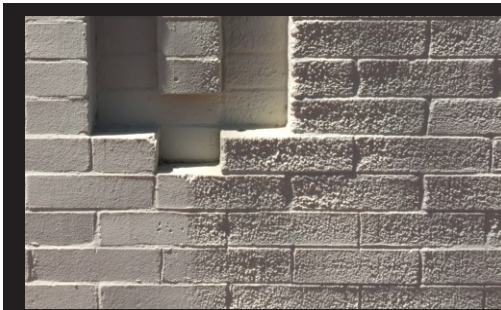
The brick on the right side in the photo has been sandblasted, causing the outer hard fired layer to be removed and making it more susceptible to further damage and destroying its historic architectural character. The Board considers this demolition of the masonry.

Improper paint removal or cleaning can irreversibly damage masonry. Harsh methods like sandblasting or power washing can remove the hard-fired brick surface, exposing the soft interior of the brick to weather. Milder abrasive cleaning methods like soda or media blasting may only be approved by Staff when a skilled architectural conservator has demonstrated it to be the best and safest method. There are several environmentally friendly paint strippers available that can remove multiple layers of paint relatively easily. The use of a paint stripper usually requires the use of low pressure water to remove and neutralize the chemicals and paint residue. It is important that you consult with Staff on the proper water pressure (psi) to prevent mechanical damage to the masonry surface and avoid penetrating the masonry with the water and chemical residue, which can lead to interior damage or damage to the masonry. Control of water runoff and dust may require a separate permit from Transportation & Environmental Services.

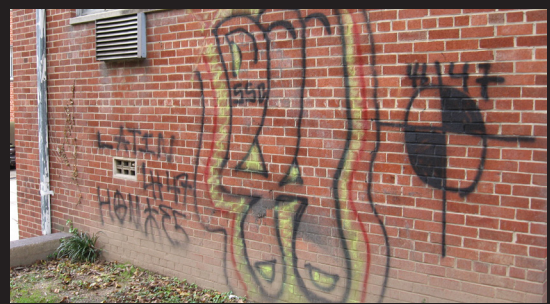
Graffiti should be removed using the same gentle cleaning methods.

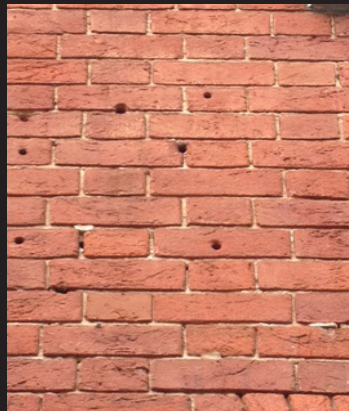
Holes from previous signs.

Masonry is often damaged due to water-related issues. Some common causes of water damage include interior water leaks, leaking air conditioning units, pipes, drains, clogged gutters and downspouts, and moisture caused by rising damp from below grade. Some of the most common causes of damage to masonry are due to water damage. Masonry can also be damaged by drilling holes into the masonry surface or using silicone glue. Anchors should always be installed in the mortar joint rather than the body of the masonry unit, and should be smaller than the mortar joint, if possible. Like mortar repairs, masonry repairs should use material matching in color and texture. Never use caulk to fill masonry holes.

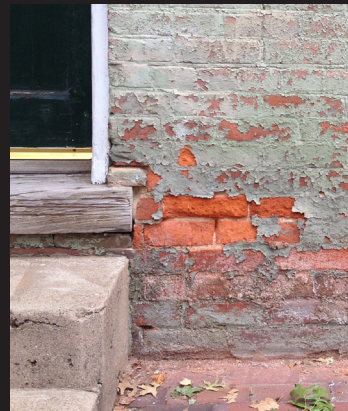
Rising damp (water wicking from below) has caused the face of this early brick to crumble from the freeze-thaw cycle.

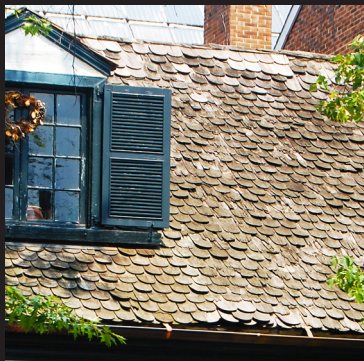
^ FISHSCALE WOOD SHINGLE
18TH - 19TH CENTURY

Wood shingle was the predominant roofing material in Alexandria until the early 19th Century. Historic wood shingle roofs were hand split and hand planed to a uniform thickness. Wood shingle roofs were often painted and/or scalloped to simulate tile or slate roofs.

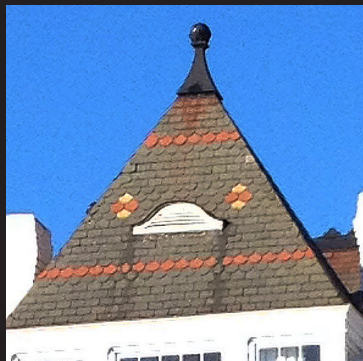
^ POLYCHROME SLATE
MID 19TH - EARLY 20TH CENTURY

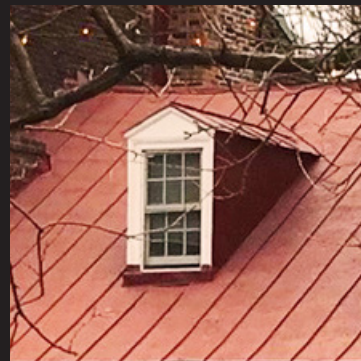
^ STANDING SEAM METAL
MID 19TH - 21ST CENTURY

Standing seam metal roofs were in wide use throughout the historic districts by the mid 19th Century. Metal roofs are more fire resistant than wood roofs and have a life span of 50 to 100 years with proper maintenance. Other roofing materials such as slate shingles and clay tile were not widely used in Alexandria until the late 19th Century. Patterned slate shingles are a central architectural feature of roofs of Gothic Revival and mansard roofs on Second Empire style buildings. Clay tile roofs are a standard feature of Romanesque style buildings.

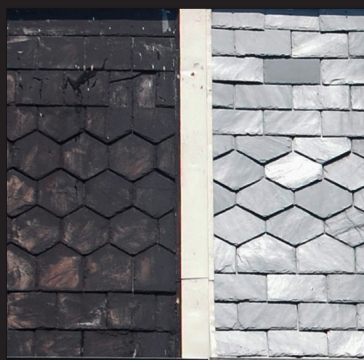
^ FANCY CUT SLATE
19TH - EARLY 20TH CENTURY

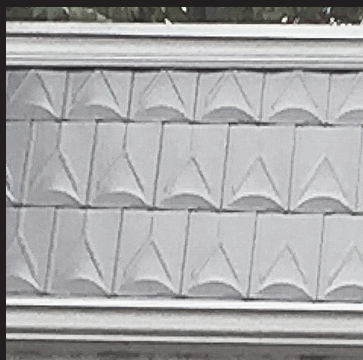
^ STAMPED METAL SHINGLE
19TH - 21ST CENTURY

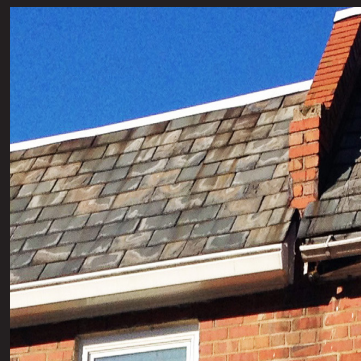
^ SLATE SHINGLE
19TH - 21ST CENTURY

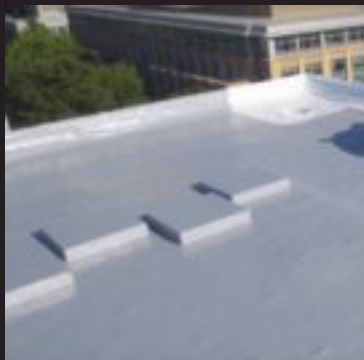
^ SINGLE PLY MEMBRANE
20TH - 21ST CENTURY

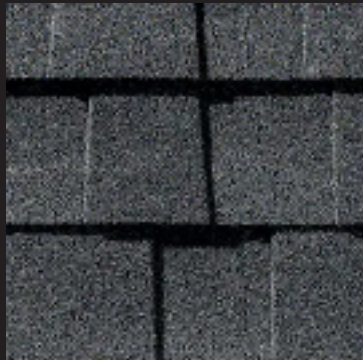
^ ARCHITECTURAL GRADE ASPHALT
20TH - 21ST CENTURY

Modern materials such as composite (synthetic) roofing and composition shingles may be used if appropriate to the architectural style of the building. The Board recommends using architectural grade composition shingles in weathered wood or slate blend colors.

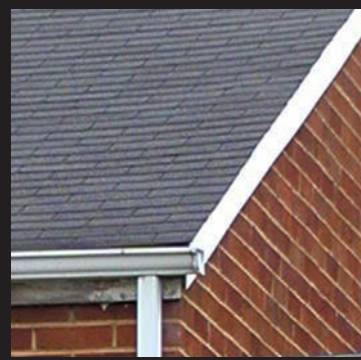
^ 3-TAB COMPOSITION
20TH - 21ST CENTURY

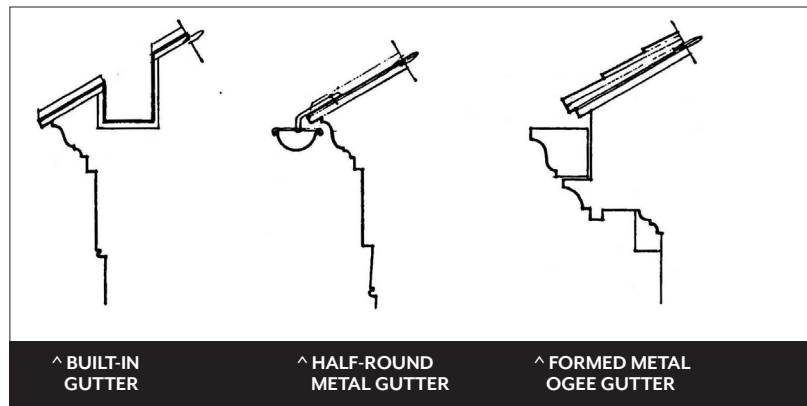
Types of gutters appropriate in the historic districts.

- o Half-round gutters hang from the roof bracket and should be used when no fascia board exists.
- o K-style or ogee gutters should be used when there is a pre-existing fascia board to which the flat side of an ogee gutter can be easily mounted.
- o Gutters and downspouts should be metal or wood and painted or factory finished in a color to match the wall or trim.

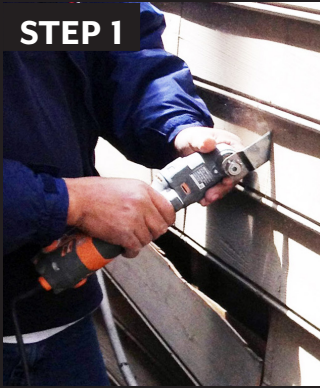
STEP 1

Carefully remove a 2 feet by 2 feet portion of the surface siding.

Intact historic siding may be hidden beneath layers of siding, such as aluminum, vinyl, artificial brick, or stone. To determine if multiple layers of siding exist, remove at least one portion a minimum of 2 feet by 2 feet to reveal the first layer of siding. Staff will inspect the mock-up in the field prior to any approval. The graphic on the following page gives an overview of this process.

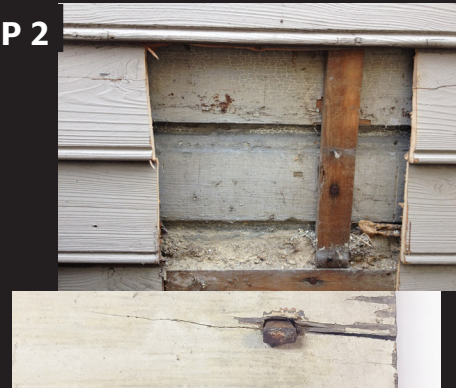
STEP 2

Using clues such as the siding profile and the type of nails used, Staff makes a determination on the age of the siding.

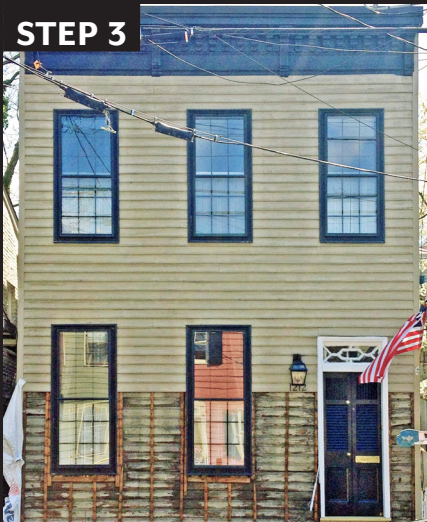
STEP 3

^ BEFORE

More of the historic siding is exposed for Staff to assess its condition. In this case, the historic siding is in very good condition and will be stripped and painted for reuse on this building.

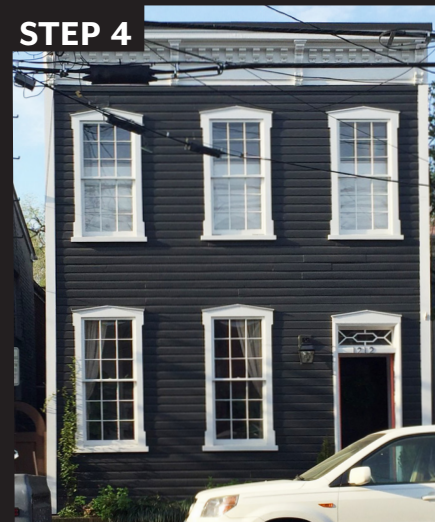
STEP 4

^ AFTER

In this case, removal of the contemporary siding also revealed ghost marks in the old paint from which the original window and door trim was able to be recreated.

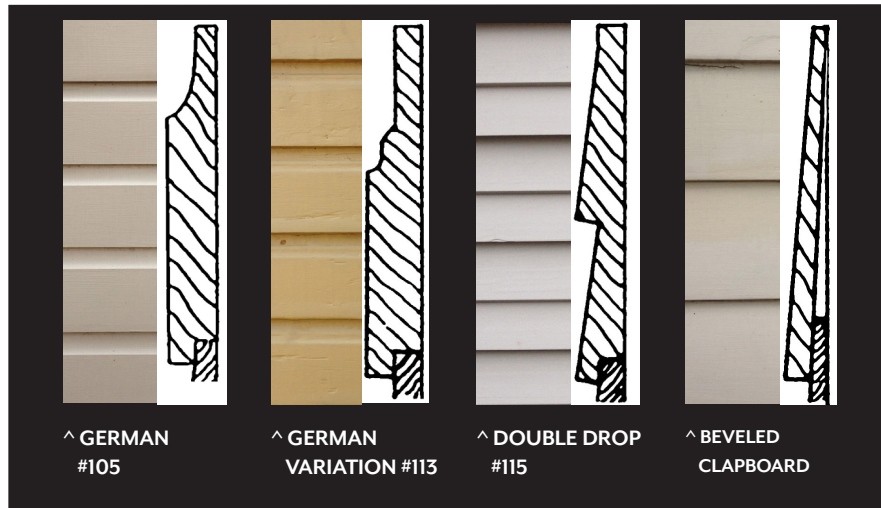
Common types of wood siding in the historic districts.
