SIDING + TRIM

OLD AND HISTORIC DISTRICT CITY OF ALEXANDRIA

Docket Item #17

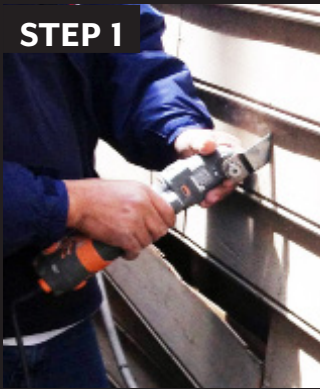
STEP 1

Carefully remove a 2 foot by 2 foot portion of the surface siding.

Intact historic siding may be hidden beneath layers of siding, such as aluminum, vinyl, artificial brick, or stone. To determine if multiple layers of siding exist, remove at least one portion a minimum of 2 feet by 2 feet to reveal the first layer of siding. Staff will inspect the mock-up in the field prior to any approval. The graphic on the following page gives an overview of this process.

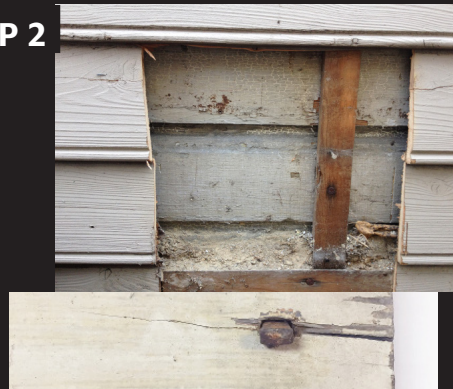
STEP 2

Using clues such as the siding profile and the type of nails used, Staff makes a determination on the age of the siding.

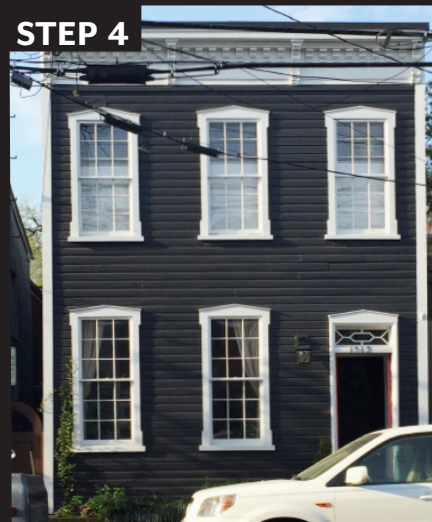
STEP 4

^ AFTER

In this case, removal of the contemporary siding also revealed ghost marks in the old paint from which the original window and door trim was able to be recreated.
