**ISSUE:** Permit to Demolish/Capsulate (partial) and Certificate of Appropriateness for alterations and Waiver of Rooftop HVAC Screening Requirement

**LOCATION:** Old and Historic Alexandria District  
413 North Washington Street

**BAR #2021-00236 & BAR #2021-00261**  
**413 North Washington Street**

# Toth Residence

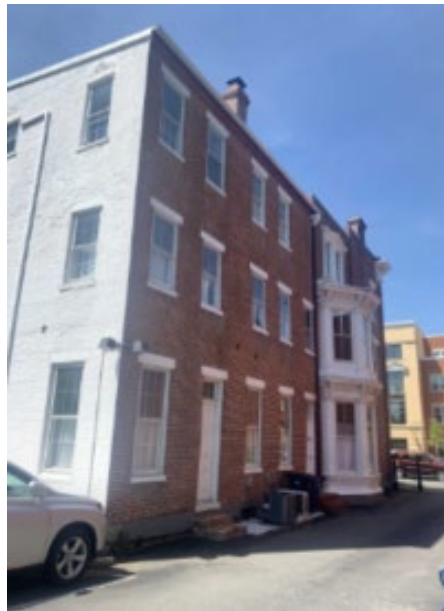
**Figure 2: Photograph showing existing window configuration on east side of north elevation**

Per the submitted documents, the applicant is proposing to replace the existing windows on the second and third floor, east of the existing two-story bay window. New windows are proposed on the second and third floors, the windows being proposed are to be 6-over-6 wood double glazed windows with simulated divided lites in the original openings. Staff and the applicant walked through the interior of the house to inspect each window on the north elevation and the majority are either original or very old, and most have cylinder glass. One aspect that staff was particularly interested in understanding as part of the site visit was why the first and third floor had six-over-six windows and the second floor had two-over-two windows (Figure 2). Staff has determined that it is likely that the two-over-two windows are very early replacement windows and that these windows were all probably six-over-six, which is the case with the twin townhouse at 411 North Washington Street. This is not unusual as builders typically used the most modern and most expensive materials on the fronts of buildings, or in this case, the side of the building up to and including the projecting bay.

Per the Board's policy and general preservation philosophy, staff does not support the replacement of historic wood windows that can be retained and repaired. However, since the two-over-two windows were early replacement windows, staff does not object to the replacement of the second-floor windows with wood six-over-six windows, provided that the applicant preserve the glass in the windows to be removed to replace the various pieces of broken glass in the historic six-over-six windows. In summary, staff finds the following with respect to the proposed new windows on the north elevation:

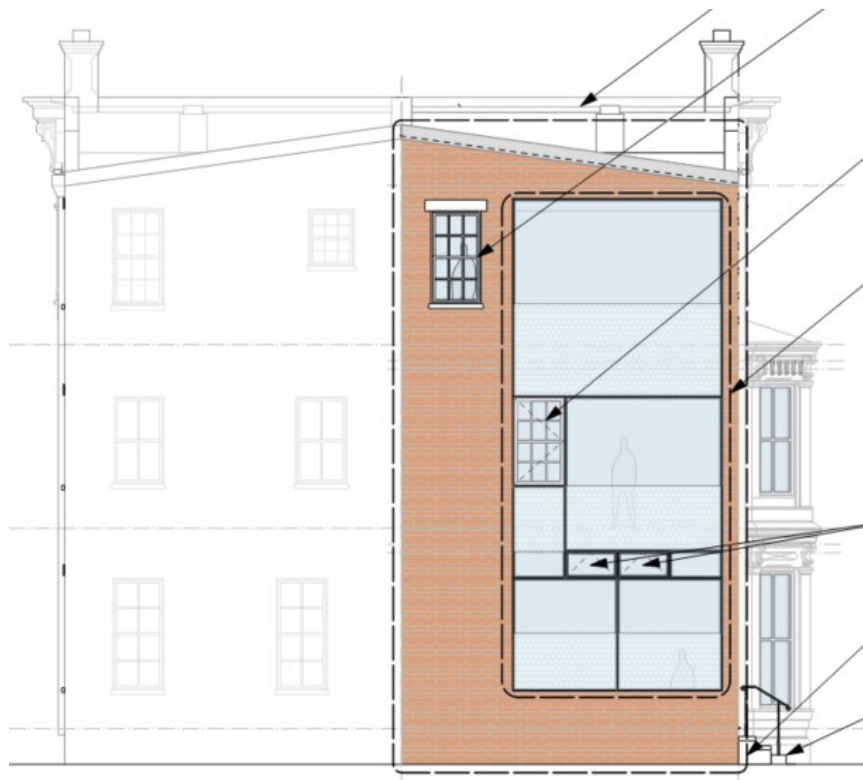
**Figure 3: Proposed elevation of east wall**

The applicant is proposing that rather than rebuild the wall to simulate what could have been an original configuration, they install a modern storefront fenestration system that extends from the first floor to the third floor with minimal muntins and including three operable portions (Figure 3).

Upon deconstruction of the existing wall, any brick that can be salvaged will be used to reconstruct the portion of the wall to the south of the new window opening. While the rear wall will contain some historic brick, it is essentially a blank canvas, and the use of modern fenestration helps to differentiate this part of the house from the largely untouched side and front elevations. While this elevation is not an addition, it is consistent with the *Design Guidelines* recommendation that “An addition to a historic building should be clearly distinguishable from the original structure. An addition should not obscure or dilute the architectural and historic importance of an existing building by creating a false sense of the past.”

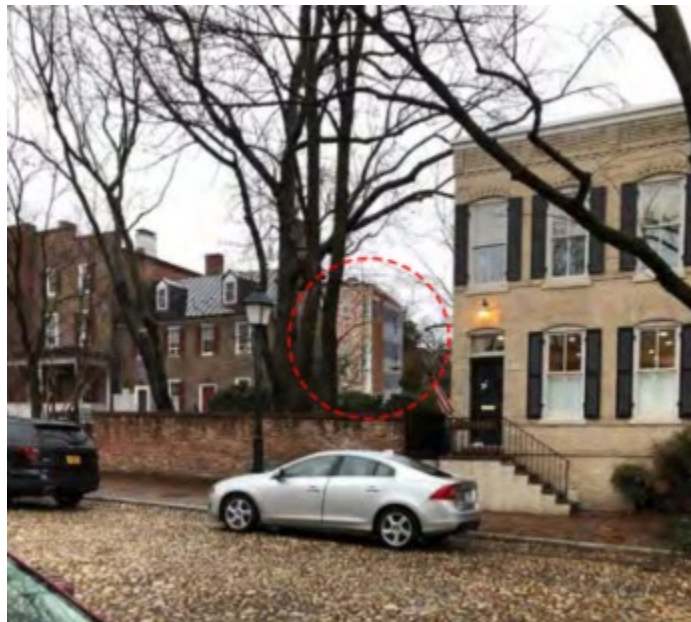
Figure 4: Proposed view of east (rear) wall of building from Princess Street

The east side of the building will be minimally visible from a public right of way. The parking lot to the east of the building is private property, meaning that the only visibility will be oblique views from Oronoco St, St Asaph, and Princess Streets (Figure 4). Due to the minimal visibility and structural need to rebuild the existing wall, staff supports the proposed modification and recommends that the applicant work with staff to ensure that the storefront system meets the *New and Replacement Window Performance Specifications*.

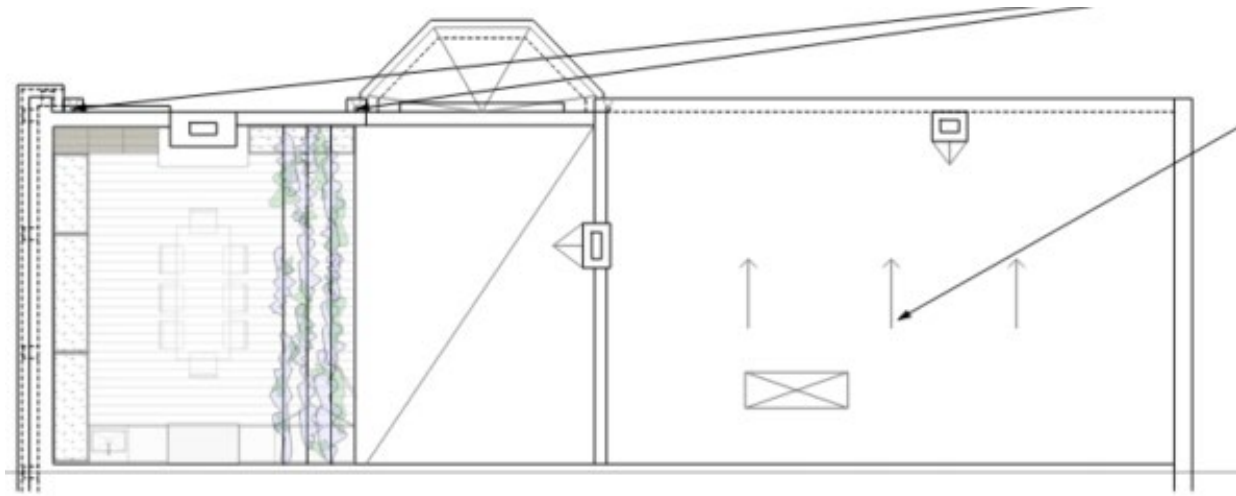
**Figure 5: Proposed roof plan showing sunken roof deck at the west end of the roof**

The applicant is proposing to create an occupiable roof deck on the western portion of the third floor through the removal of a portion of the existing roof. The existing exterior walls and windows in this area will remain but the area will be open to above. This area will include access from the enclosed third floor and will require internal drainage (Figure 5). The removal of the roof framing in this area will include the removal of lateral bracing for the exterior walls. The applicant will need to provide a framing system that will brace these walls to ensure their structural integrity. The submitted documents include views from North Washington Street, including site sections, to demonstrate the visibility of these modifications to the existing building but details on the execution of the modification are not currently included.

The proposed modifications to the building to create the new roof deck do not have a direct influence on the appearance of the building with the exception of how the third floor will be perceived from North Washington Street. This is an important view and staff has expressed to the applicant that the presence of a roof deck in this area should not be evident from the public right of way. This proposal is a unique approach to the introduction of a roof deck into a historic structure and resolves some of the concerns typically associated with the construction of a roof deck. Because the deck is at the level of the third floor, there is no need to extend stairs or an elevator above the existing roof line. The proposed roof deck does not alter the roof line in any way, preserving the historic building form.

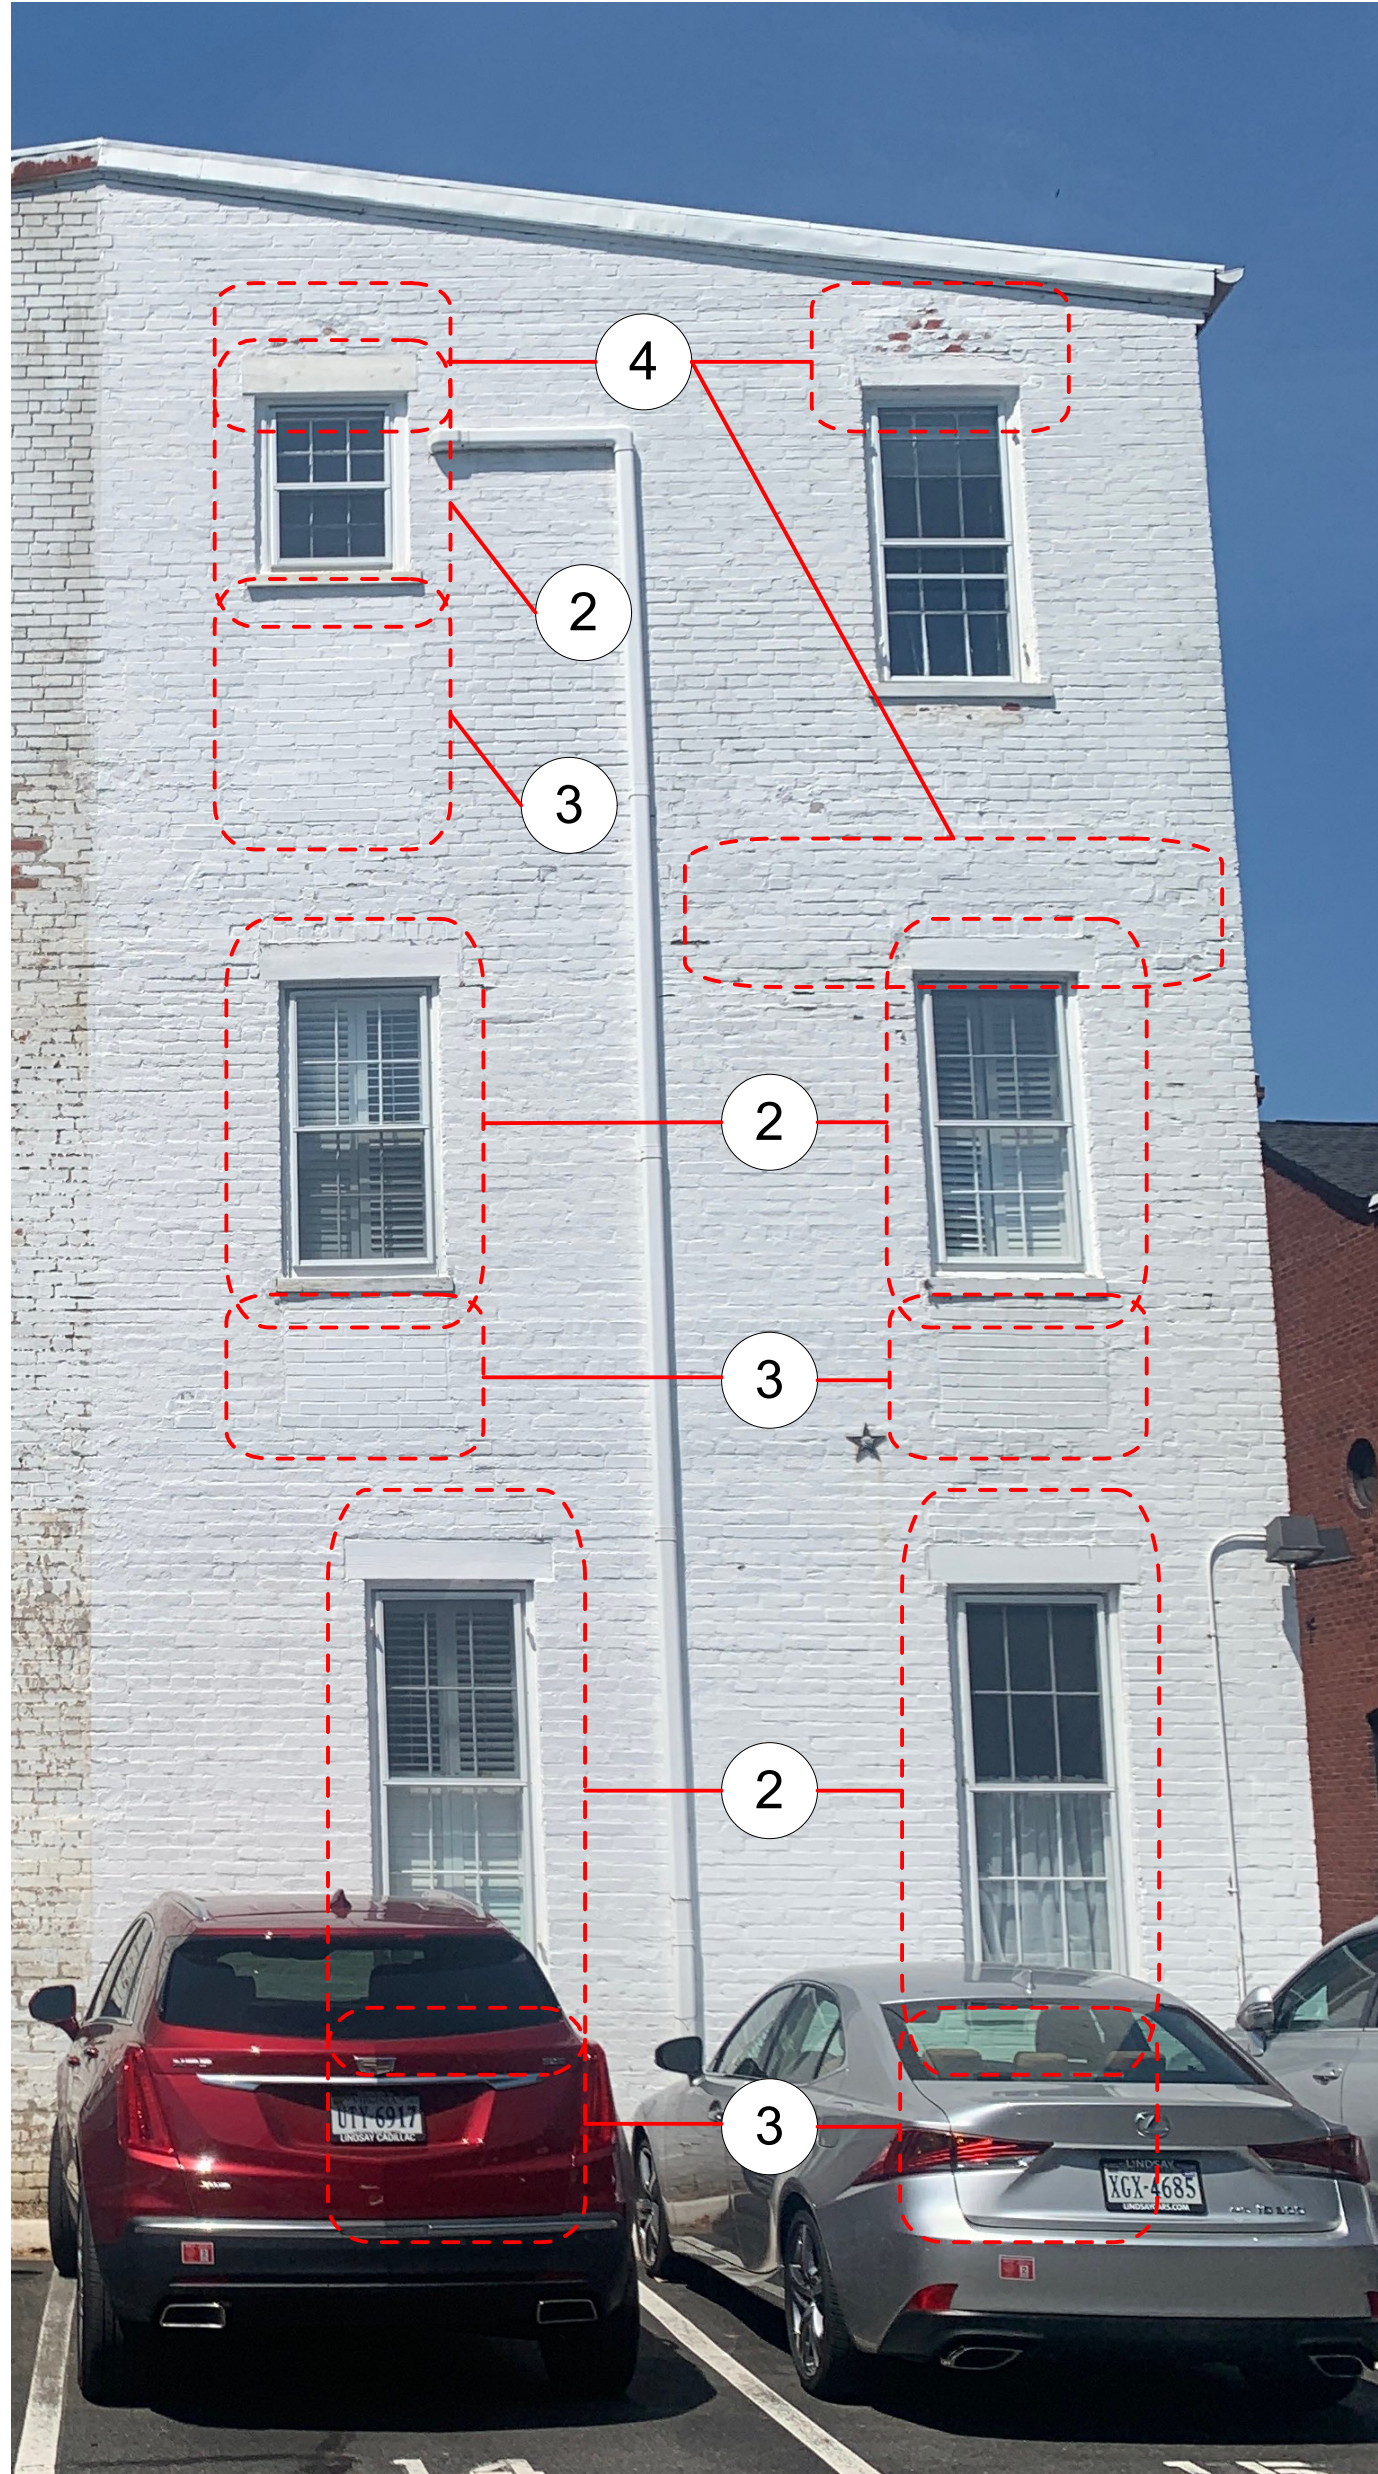
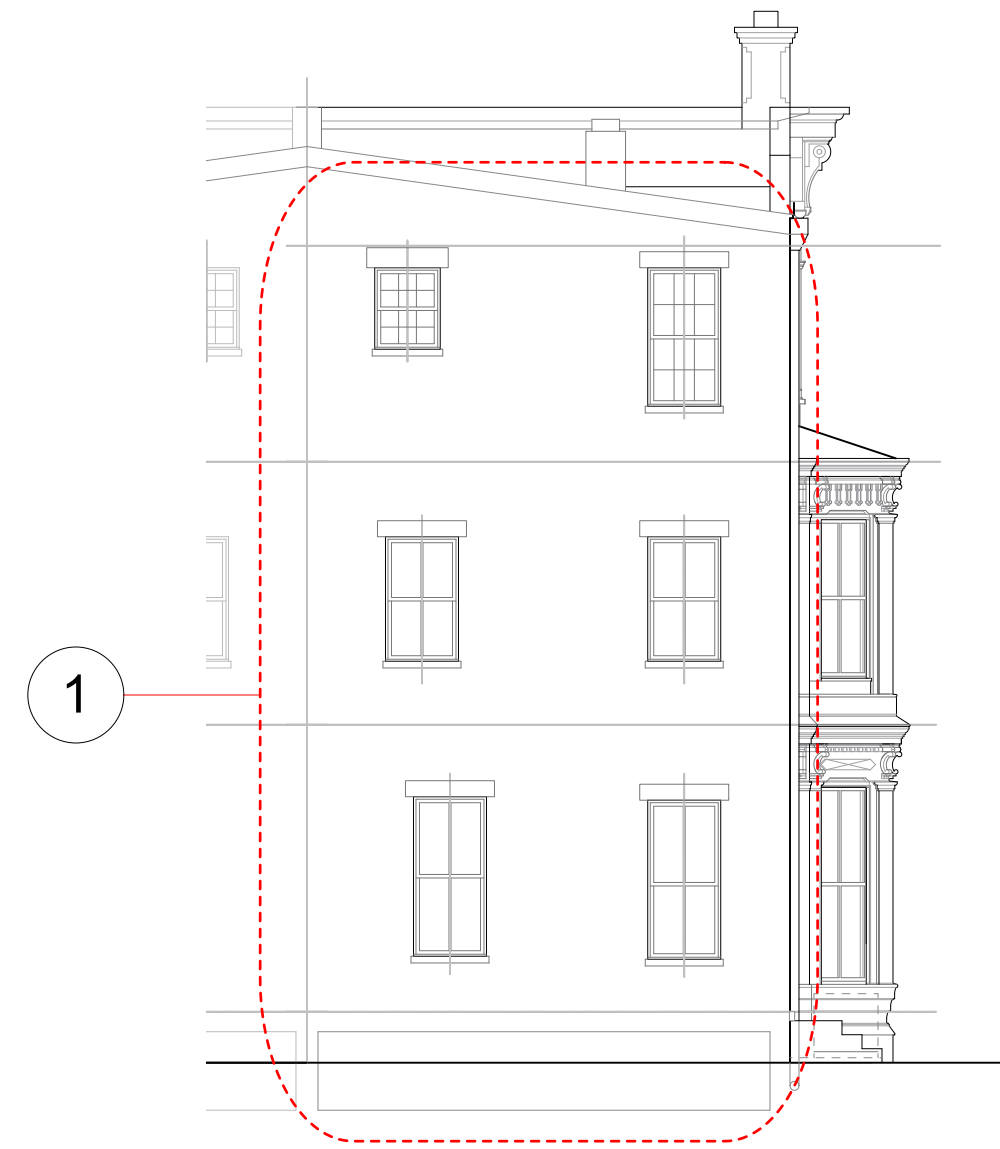
1 **Rear (East) Elevation**  
Scale: 1/8" = 1'-0"

- 1 Historic Brick Has Been Painted Over
- 2 Historic Openings Closed in with New Window Replacements
- 3 Historic Brick Replaced in Several Places
- 4
  - Spalled Brick
  - \* Structural Repairs Needed. See: Structural Engineer 1200AE's Field Report

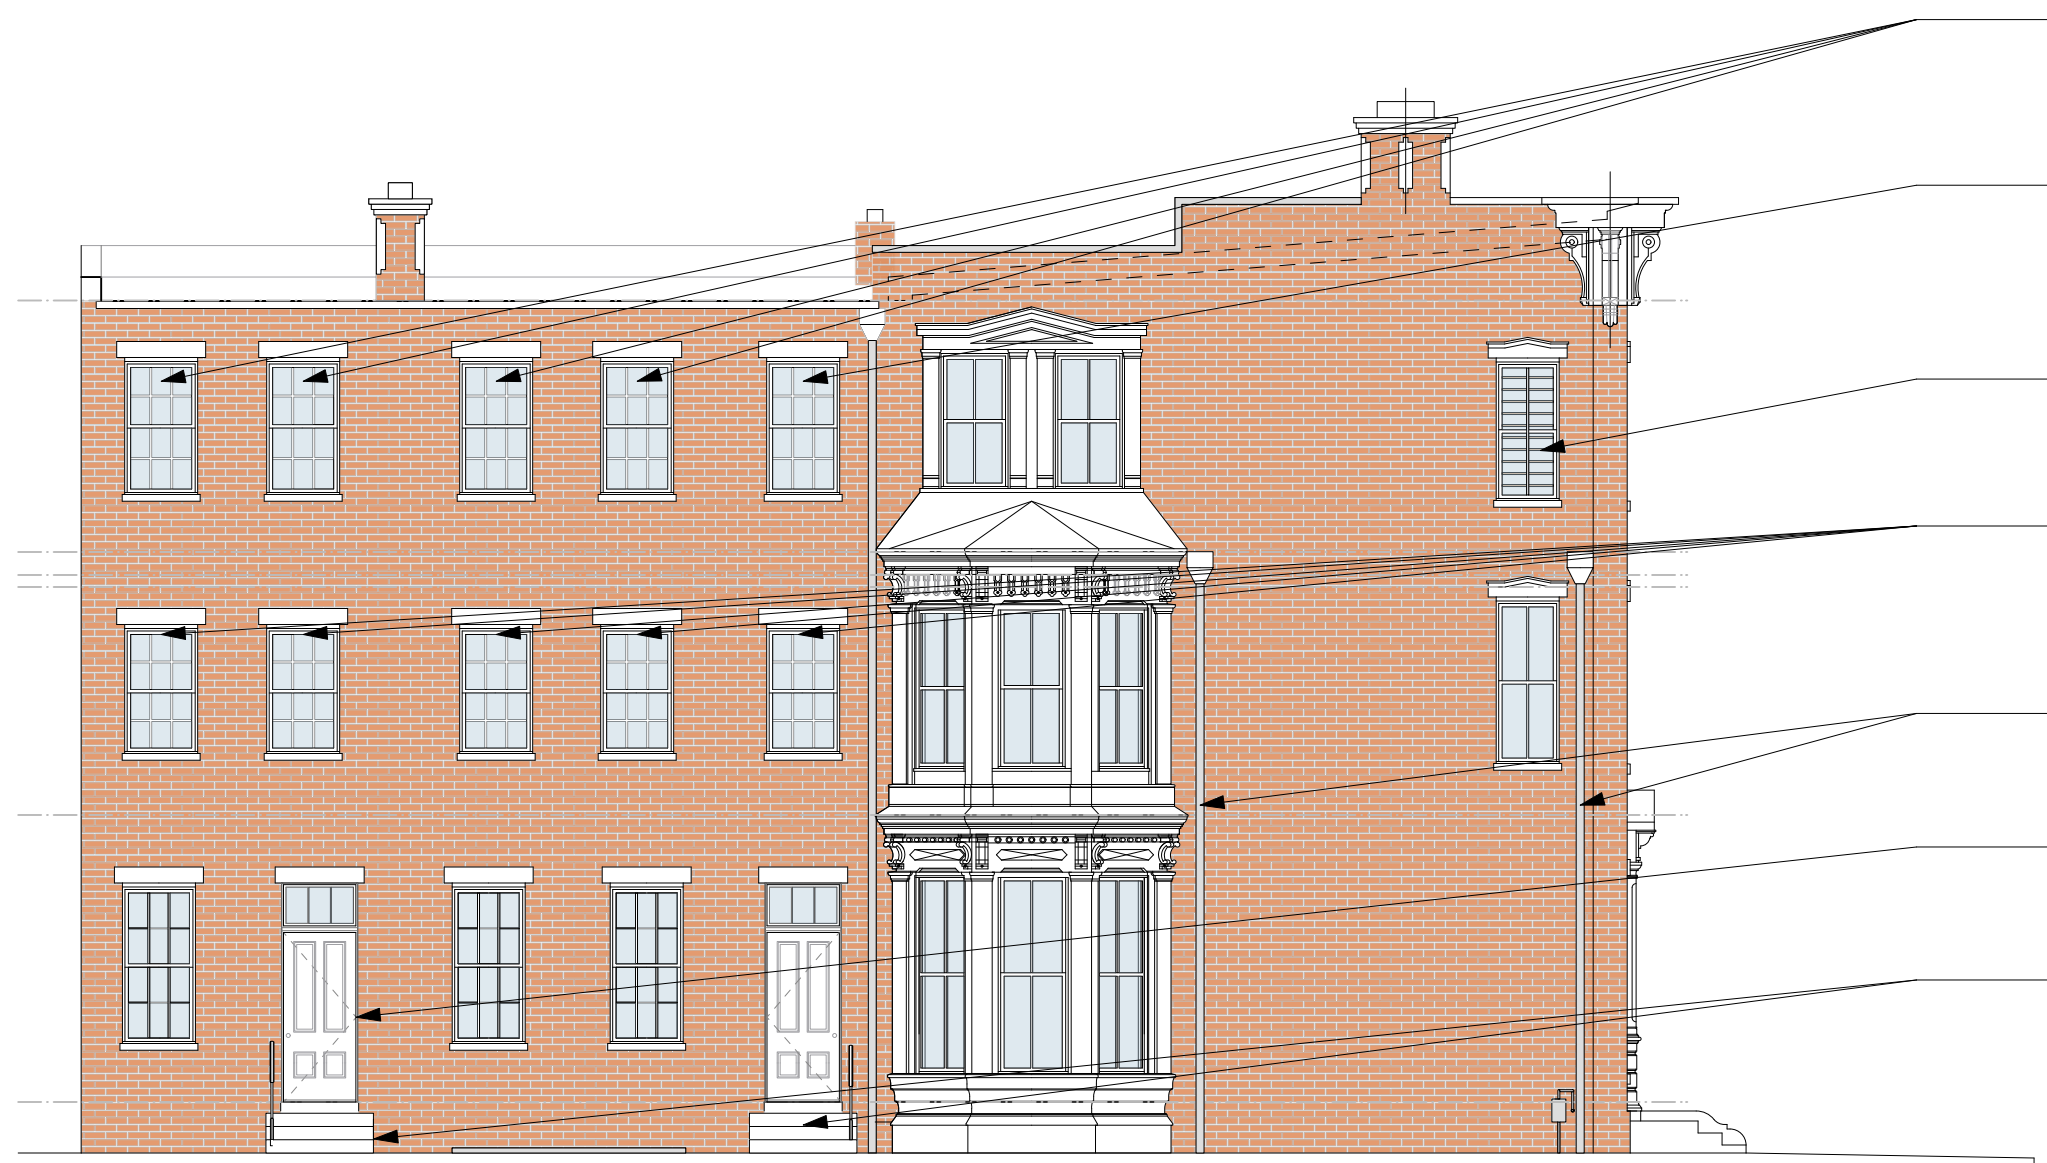
**North Elevation**  
Scale: 1/8" = 1'-0"

- New 6over6 Painted, Wood Framed, Double-glazed Sash Replacement Window Units w/ SDL in Existing Openings (See Marvin Cutsheets)
- New 6over6 Painted, Wood Framed, Double-glazed Sash Window w/ SDL to Match Adjacent New, Wood-Framed 6over6 Replacement Units (See Marvin Cutsheets)
- Add Kebony or Sim., Wooden Plantation-style Sun Louvres on Inside of Existing Historic Windows. (See Cutsheet A4.06)
- New 6over6 Painted, Wood Framed, Double-glazed Sash Replacement Window Units w/ SDL in Existing Openings (See Marvin Cutsheets)
- New Drainage Scuppers and Copper Downspouts
- Re-hang and Reverse Existing Door Swing
- Repair Existing Stair and Add New Bronze and Forged Steel Handrail

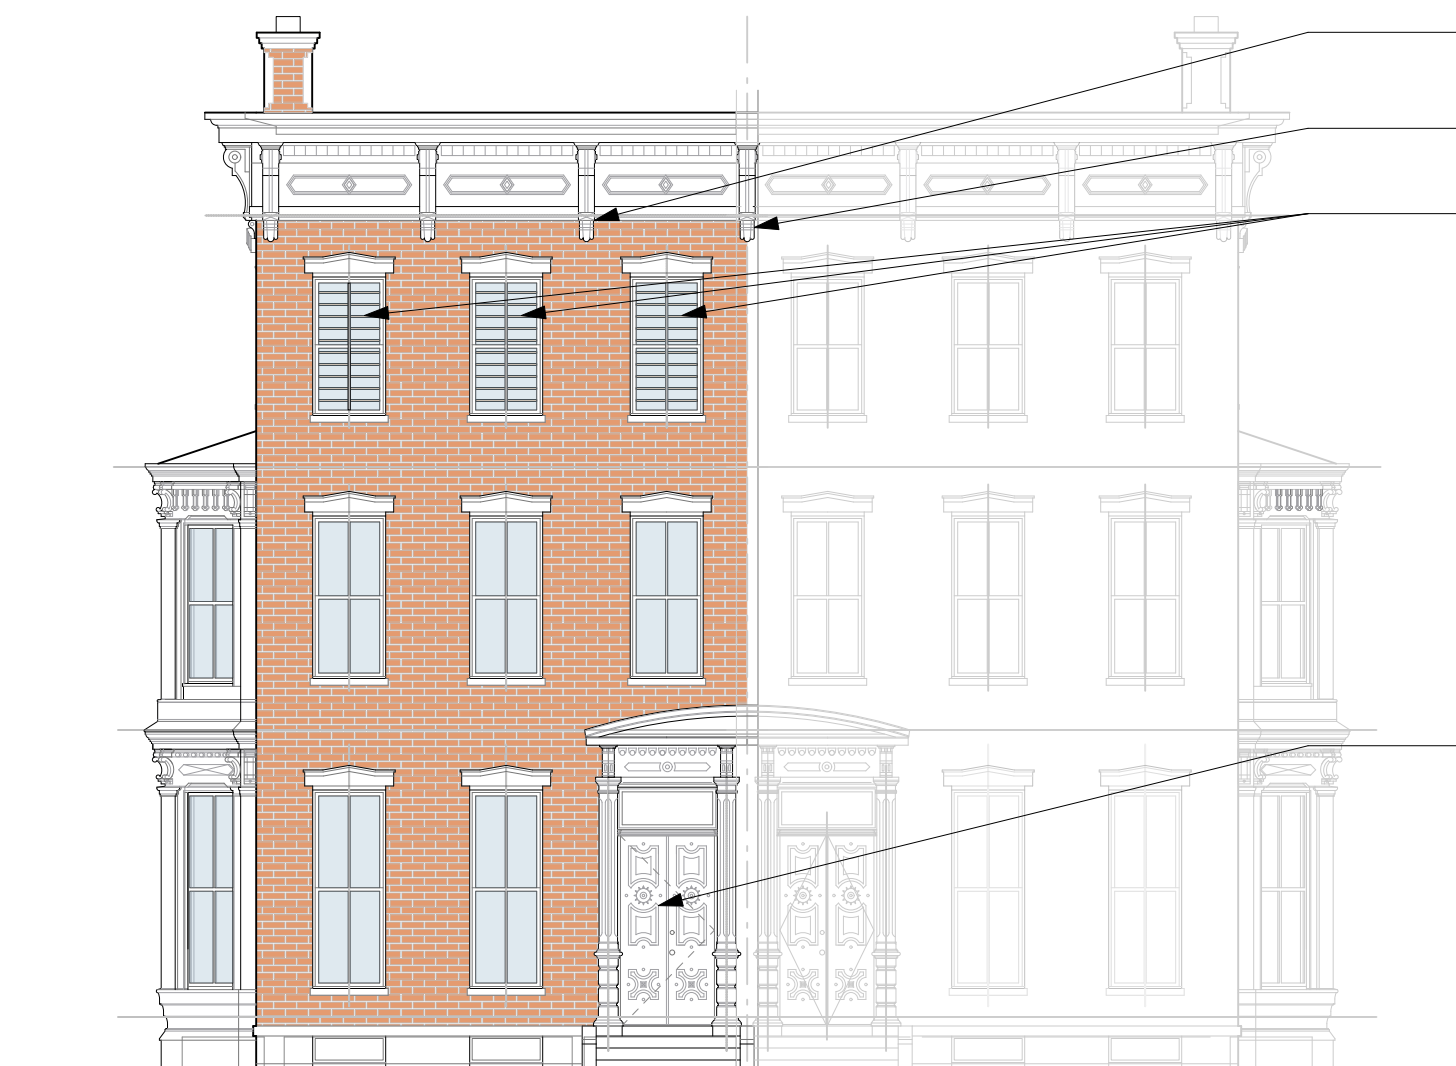
**West Elevation**  
Scale: 1/8" = 1'-0"

- Replicate and Add Missing Historic "Nipple" Detail
- Replicate and Add Missing Bottom of Historic Bracket
- Add Kebony or Sim., Wooden Plantation-style Sun Louvres on Inside of Existing Historic Windows. (See Cutsheet A4.06)
- Join Existing Pair of Door Leaves into Single Door Leaf

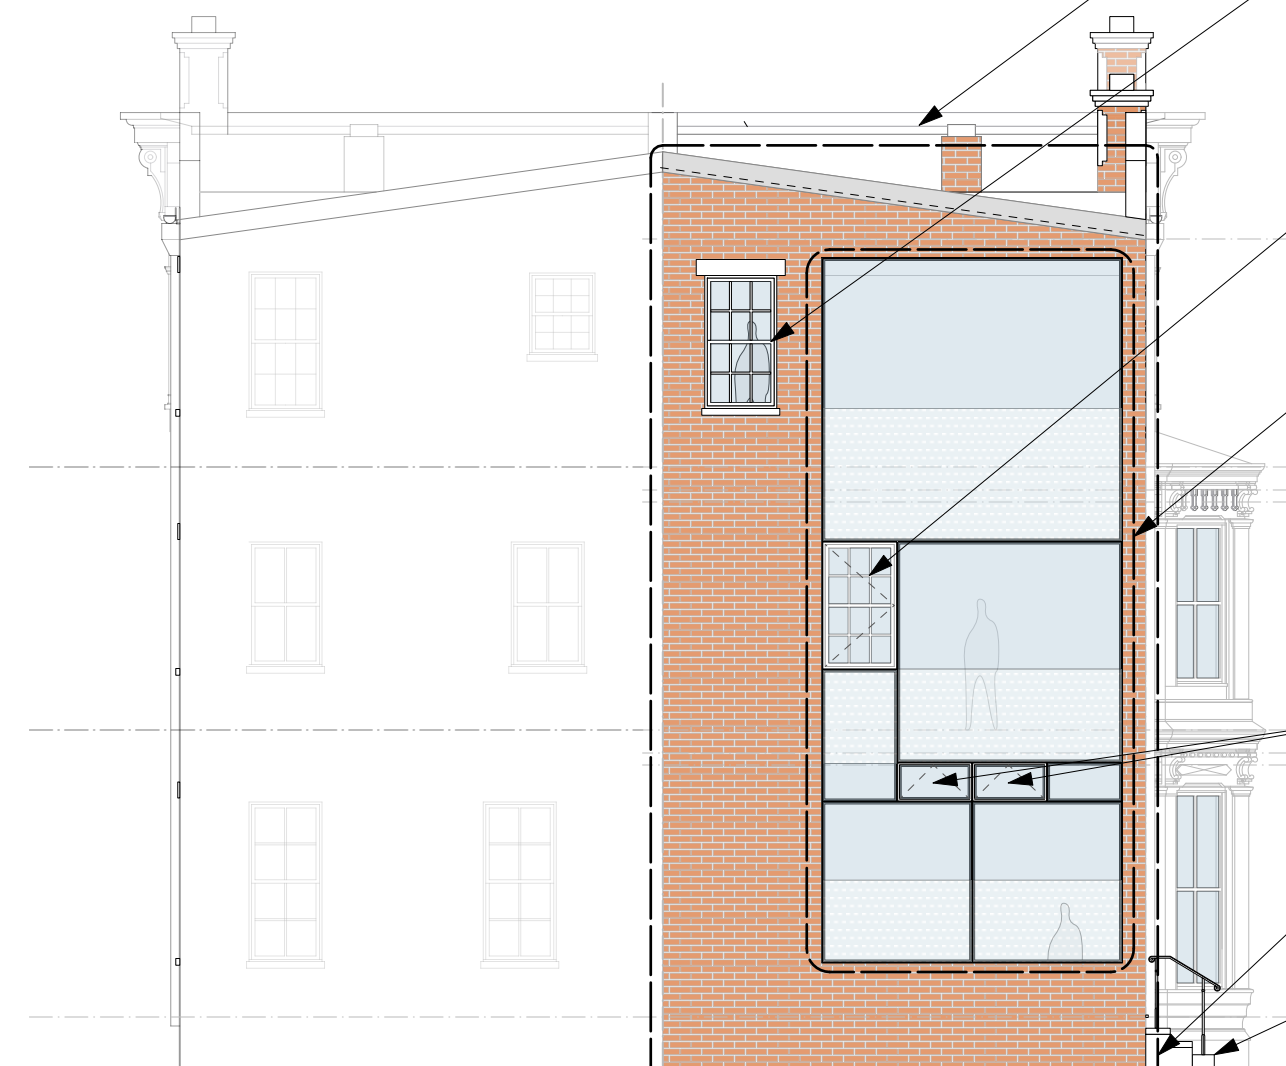
**East Elevation**  
Scale: 1/8" = 1'-0"

- Solar Panels To Be Designed by Subcontractors (Sunpower or sim.)
- New 6over6 Painted, Wood Framed, Double-glazed Sash Replacement Window Units w/ SDL To Match New Replacement Windows on 3rd Level (See Marvin Cutsheets)
- New White-Painted 6over6 Casement Window Unit to Match Those on North Elevation (See Wausau Cutsheets)
- New Custom Window Unit Comprising Double-glazed Fixed, Casement and Awning Lites in White-painted Metal Frame Designed, Engineered, Fabricated and Installed by GlassandMetals.com
- New Operable Awning Window Units (See Wausau Cutsheets)
- New Brick Wall Elevation Using Salvaged Brick to Replace Damaged Existing Painted Brick Wall
- Repair Existing Stair and Add New Bronze and Forged Steel Handrail

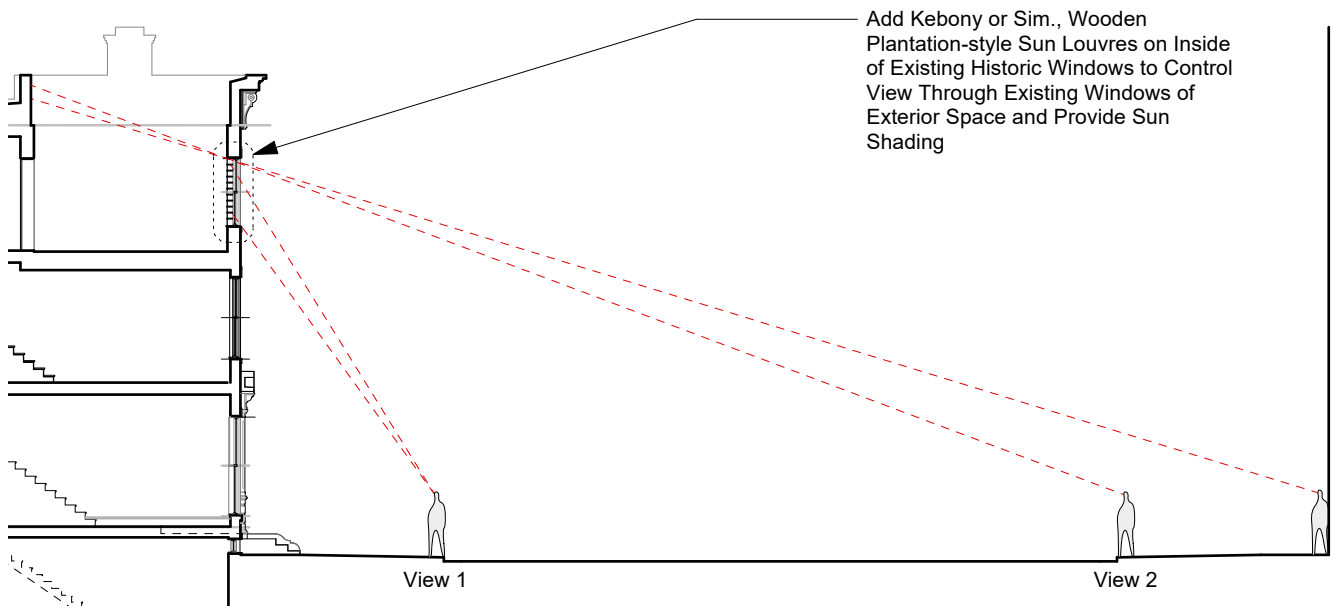
Louvre system on 3rd floor exterior deck windows to eliminate visibility of sky from public way

3 Deck Sightlines  
Scale: 1/16" = 1'-0"

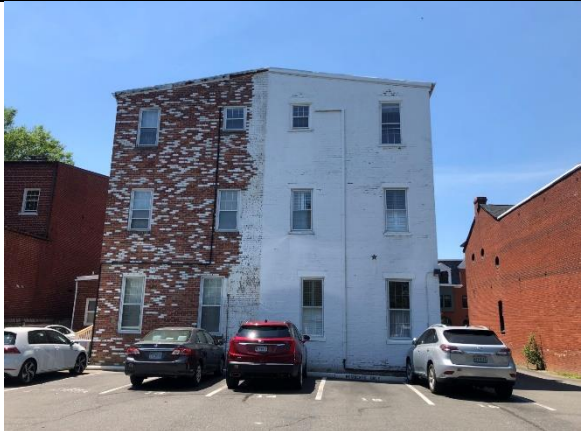
OBSERVATIONS	IMAGES
<p>John Matteo of 1200 Architectural Engineers, PLLC visited the site on May 21, 2021 to review and discuss the structural condition of the east wall at the above residence. As depicted in Photo 1, the wall is currently painted white and integral with the adjacent brick masonry wall to the south. The wall is currently in poor structural condition and in need of significant repair. The conditions are broadly shown in Figure 1 and then described with detailed photos. The historic residence is being renovated and modifications to the east wall are proposed that will address the current structural weaknesses while also introducing changes to fit with the interior renovation. As the rear wall of the property, the visibility of the proposed changes for the general public is very limited.</p> <p>Of note in Photo 1, and shown in detail in Photo 2, is the fact that the wall to the south has been substantially rebuilt. The painted white portions of the wall consist of some portions that were left in place along the centerline of the combined façade, with the scattered white brick perhaps representing salvaged brick. The red brick appears newer and no longer is constructed with the common bond pattern of the original construction. The wood lintels have been replaced with steel angles over the windows.</p>

<p>Photo 1: East Elevation</p>

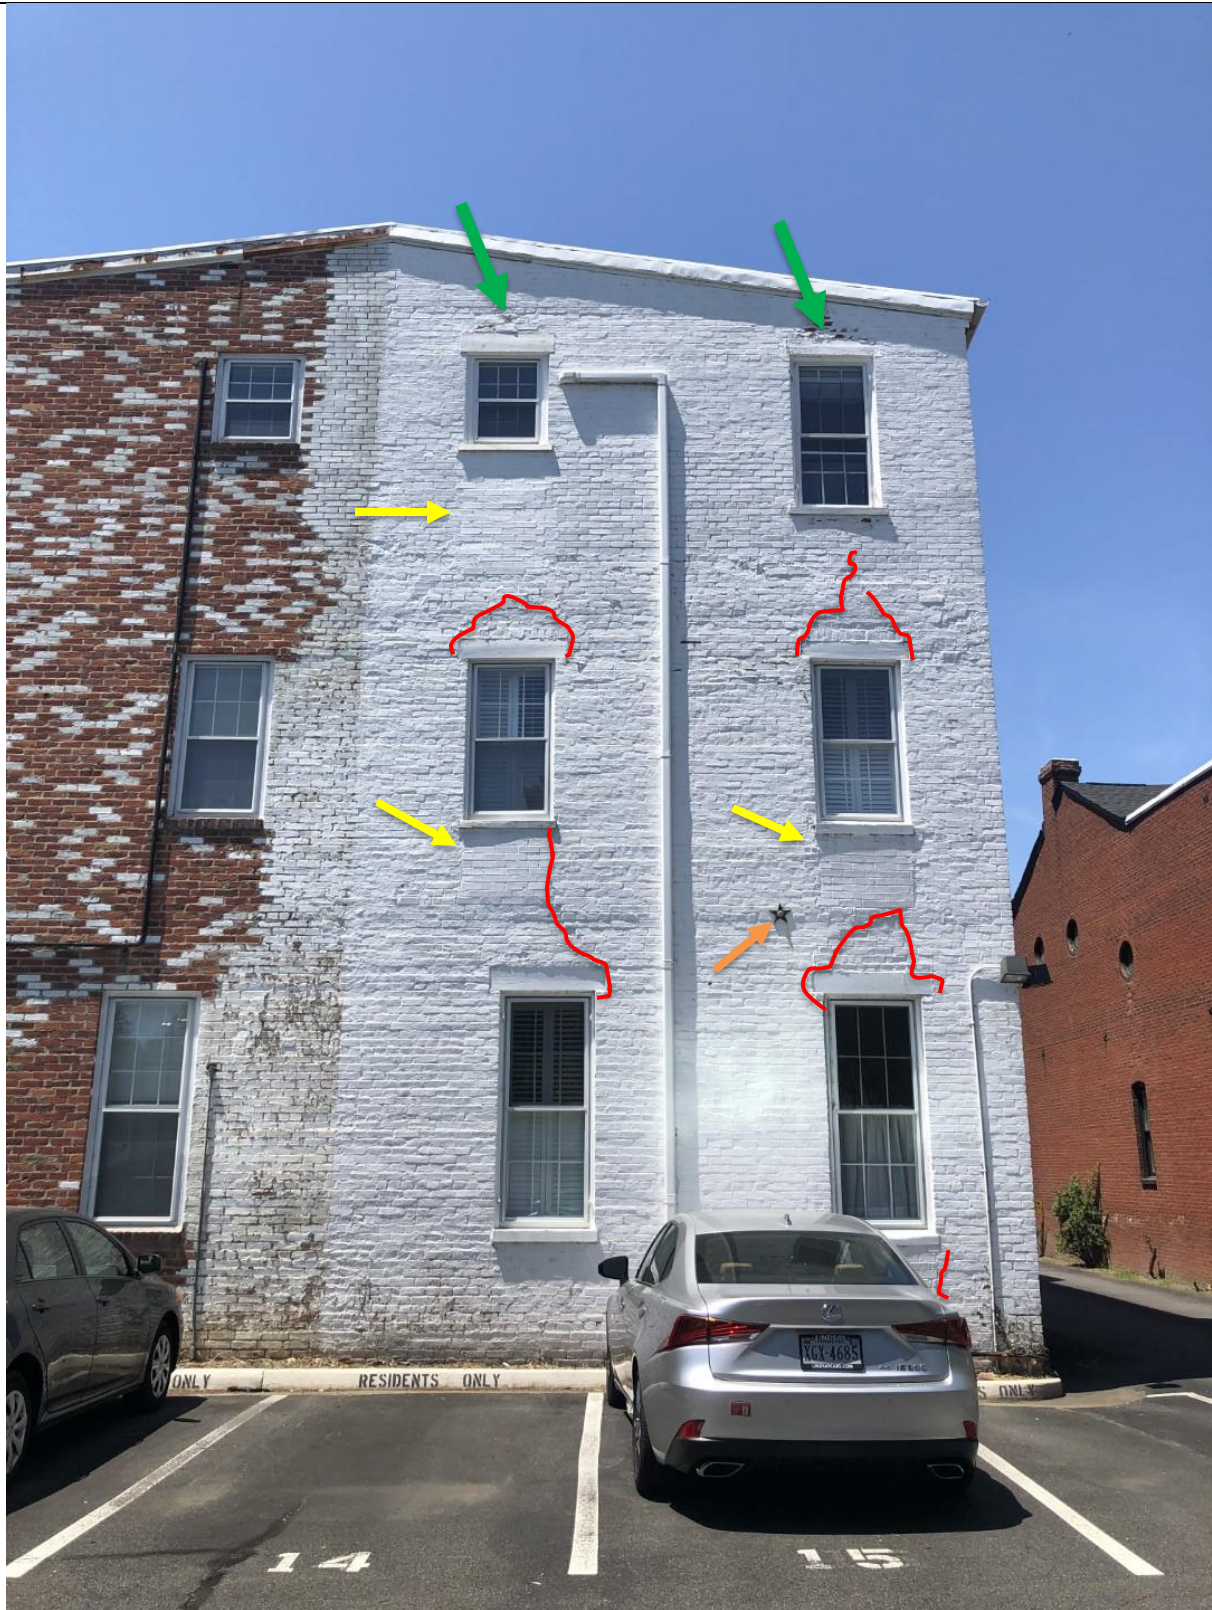
Figure 1: East Elevation with Structural Conditions Noted

Figure 1 shows the conditions of the east wall in broad perspective.

The red lines represent larger scale cracking that is generally focused around the window openings (shown in some detail in Photo 3). The cracking is likely the result of several factors, the first of which is the apparent replacement of the wood lintels at some point in the past. The current lintels, with smooth finish and sharp 90 degree edges, are clearly newer and sawn from modern machinery. The original wood likely rotted from the sustained presence of moisture in the wall. As the rear wall functions as a primary component of lateral resistance for the building, the cracking may also be associated with stresses imposed on the façade from wind and seismic loadings (recalling the 2011 Mineral, VA earthquake as a fairly recent, significant event). The loose connection of the east façade to the floor and roof diaphragms and its resulting bowing, as discussed below, is also likely a factor contributing to the masonry cracking. An important note is that the cracking observed is clearly subsequent to the latest painting effort, and also after the lintel replacement.

The green arrows show examples of paint loss that is the result of brick deterioration. The loss of coating is fairly widespread, with concentrations above the upper two windows (Photo 4). However, the coating loss is less important structurally than the material disintegration of the brick units and mortar that appears to be the root cause within the wall construction. This is likely the result of sustained moisture within the wall, perhaps even being retained by the coating, and then the resulting stressing from freeze-thaw cycling. As retained water freezes it expands volumetrically, inducing internal stresses to the moisture-containing masonry.

The yellow arrows show areas of infill below windows. It appears that there was some sort of accessible porch as the windows were previously serving as doorways. The new brick has not been toothed into the original jambs, providing a

The structural conditions noted above warrant significant structural repair and stabilization as part of the upcoming renovation and preservation work. Of particular concern is the outward bowing of the façade, which needs to be minimally addressed with more robust connection to the floor and roof diaphragms. Also very significant, but less easily quantified, is the apparent deterioration of the mortar and masonry units that has resulted from a long history of moisture infiltration and entrapment. The combined effects of these structural conditions and the history of modification (window infills, lintel replacements) makes a more substantial rebuilding much more appropriate and offers an opportunity to restore physical integrity to this essential component to the building structure.

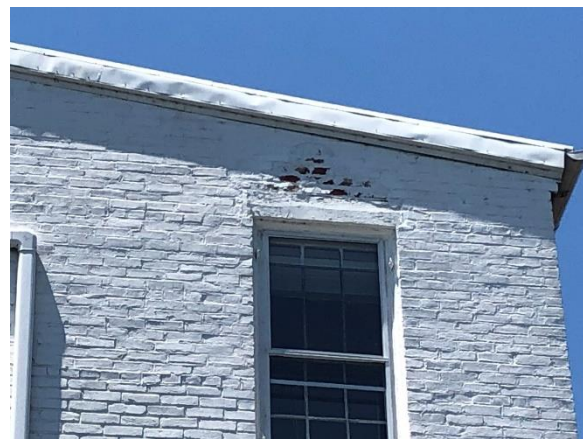
Photo 4: Brick deterioration over lintels

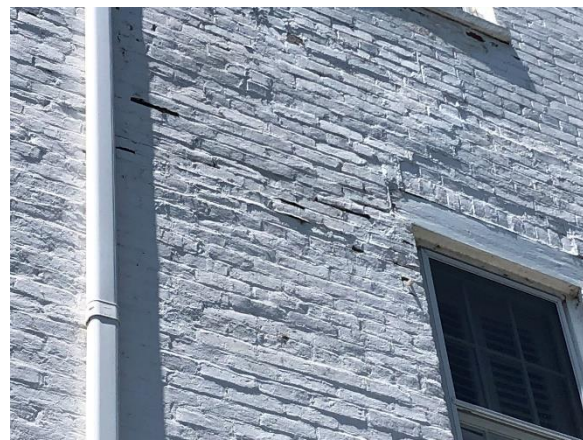
Photo 5:

Photo 5 show both the deterioration of the masonry and its outward displacement at the second floor level.

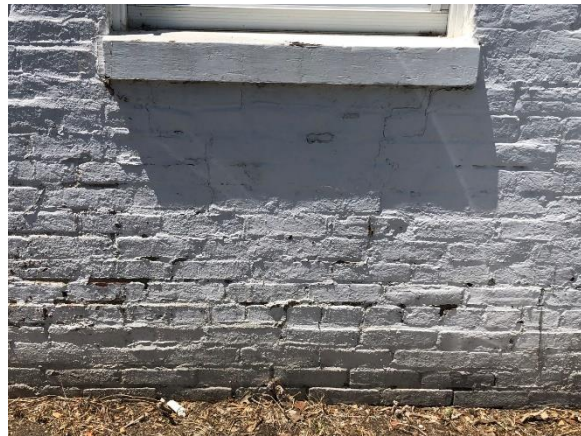
Photo 6:

Photo 6 shows a rapid outward displacement at the ground level, as the bowed wall realigns itself with foundation level masonry that is kept in place by the surrounding soil.

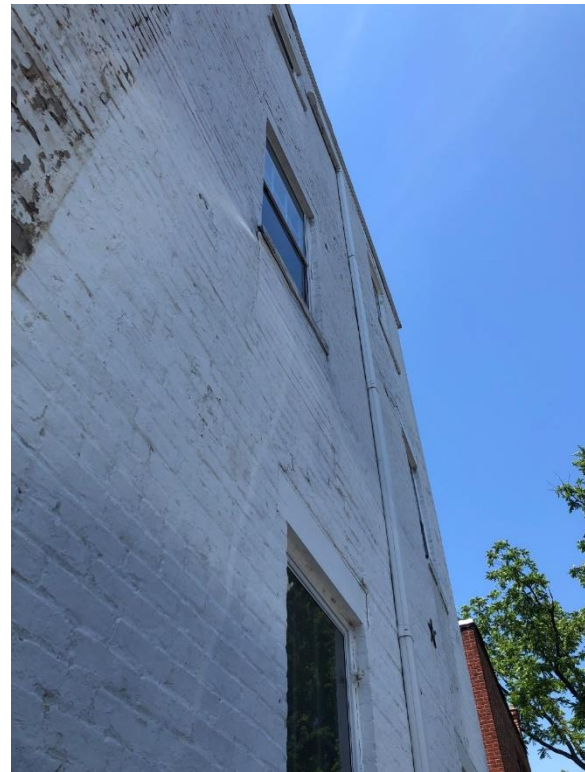
Photo 7 shows that the bowing is restrained at the return walls (both the north wall and the south demising wall between the connected buildings) but increases substantially toward the middle of the façade, both north to south, and from ground to roof.

Photo 7: Outward Bowing of East Wall
