We would like to ask you all in helping us with a variance on our future house.
We would like to have it sit back from the location the City of Alexandria has chosen. We would like to save as many trees as we can. One of which is a large pecan tree and a small oak.
If you could please: sign, add phone number and house address.
We appreciate all your help. Thank you.

Re: Bearing Evaluation for Planned Single-Family Homes
701, 703 and 707 South View Terrace
Alexandria, Virginia
Project No. T2901

TEST PIT LOCATION PLAN	SHEET: 1
701, 703 AND 707 SOUTH VIEW TERRACE	DATE: 02/16/21
ALEXANDRIA, VIRGINIA	SCALE: NTS
CLIENT: KATHARINE NORTON, JOHN AND ILIANA HERRMAN	SI PROJECT#: T2901

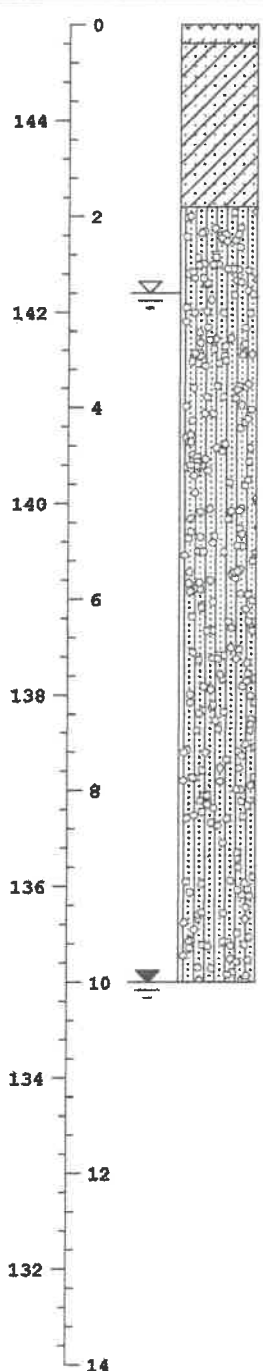
PROJECT: 701, 703, 707 South View Terrace
 CLIENT: Katharine Norton, John and Iliana Herrman
 LOCATION: Northeast of remains of pond
 DRILLER: Marshall Cheatwood
 DRILL RIG: Takeuchi TB235
 DEPTH TO WATER> INITIAL ∇ : 2.8

CL	Topsoil consisting of dark brown clay with minor organics and root matter Brown silty CLAY (CL-ML) with sand, stiff, moist				
144							
2		SM	Reddish brown silty SAND (SM) with rounded gravels, medium dense, slightly moist			2.0	20-20-20
142							
4						4.0	21-21-21
140							
6						6.0	44/1.75"
138							
8						8.0	25/1.75"
136							
10			Test pit terminated at a depth of 10.0 feet			10.0	35/1.75"
134							
12							
132							
14

Based on visual classification, natural (coastal) soils consisting of silty CLAY (CL-ML) and silty SAND with rounded gravels (SM) were encountered in the test pits. No high shrink-swell soils were encountered in any of the test pits. Groundwater was encountered at a depth of 2.8 feet in test pit TP-2 during excavation. Groundwater was not encountered in any of the other test pits during or upon completion of excavation.

Due to the groundwater encountered in test pit TP-2 near the remains of the old pond, there is a significant risk of groundwater entering the basement floor slab if a home with basement is located in the area of test pit TP-2. In order to avoid groundwater issues, we recommend moving the footprint of the planned home north toward the location of test pit TP-1, where no groundwater was encountered.

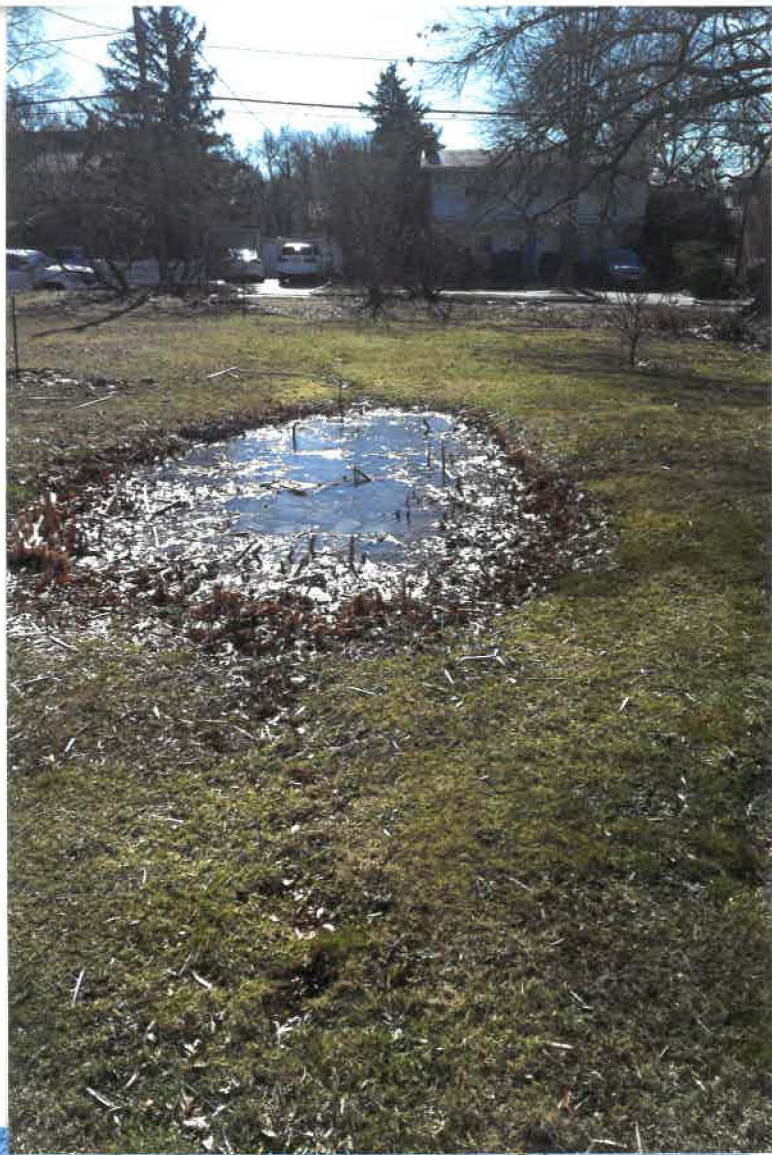
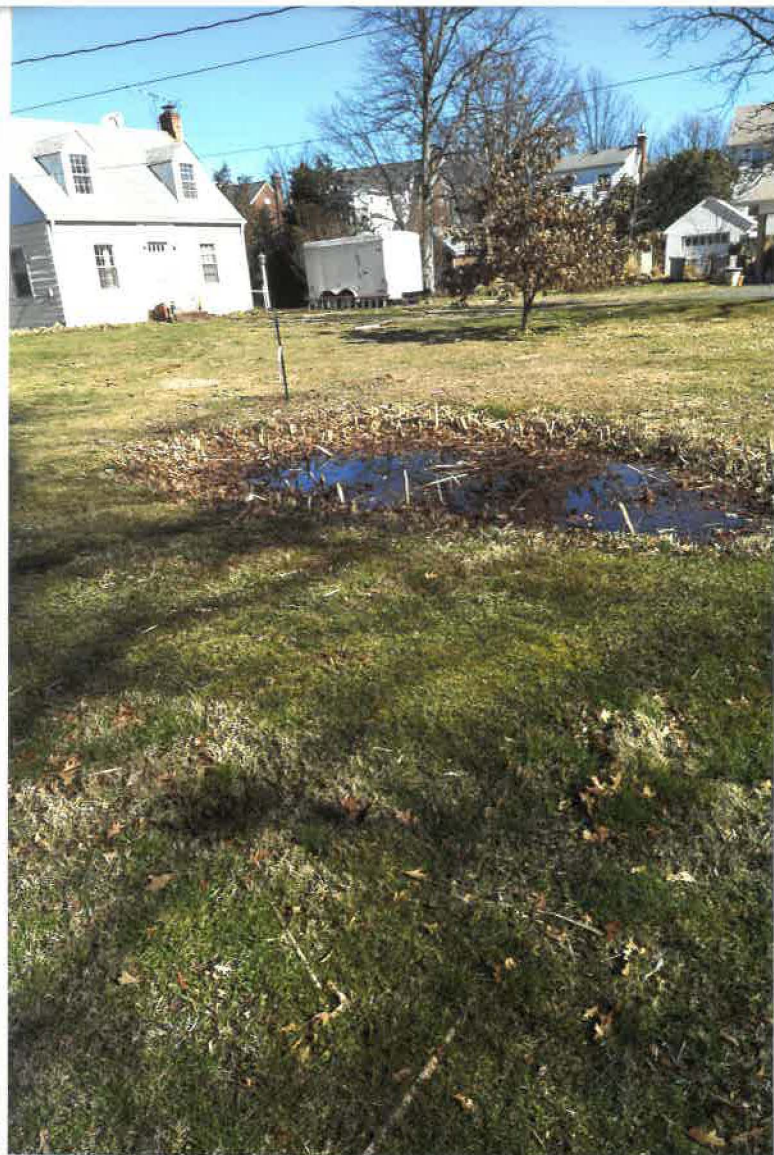
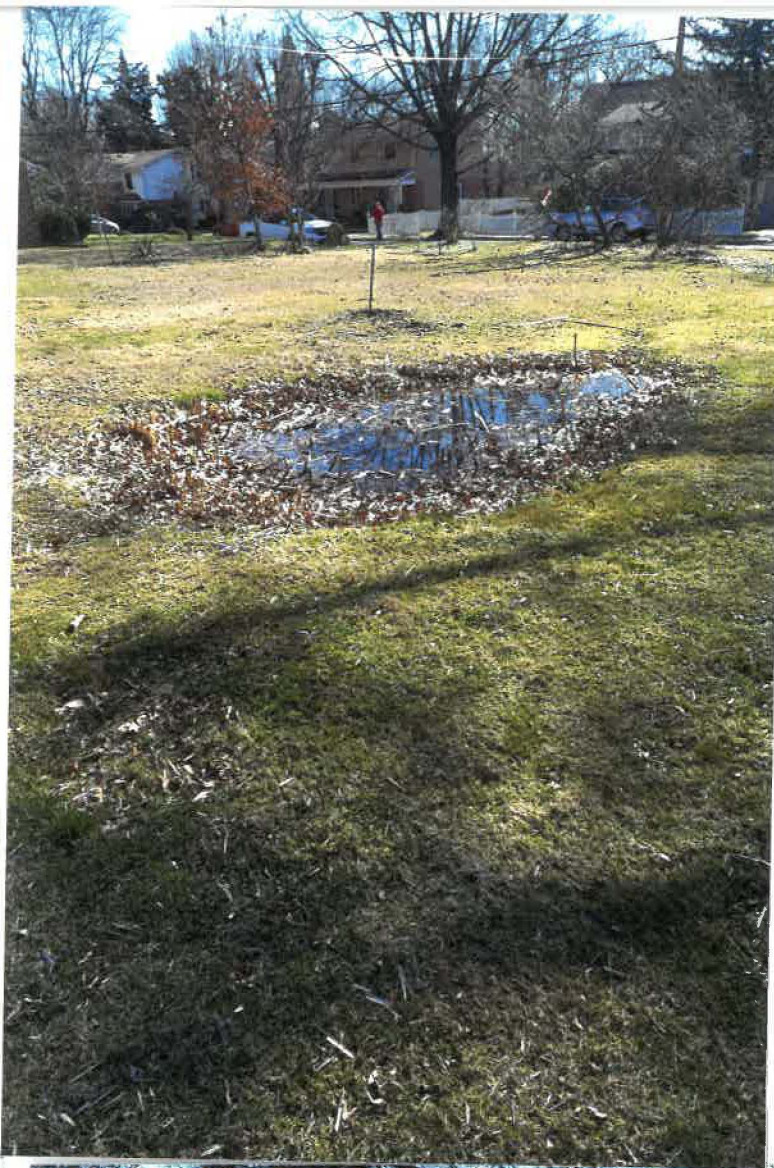
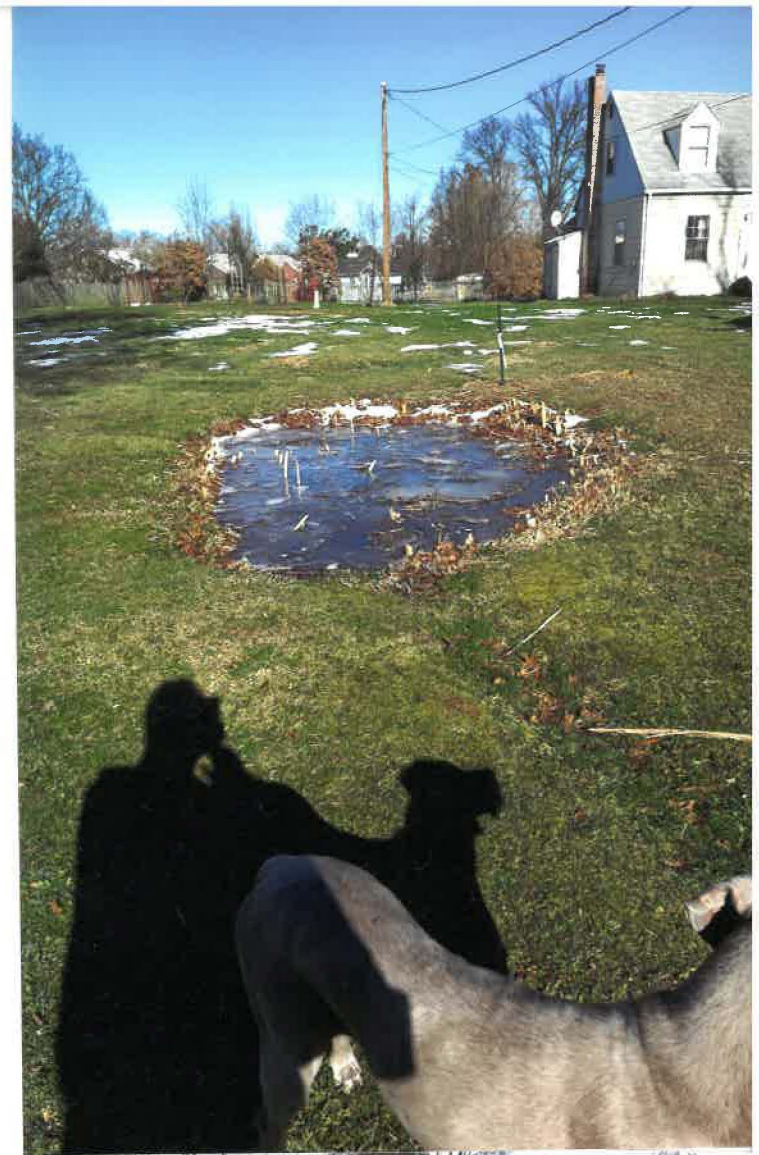
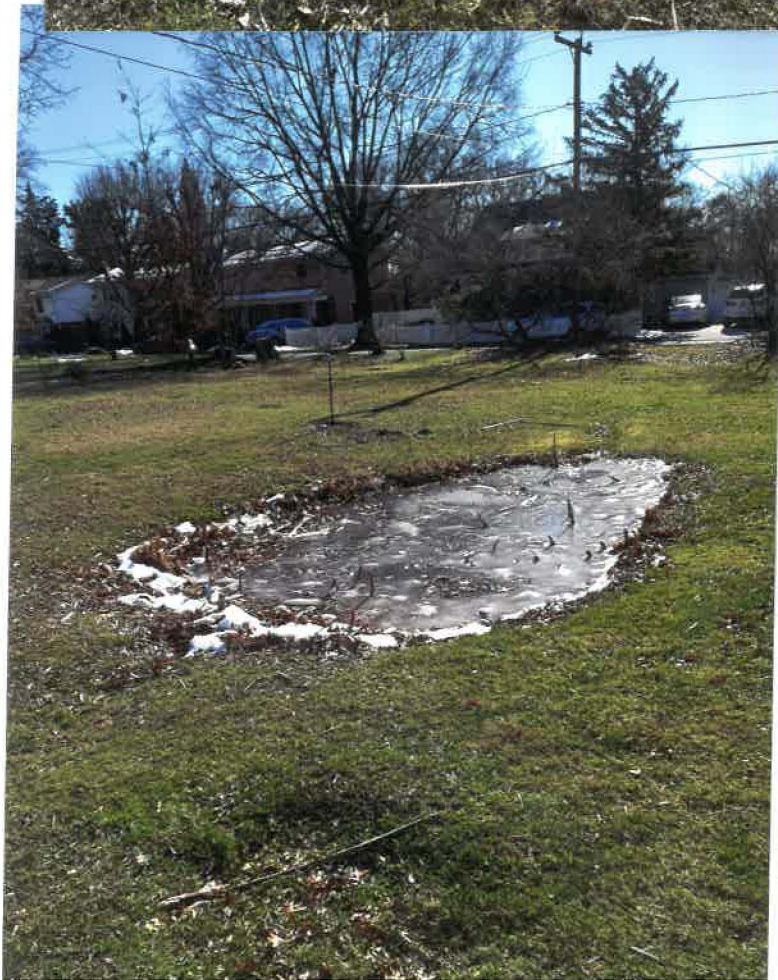
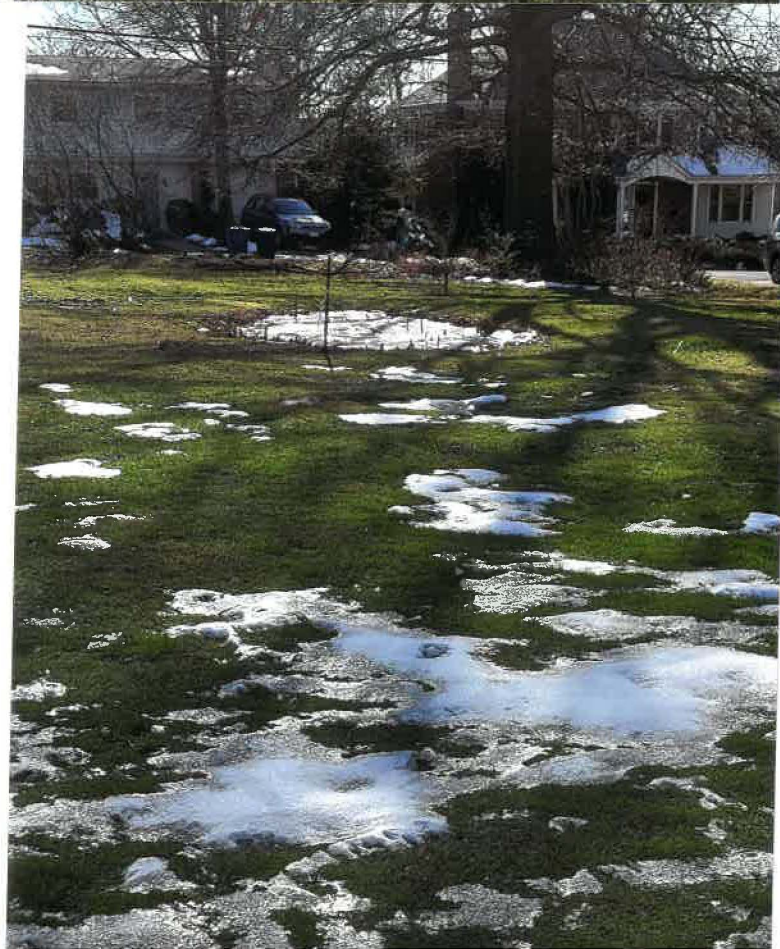
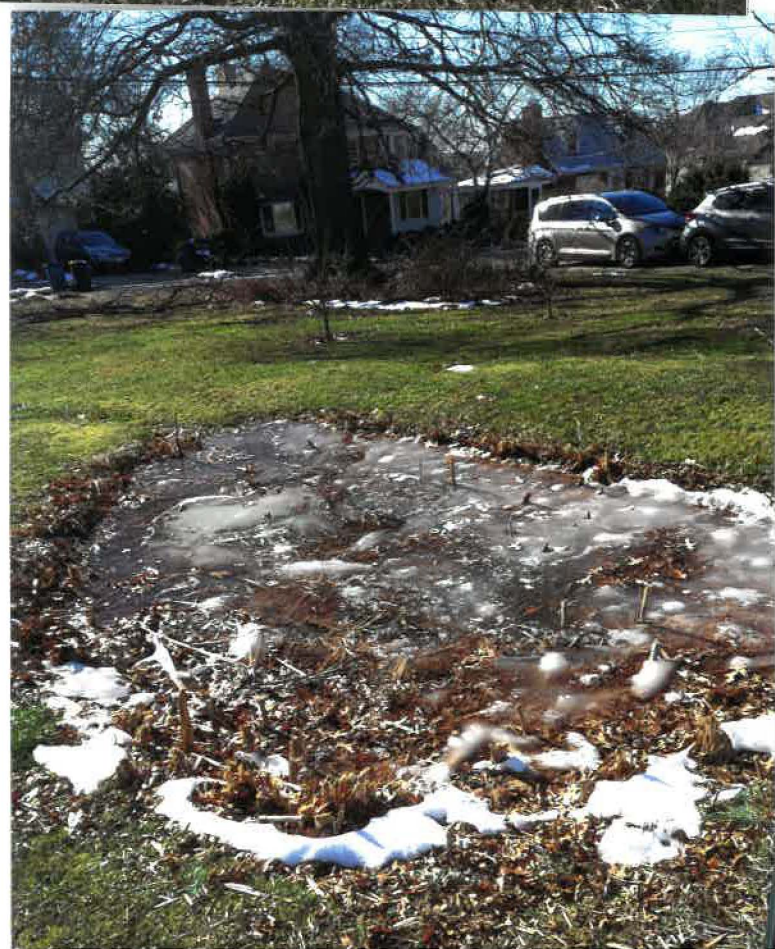
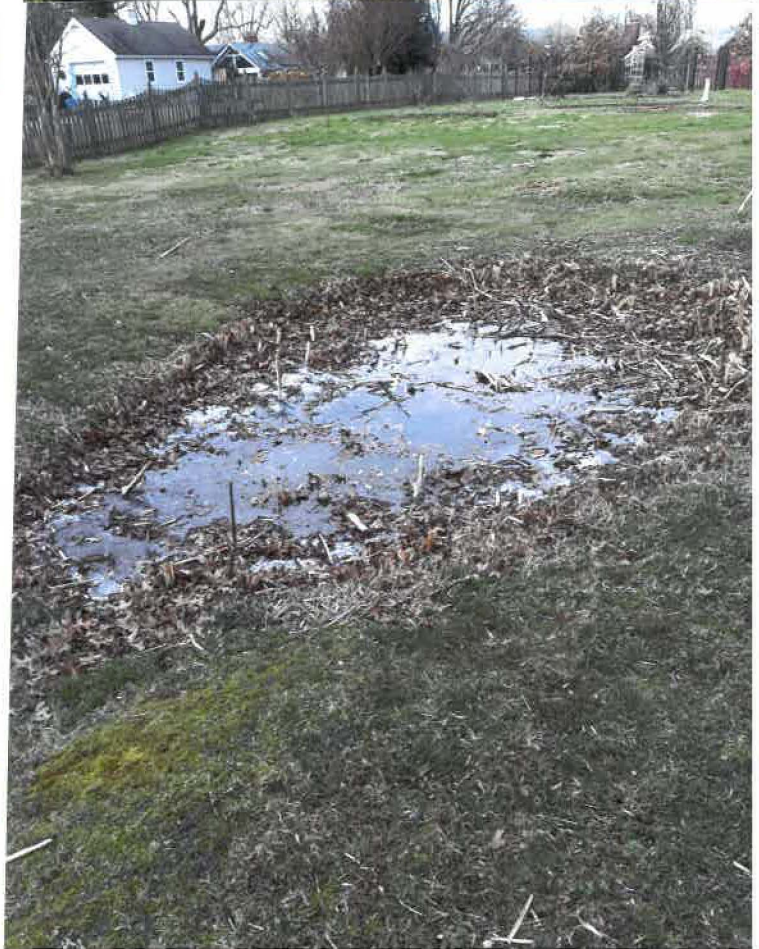
Pictures of the pond over couple months different angles showing water level

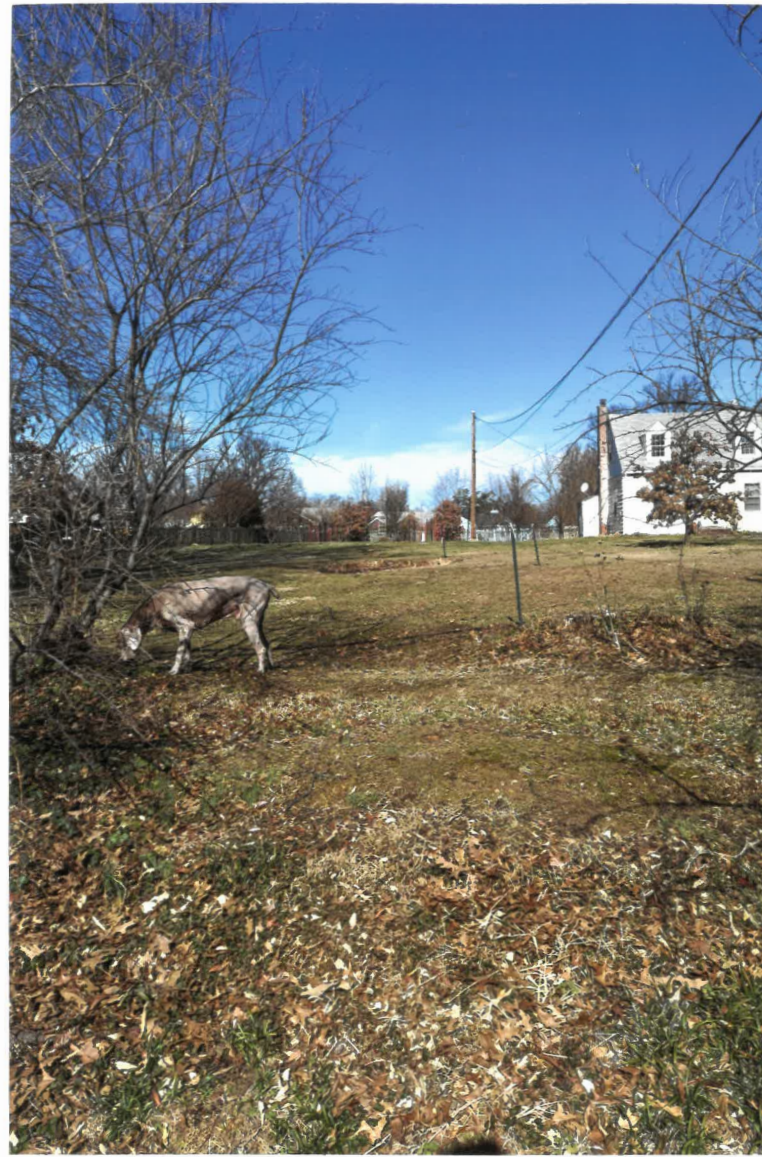
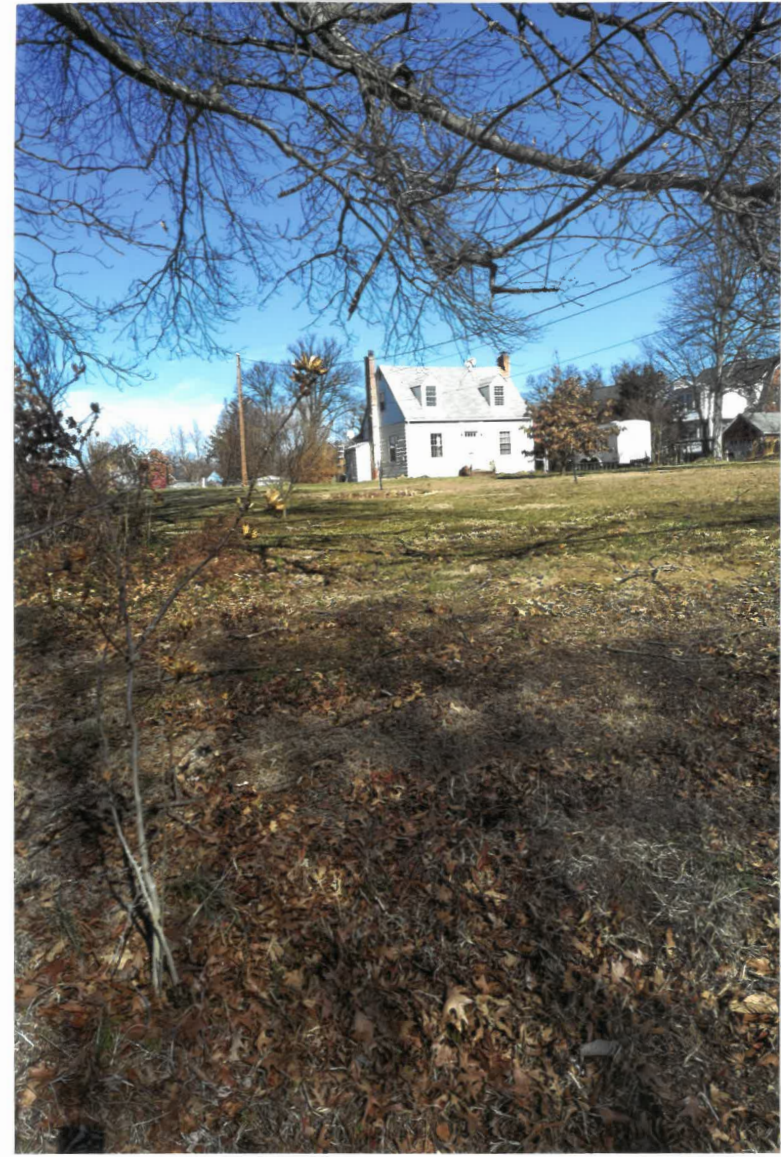
From the curbside looking North showing gentle slope and pond

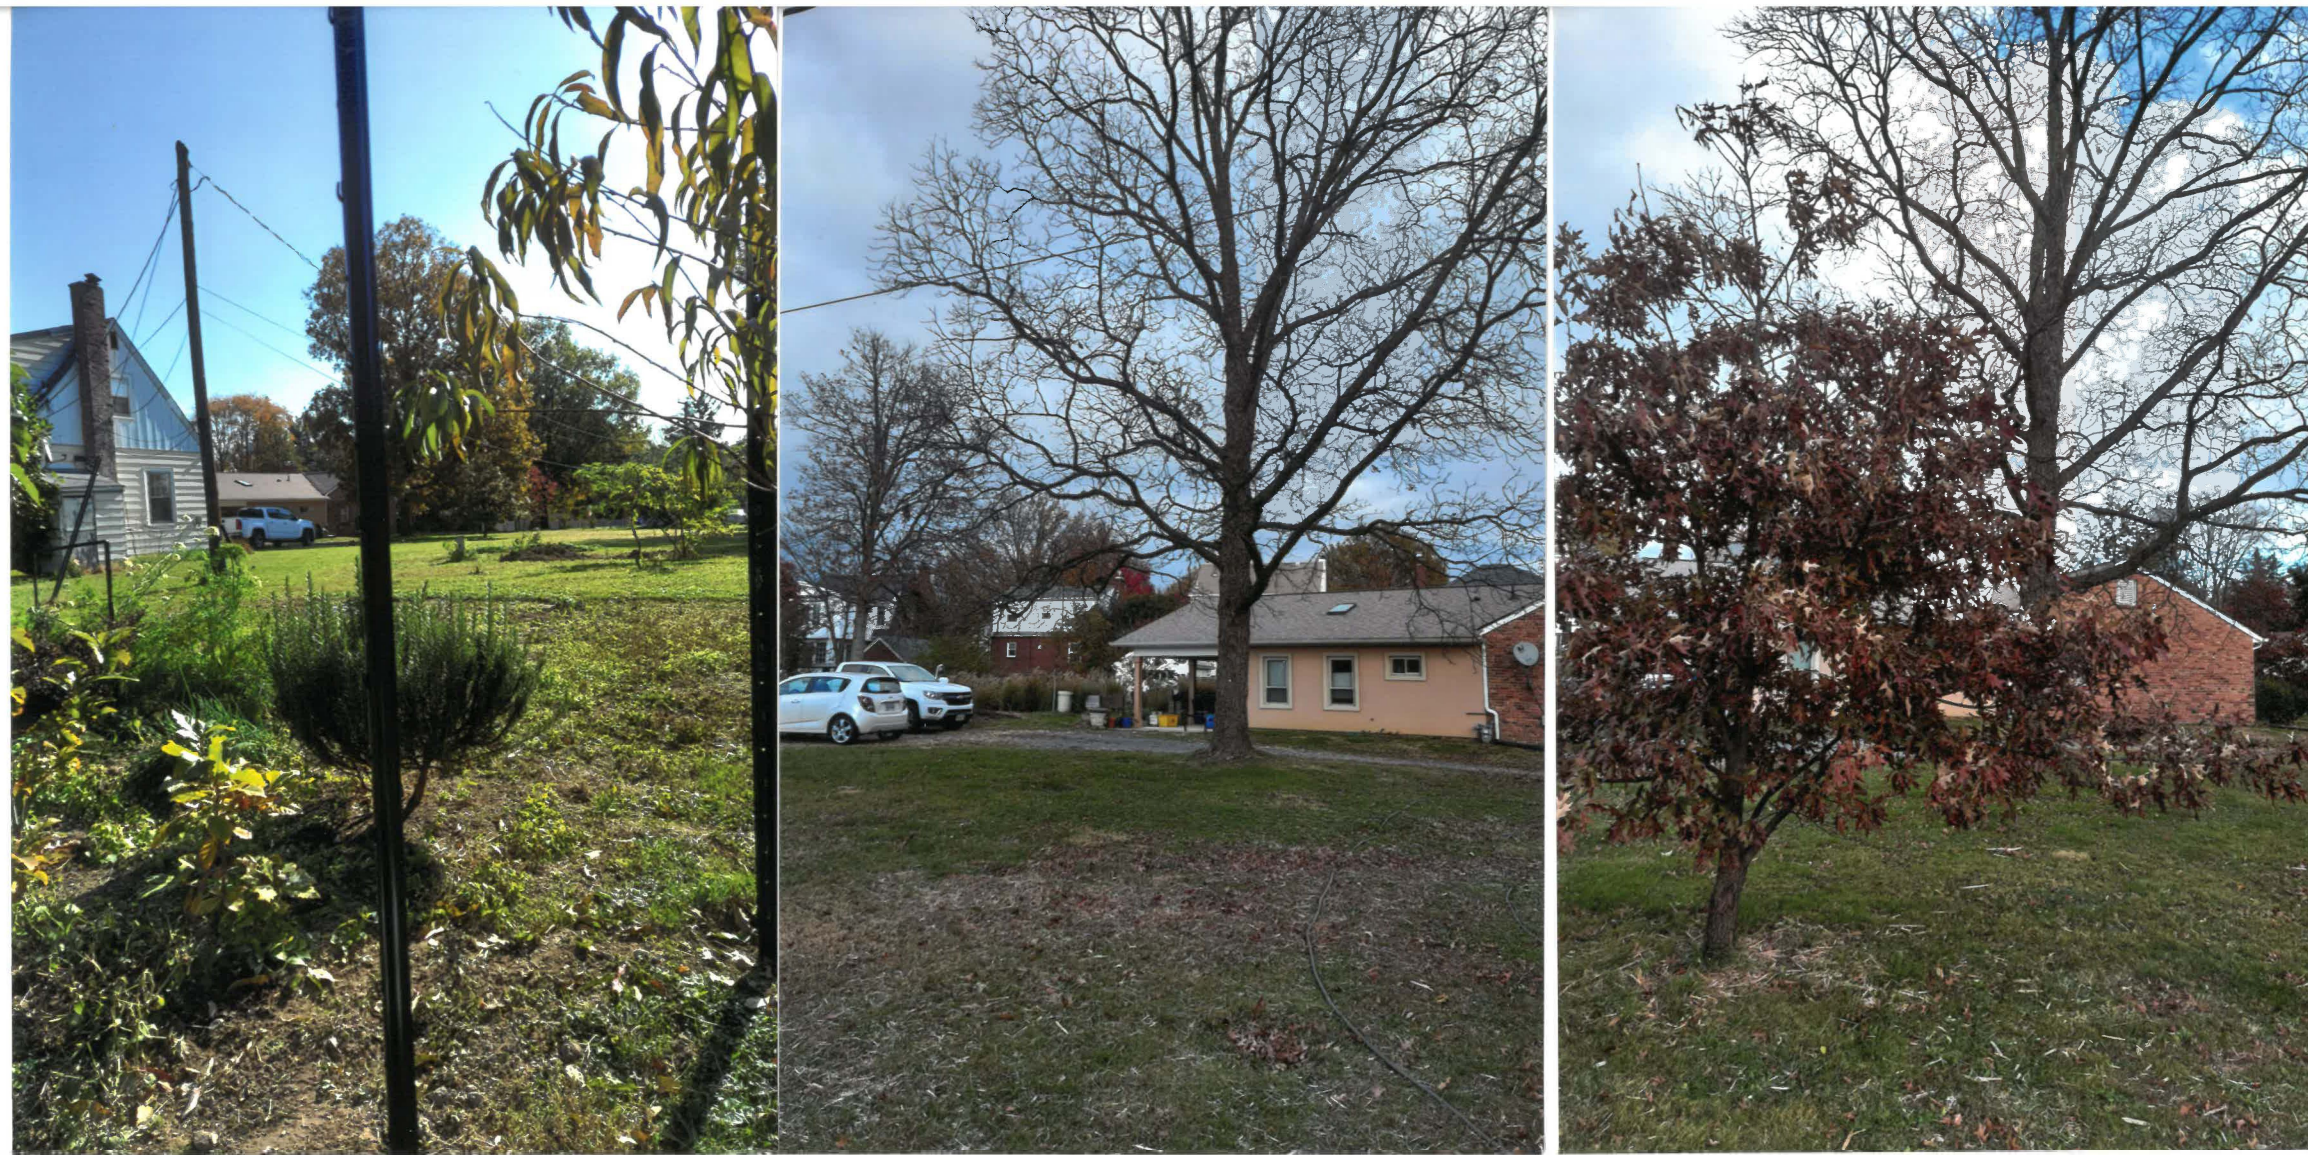
3 Pictures showing the tall southern pecan and smaller oak I planted.
These two would be removed with forward home positioning

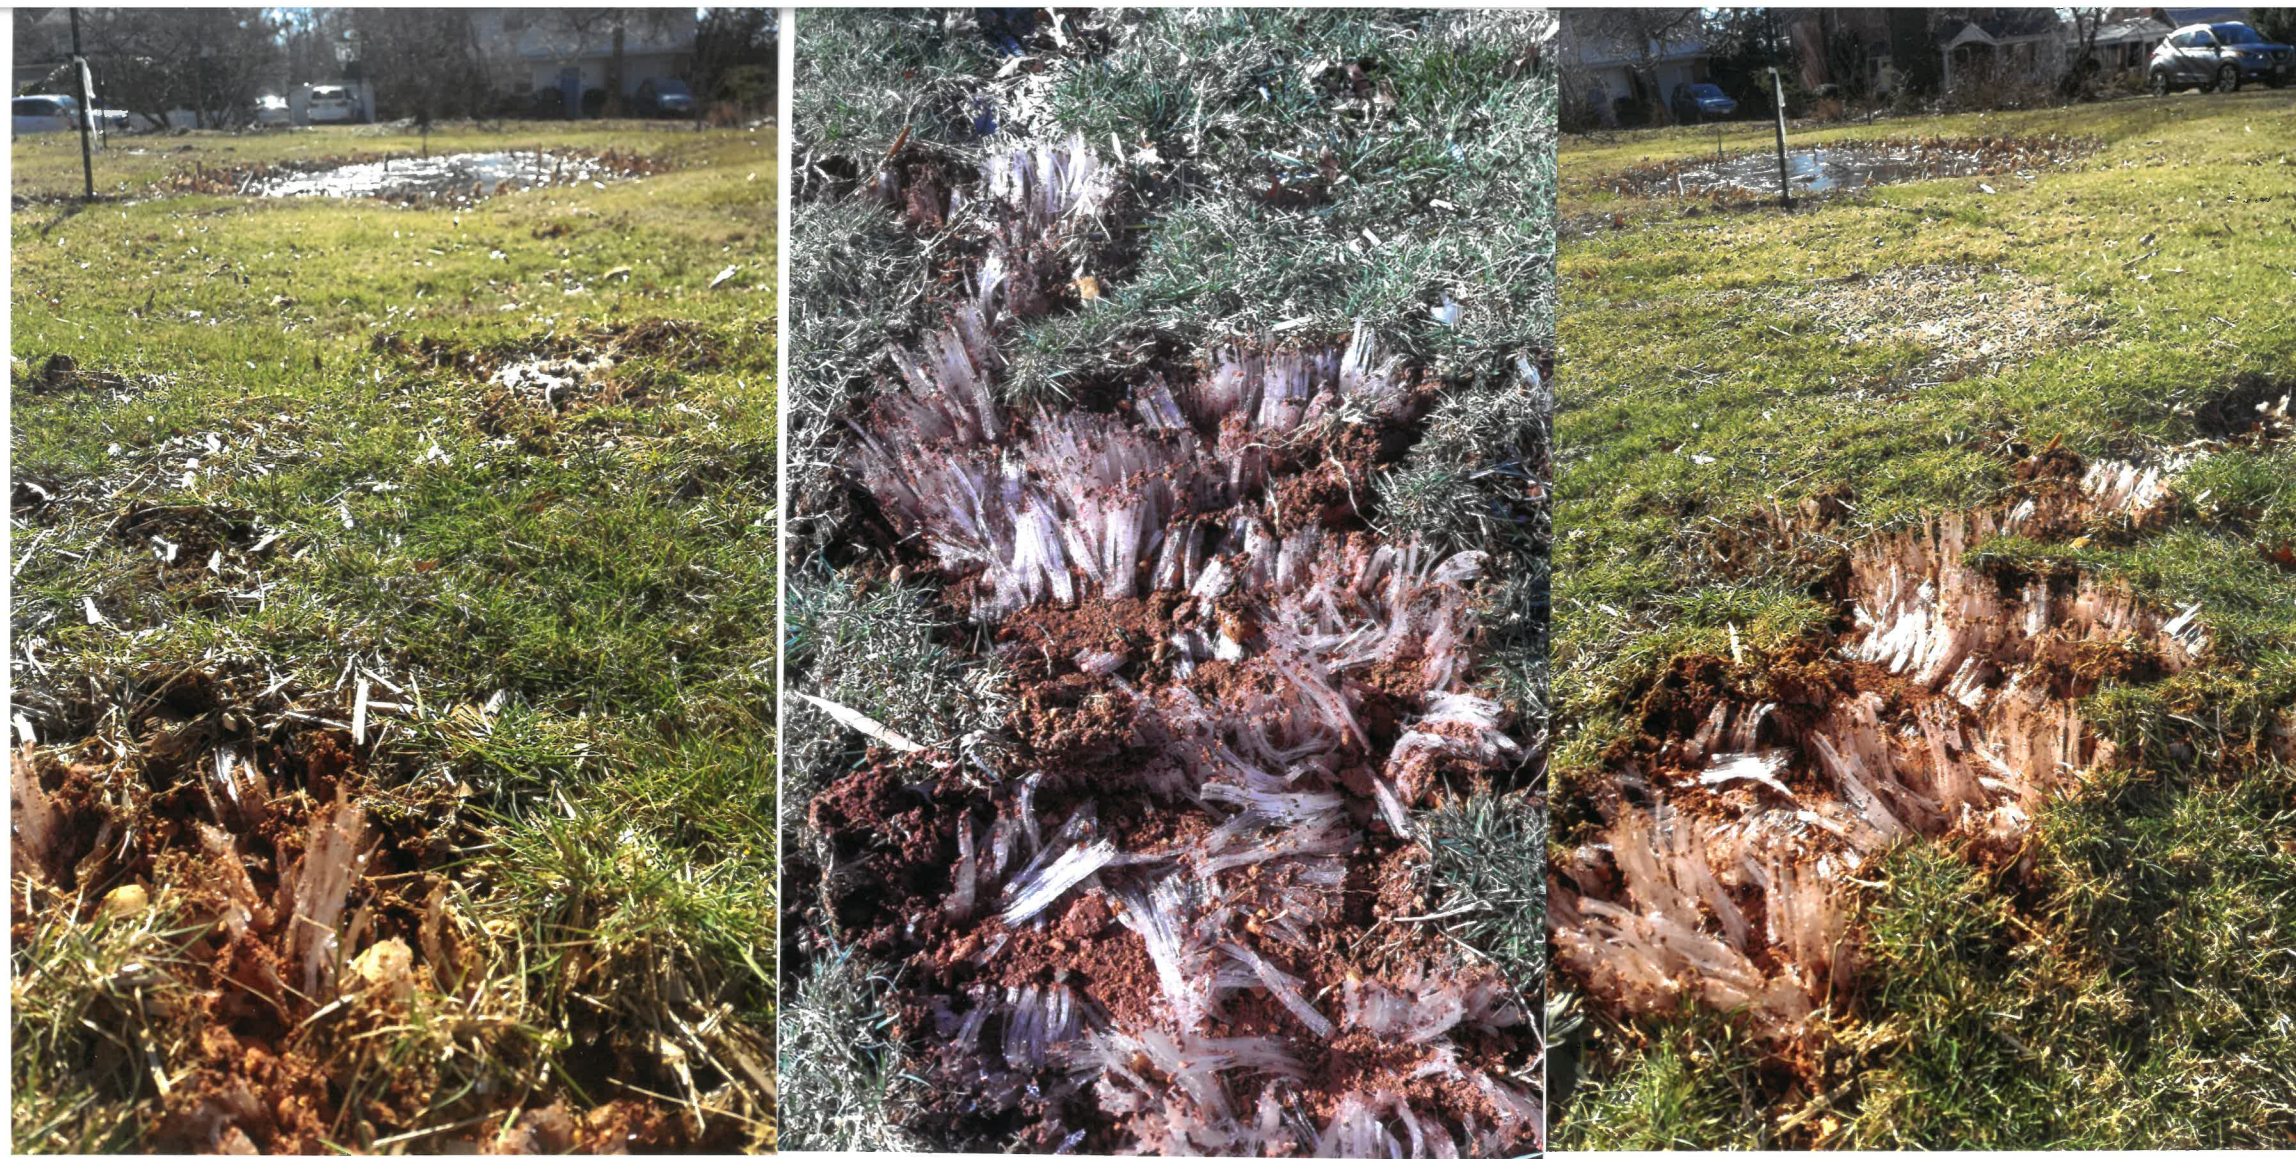
These are icicles pushing up North of pond caused by hydrostatic pressure
