- SUP request to construct a new singlefamily dwelling on a developed, substandard lot.
- Complies with R-8 zoning and residential infill guidelines.

Substandard Lot

City Council

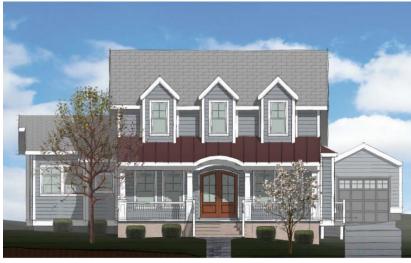
#### Proposed Dwelling

- Neighborhood-wide deep front yards push the bulk of the structure away from the street.
- Proposed dwelling is further setback than existing dwelling.
- Tiered massing, between the primary structure and smaller wings breaks up the bulk of the dwelling.

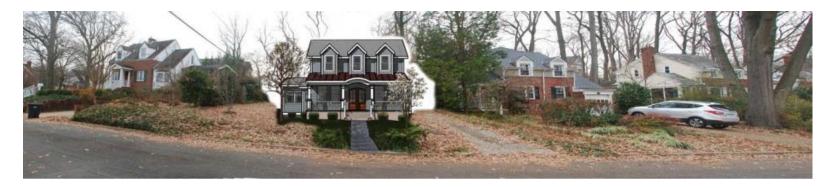
Proposed height complies with residential infill guidelines.

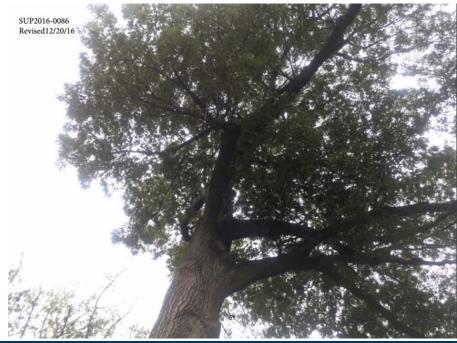
Tree 1: Signs of root and stem decay and significant deadwood in the tree crown.

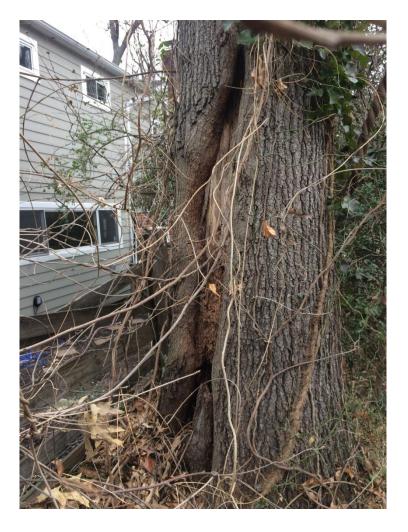
• Tree 3: Large split at base and hollow area in trunk.
