Dear Council Members,

Due to an error at Fed-Ex I had only given you the first half of the Historic Structures report, so here is the second half. The Second half does include important chapters such as approaches to rehabilitation and possible uses. If you have any questions please feel free to call or email me. I am working on showing that there is deep support, especially in the African American community for the acquisition and rehabilitation of this building.

Carver Nursery School / William Thomas Post 129, Alexandria, Virginia
Historic Structure Report

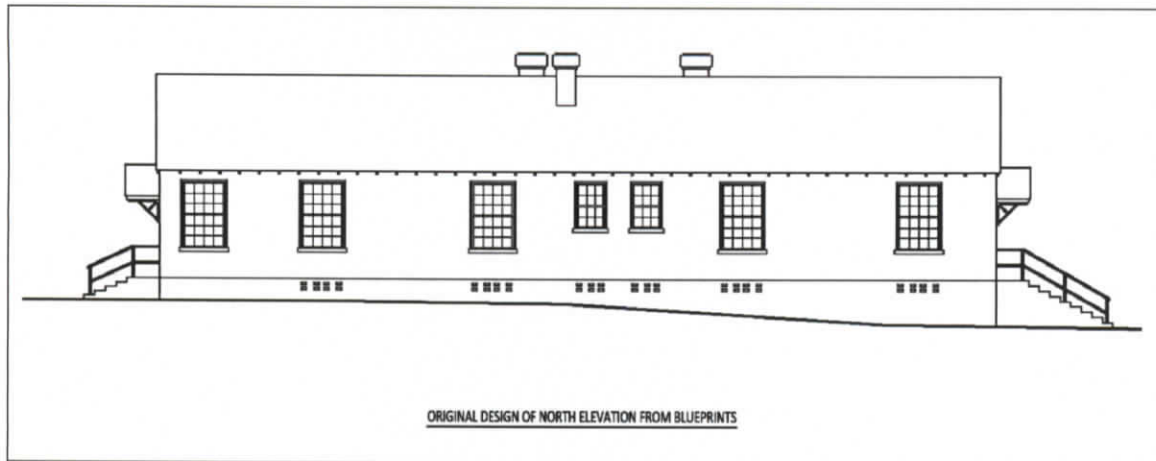
The elevation above was redrafted from the surviving blueprint of the original drawings. It shows that the intention was to place basement ventilators under all the windows except the ones at the east end, emphasizing the bilateral symmetry that was centered on the center line between the two small kitchen windows, also reflected in the two south wall chimneys (ignoring the one extra window bay at the east end and the off-center kitchen chimney). Also, the stairs at the two gable end entrances are shown with wood handrails rather than the welded pipe railing now in place.

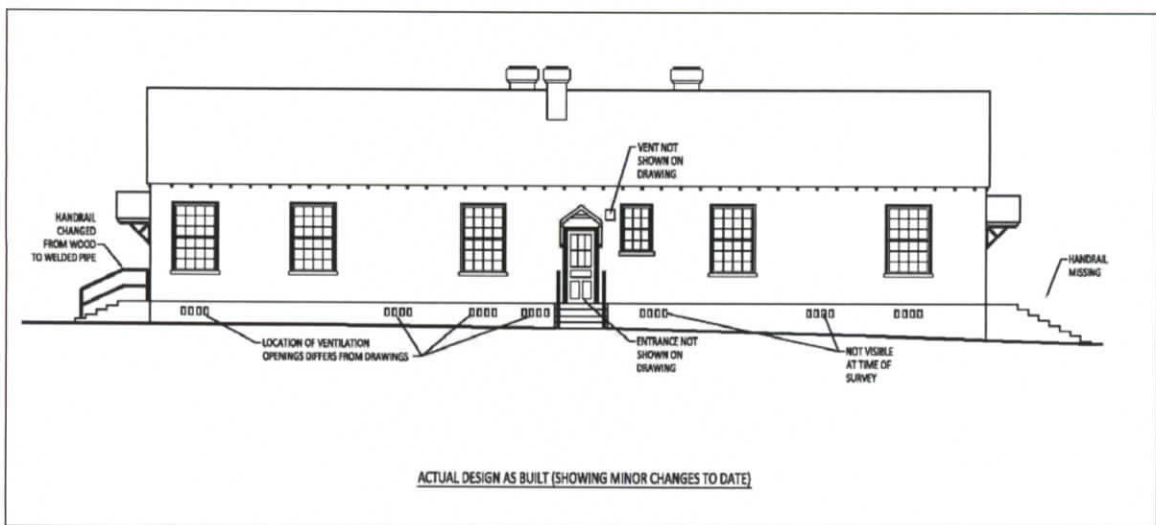
The design was changed at the time of construction, adding a doorway from the kitchen to the playground. At the same time, the designers appear to have added approximately 12" to the height of the walls, maybe in consideration of the gabled canopy over the added doorway. Also in construction, the basement ventilator design was changed to place one under every other one of the five large window openings.

In the process of adding a door in the north elevation, the decision may have been made to build the building with a slightly higher ceiling (approximately 12 inches taller than what was shown on the drawings). This change allowed enough space below the exposed rafter ends to allow for the canopy without altering the canopy design or having it intersect with the roof line.

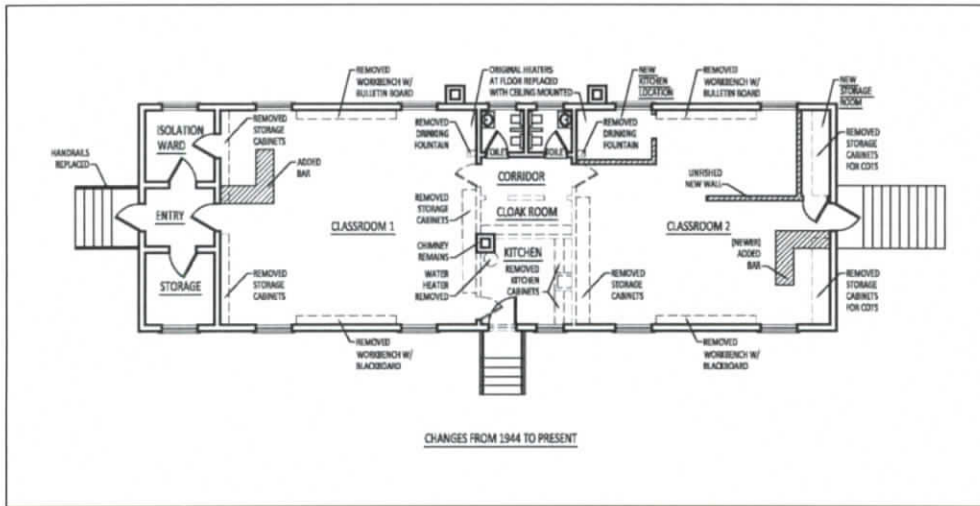
The above drawing shows all items changed (added or removed) since 1944.

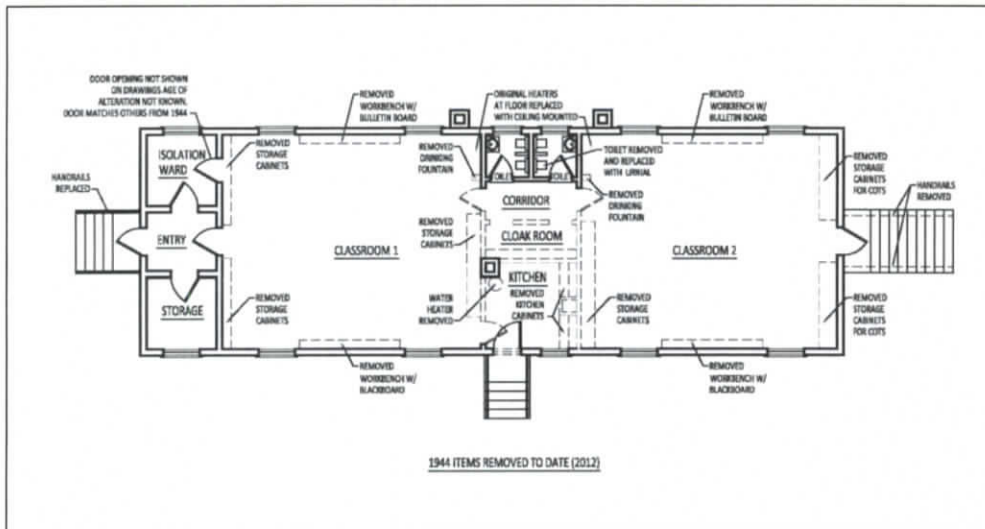
The above drawing shows all components of the 1944 design removed to date.

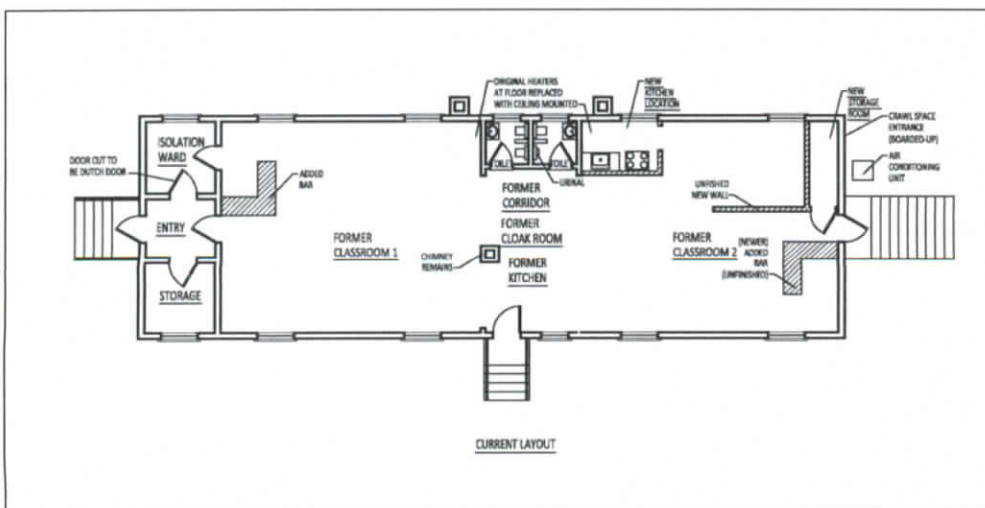
The above drawing shows the current plan with items added since 1944 hatched.

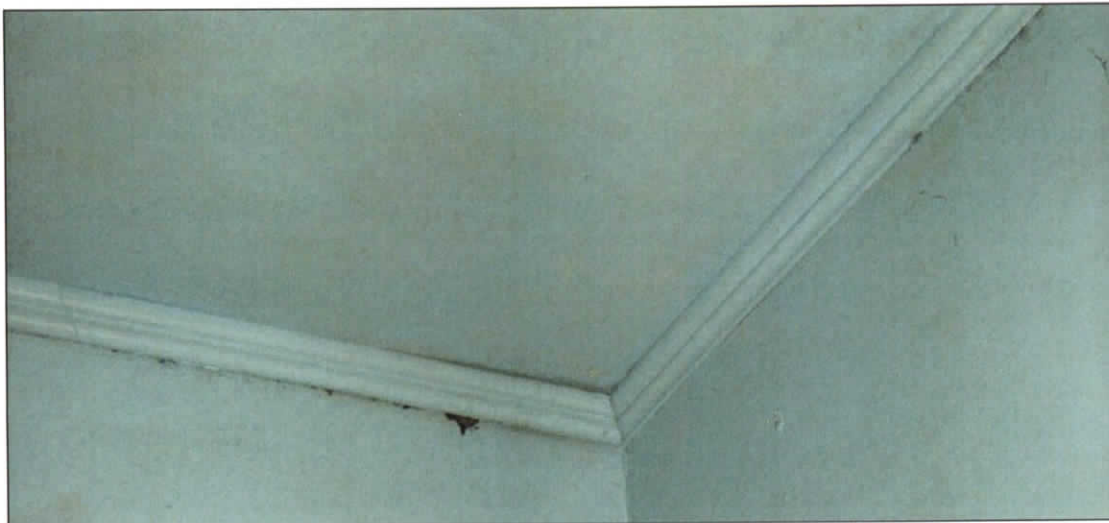
The rail at the ceiling appears to be ordinary picture molding, or at least a profile that looks the same from the floor (i.e., it may or may not have the rounded top edge needed for fastening chains to hang picture frames). The rail is modest in size and is mitered at the corners.

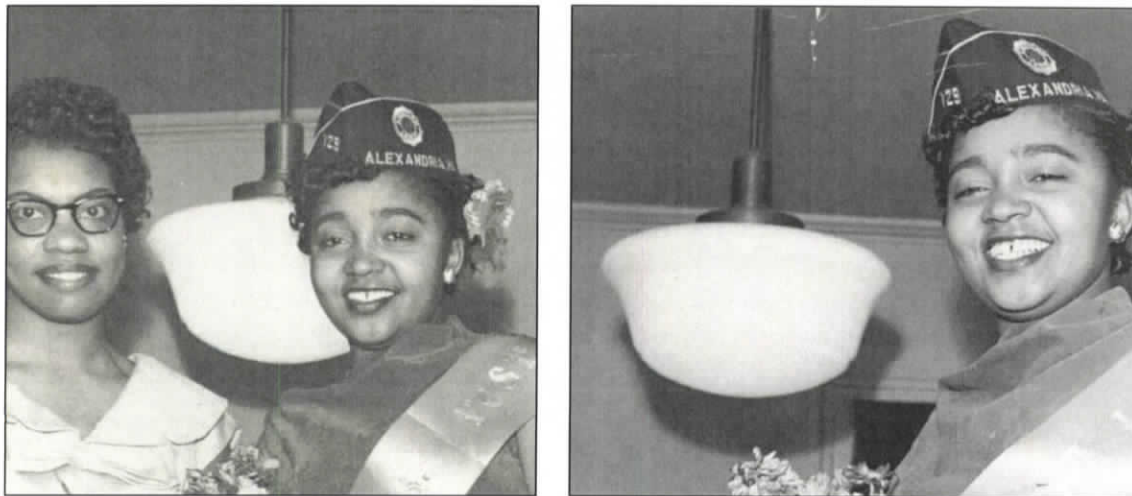
These images from the American Legion Post archives show one of the original “schoolhouse” style light fixtures. The women participating in the fashion show are apparently standing on a table (as indicated in other photographs from the same event). The table used as a stage placed the women close to the fixtures. This kind of activity may have been a reason for altering the fixtures by removing the vertical rods.

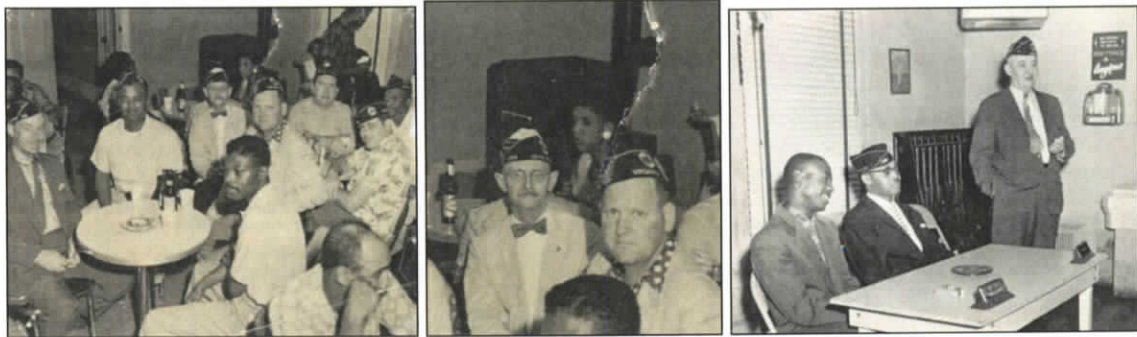
Although it is possible that the above left image is of another building, it may be the only photograph remaining of the building's original oil-fired heaters, as enlarged in the center image. The blinds, trim, door locations, and transfer grill are all consistent with the southeast corner of the west classroom in the Carver Nursery School. By the time the upper right image was made, the original heaters had been replaced by ceiling-mounted ones. This image appears to be the southwest corner of the east classroom. The transfer grill and the drinking fountain are both shown where they also appeared on the original drawings.

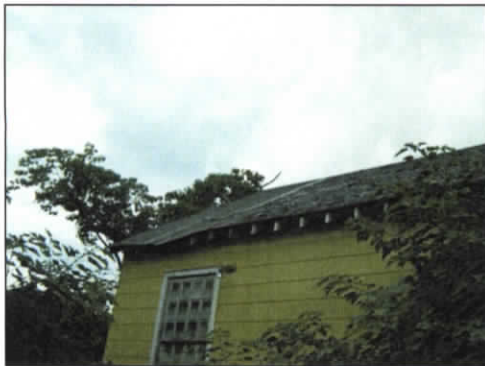
The roof surface is asphalt shingles. The shingles were installed in 1960, according to a statement made to the city by current owner William Cromley (see footnote #73 on page 57, above). Asphalt shingles are called for on the original drawings, but this kind of roofing does not typically last for more than 30 years, so the roof was probably replaced only once since the building was constructed 68 years ago. The roofing has failed in several places. The greatest area of failure is near the building's southwest corner. This area was patched at one point with new shingles covering about 150 square feet near the western edge of the south slope of the roof. The patch may have been needed in this area first because of wear and tear from the elements in the south-facing slope which would be exposed to more severe sun and weather than other areas. It is also where plumbing vents were located and directly above the relocated kitchen. The area immediately east of the patch continued to deteriorate until water and rotting caused the roof sheathing to

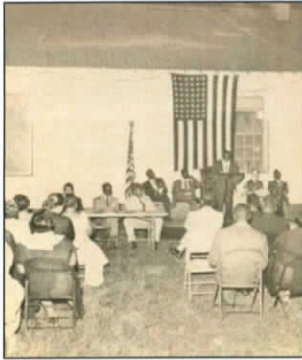
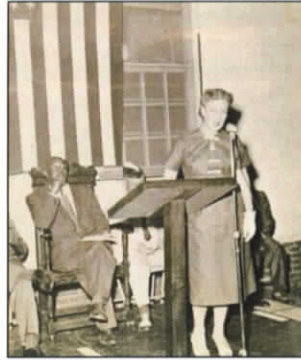
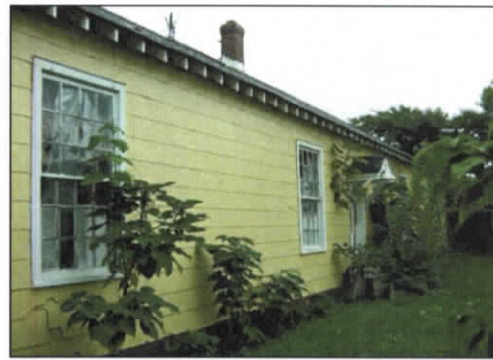
The lodge used the space along the north side of the building for certain ceremonial events when the weather was good enough to hold them out-of-doors. A head table was placed next to the kitchen door stoop, using the blank wall between windows as part of the backdrop. The unpainted brick and the ventilation openings show in the center image, above.

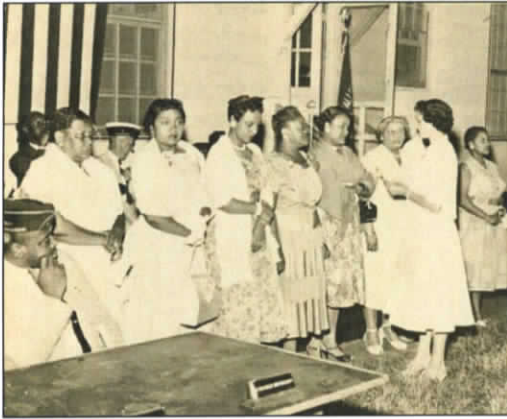
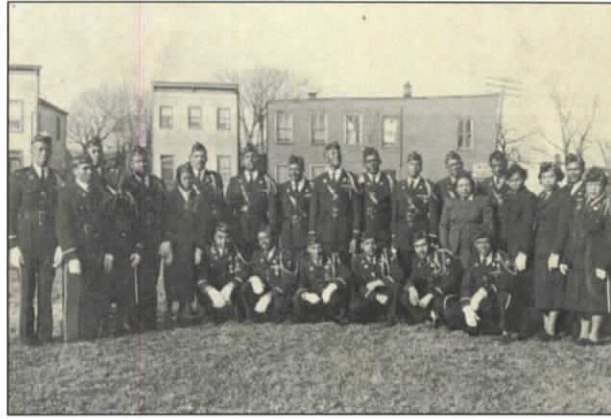
The above left image shows how the area used for outdoor events relates to the kitchen door. Having the door cocked open in this image suggests that the interior was used as well during some events. The original wood handrail design is visible in the above left image as well. The above right image shows that the current playground area was used as extension of the facility's exterior space, when there was no fence separating the two areas. Below is an image of the playground and buildings across Queen Street today.

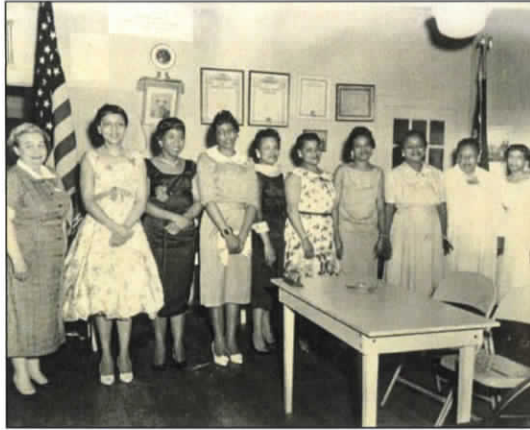
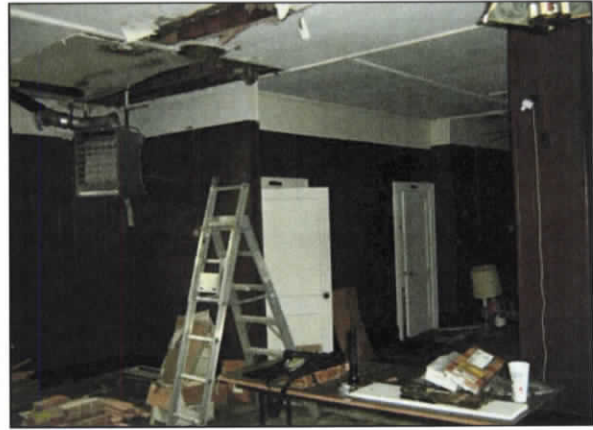
The wall in the background in the above left image has been removed. The doorway behind the flag in the image is next to the rest rooms. The light fixture appears to have been shortened in this image. The above right image shows the same area with the cloak rooms and kitchen removed. The paneling on the right (above right) encloses a chimney.

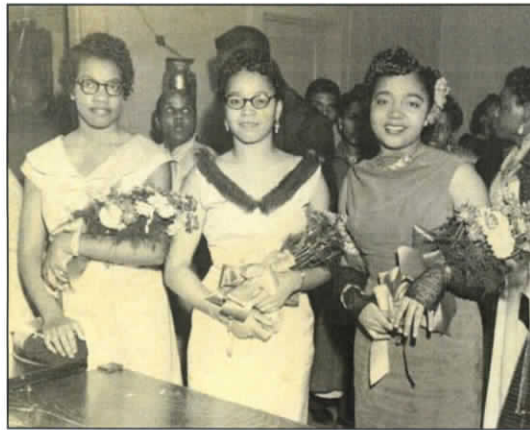
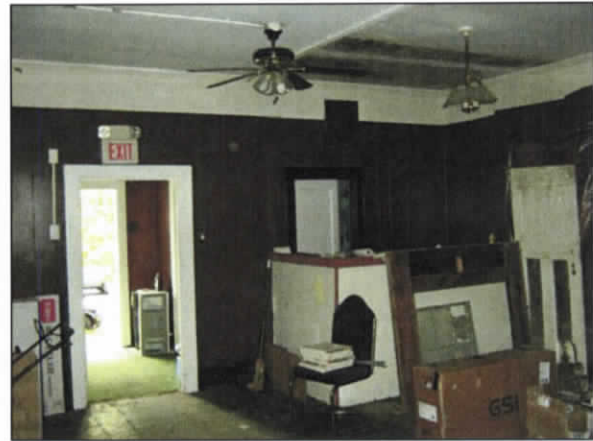
The east wall of the above space is essentially unchanged except for the paneling. The door on the right is not on the drawings, but it is consistent enough to have been original.

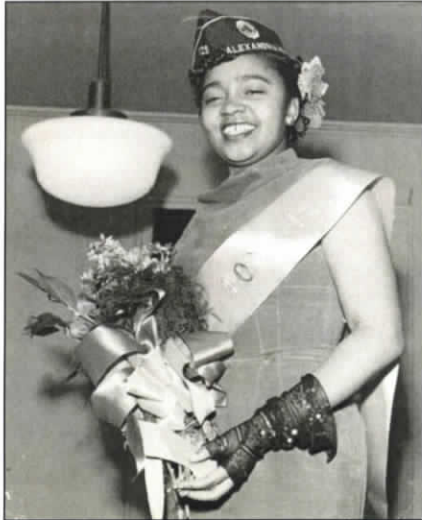
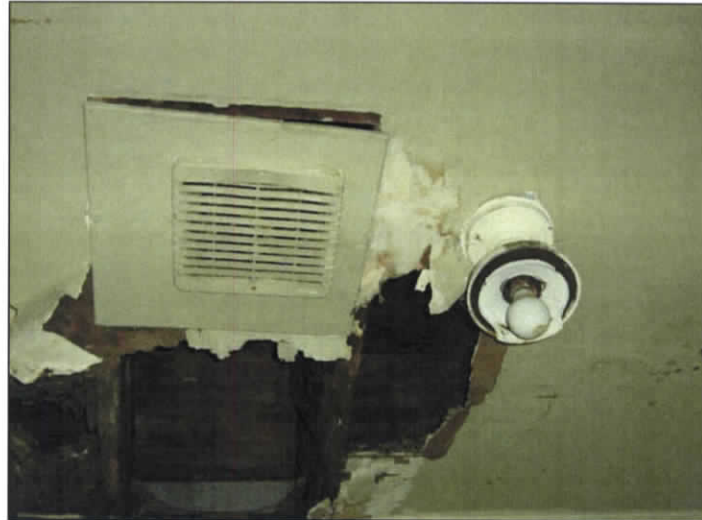
The image above on the left shows a classic “school house light fixture,” most likely what the building had in the original construction. The fixture on the right may be the escutcheon and shade-holder of one of the original school house fixtures; if so, the fixture may have been shortened by removing the rod. This may have been done to create a higher open space, since the post archives indicate they held beauty contests in the space, with people standing on tables as impromptu stages (as is the case in the upper left image). The image also shows that a molding was used at the top of the wall, and a strip of lattice wood was used over a surface joint. These strips of wood were used to hide seams since plaster sheet goods had been developed by this time, but the current process of hiding seams with joint compound was not yet in use. The strip along the top of the wall is a variation on picture rail, a specially shaped molding designed to grip hooks used to hang photos with chains. This method of hanging pictures was typically used in houses in the late nineteenth and early twentieth century. It remain popular in schools even after it passed out of fashion in residential interiors.

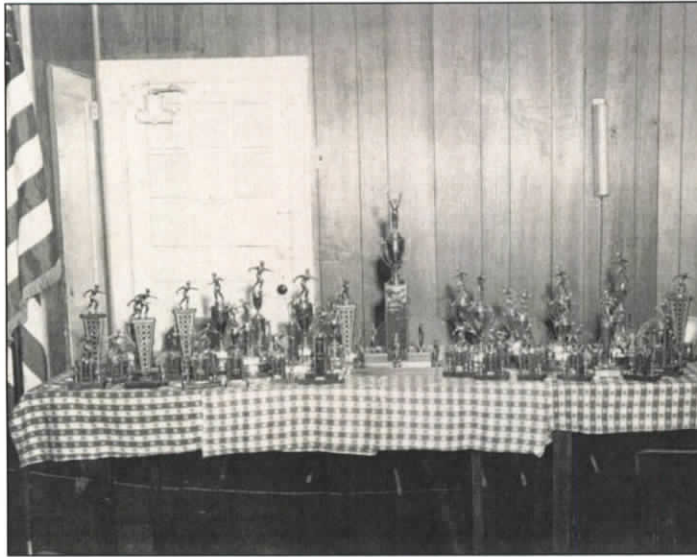
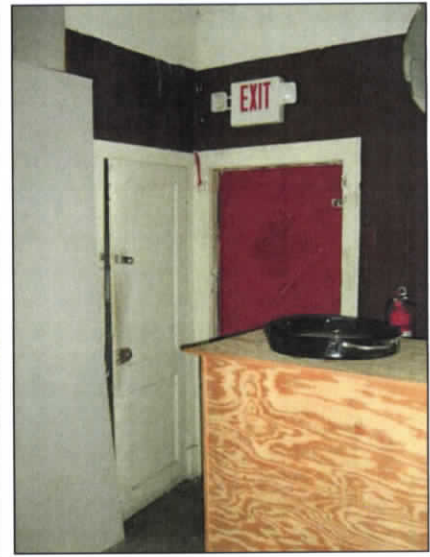
The exterior door in the west gable end wall was still the original 9-light design as late as when the paneling first went in on the walls (ca.1987? The paneling on the left is the lighter, unpainted original color). The door was later replaced by the current flush / hollow-core design with the diamond-shaped vision light (the vision light is now painted-over and/or boarded-up). The door on the left leading into the narrow storage space at the building's southwest corner appears to be an original two-panel door from the 1940s. It may have been relocated to this area from another part of the building. It looks different in the image on the left because the casing has not yet been installed around it.

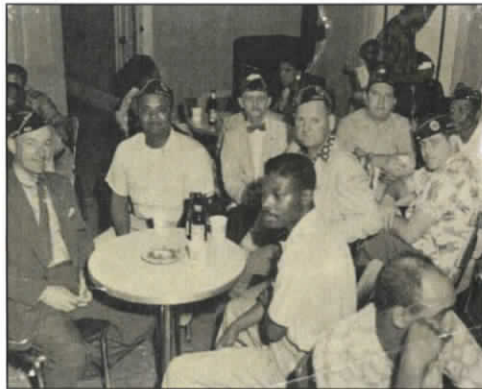
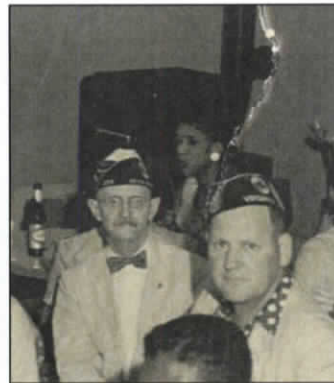
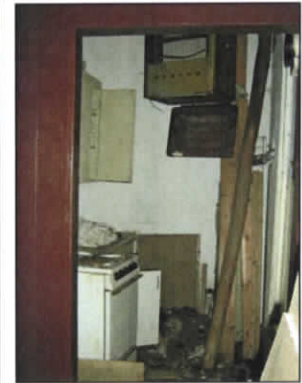
The above left image is believed to be the west classroom looking toward the southeast corner, where one of the two the oil heaters was originally installed. The heating unit in the image may be one of the two that led to the controversy shortly after the building opened. The middle image is an enlargement of it. The wall segment behind it would be the east wall of the classroom, also the west wall of the rest rooms. There appears to be a four-panel door to the left. This may have been moved here from another building. After ca.1987, the post removed this door and the walls just left of the image. They built a room in the corner in view to serve as a new kitchen. To maximize the space, they replaced the floor-model heaters with new ceiling mounted ones, in view in the top right image.
