201 Gibbon Street
Alexandria, VA 22314

Request for Alterations:

- Replace two severely damaged, non-original windows on a portion of the building dating to the 1950s, with replacement windows that fully comply with BAR guidelines, as homeowners were previously told they could in written guidance from BAR Staff in July 2022.

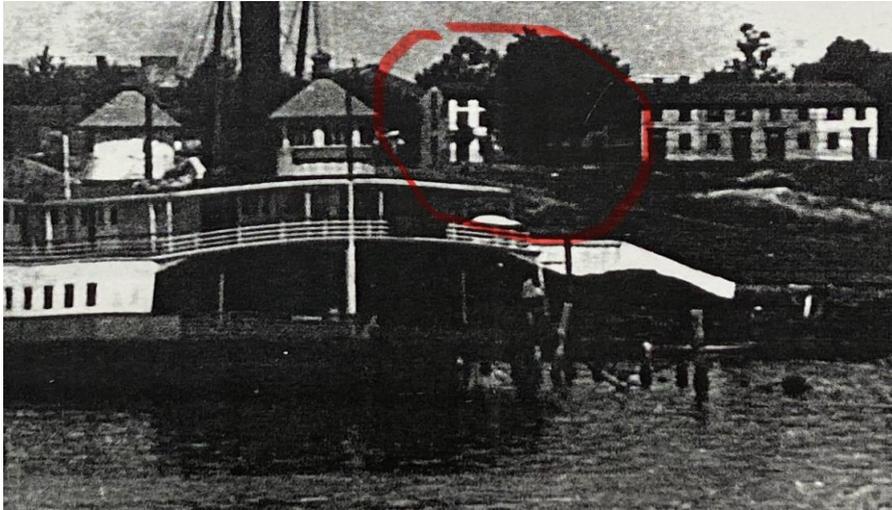
533 and 535 South Lee Street (previously Water Street)
In 1883 with front door facing east towards Potomac River

Footprint maps of the structure from the 1877 Hopkins map and 1941 Sanborn Fire map show two distinct residences, both facing east toward the Potomac.

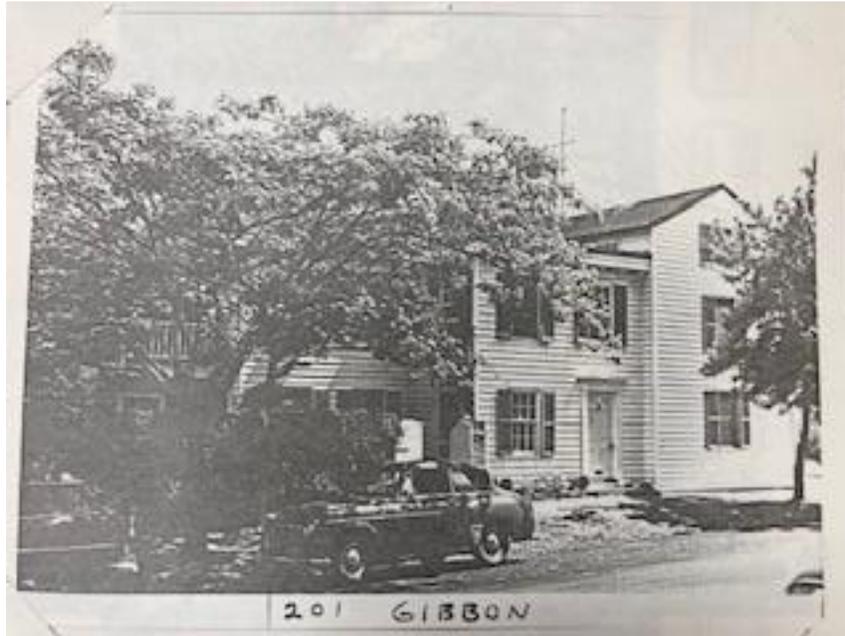
Picture of 201 Gibbon Street circa 1960s (after major renovations 1950-52)
with primary entrance facing south on Gibbon Street. Staff has determined the effective
date of this portion of the building to be 1952.

(nb - the windows are not visible here due to the tree, just like today)

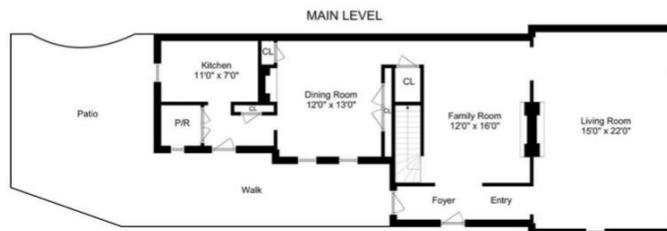
The 1950s renovations created a single house with a single front entrance
on the Gibbon Street side facing south.
