Questions from Chair McMahon with responses from Staff in red.

Docket Item #16 DSUP #2025-10001 2601 Cameron Street

Re: George Mason Elementary School Tree Removal summary analysis: 2601 Cameron Mills Road
IMEG# 24005288

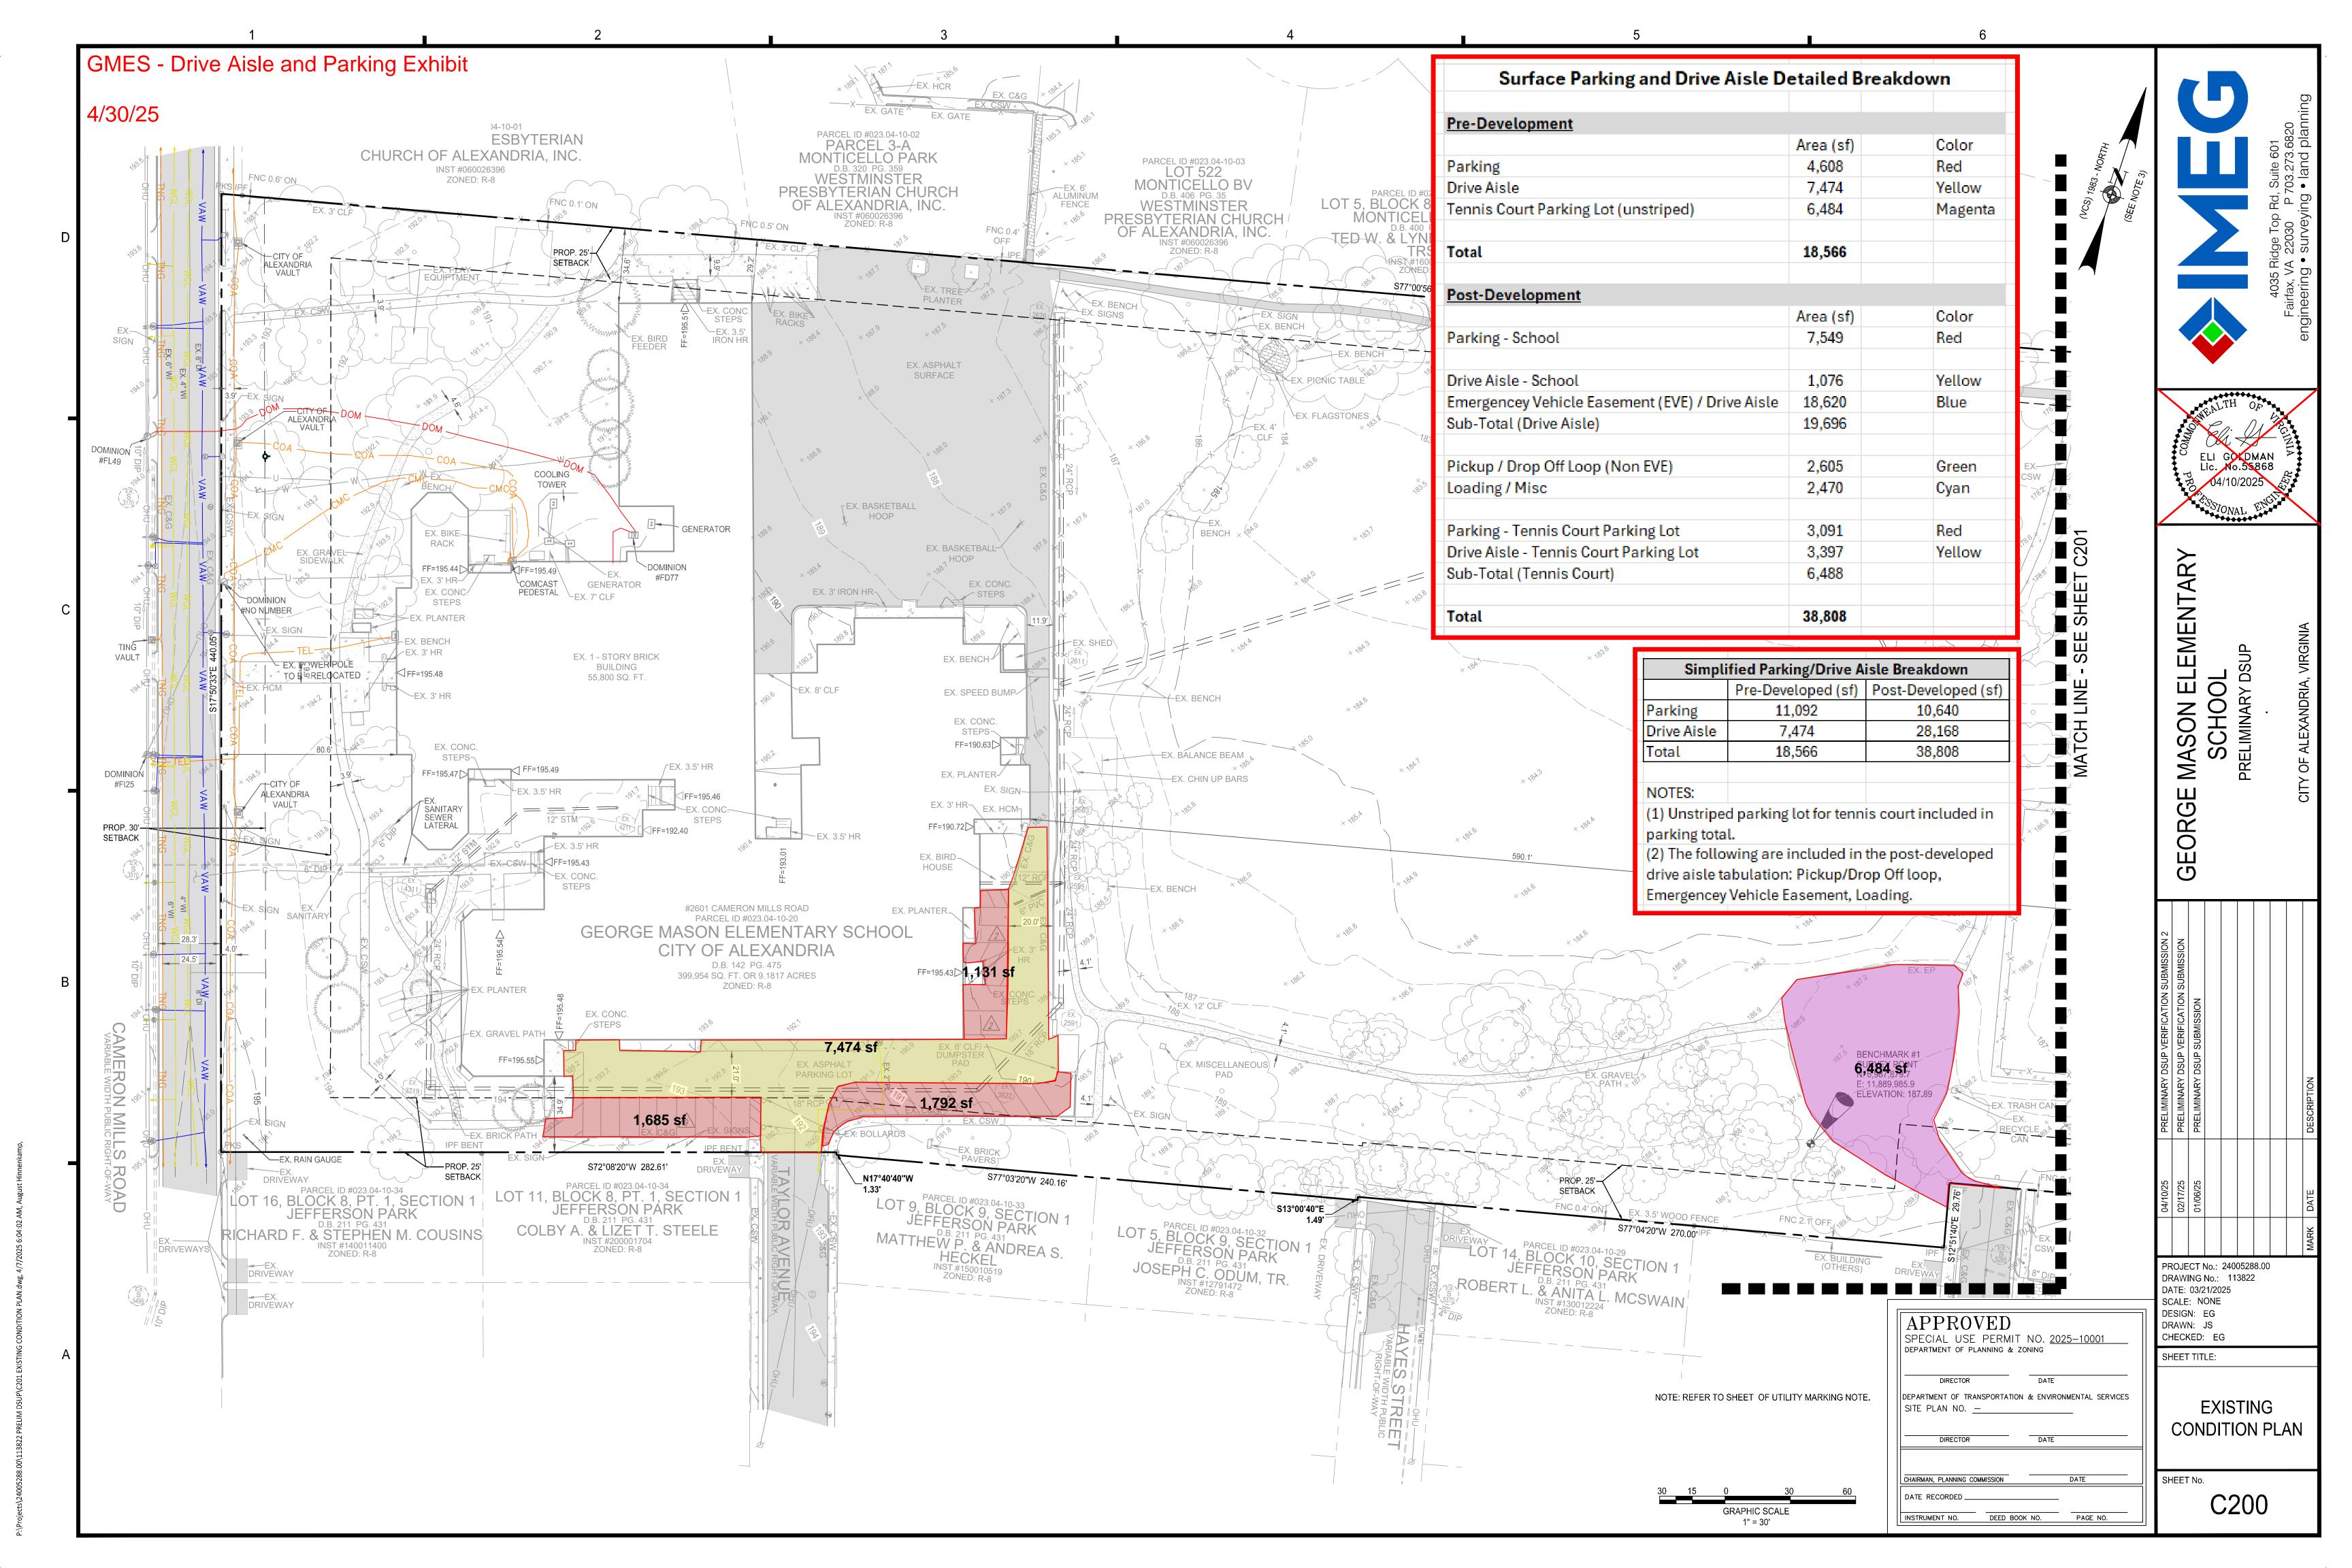
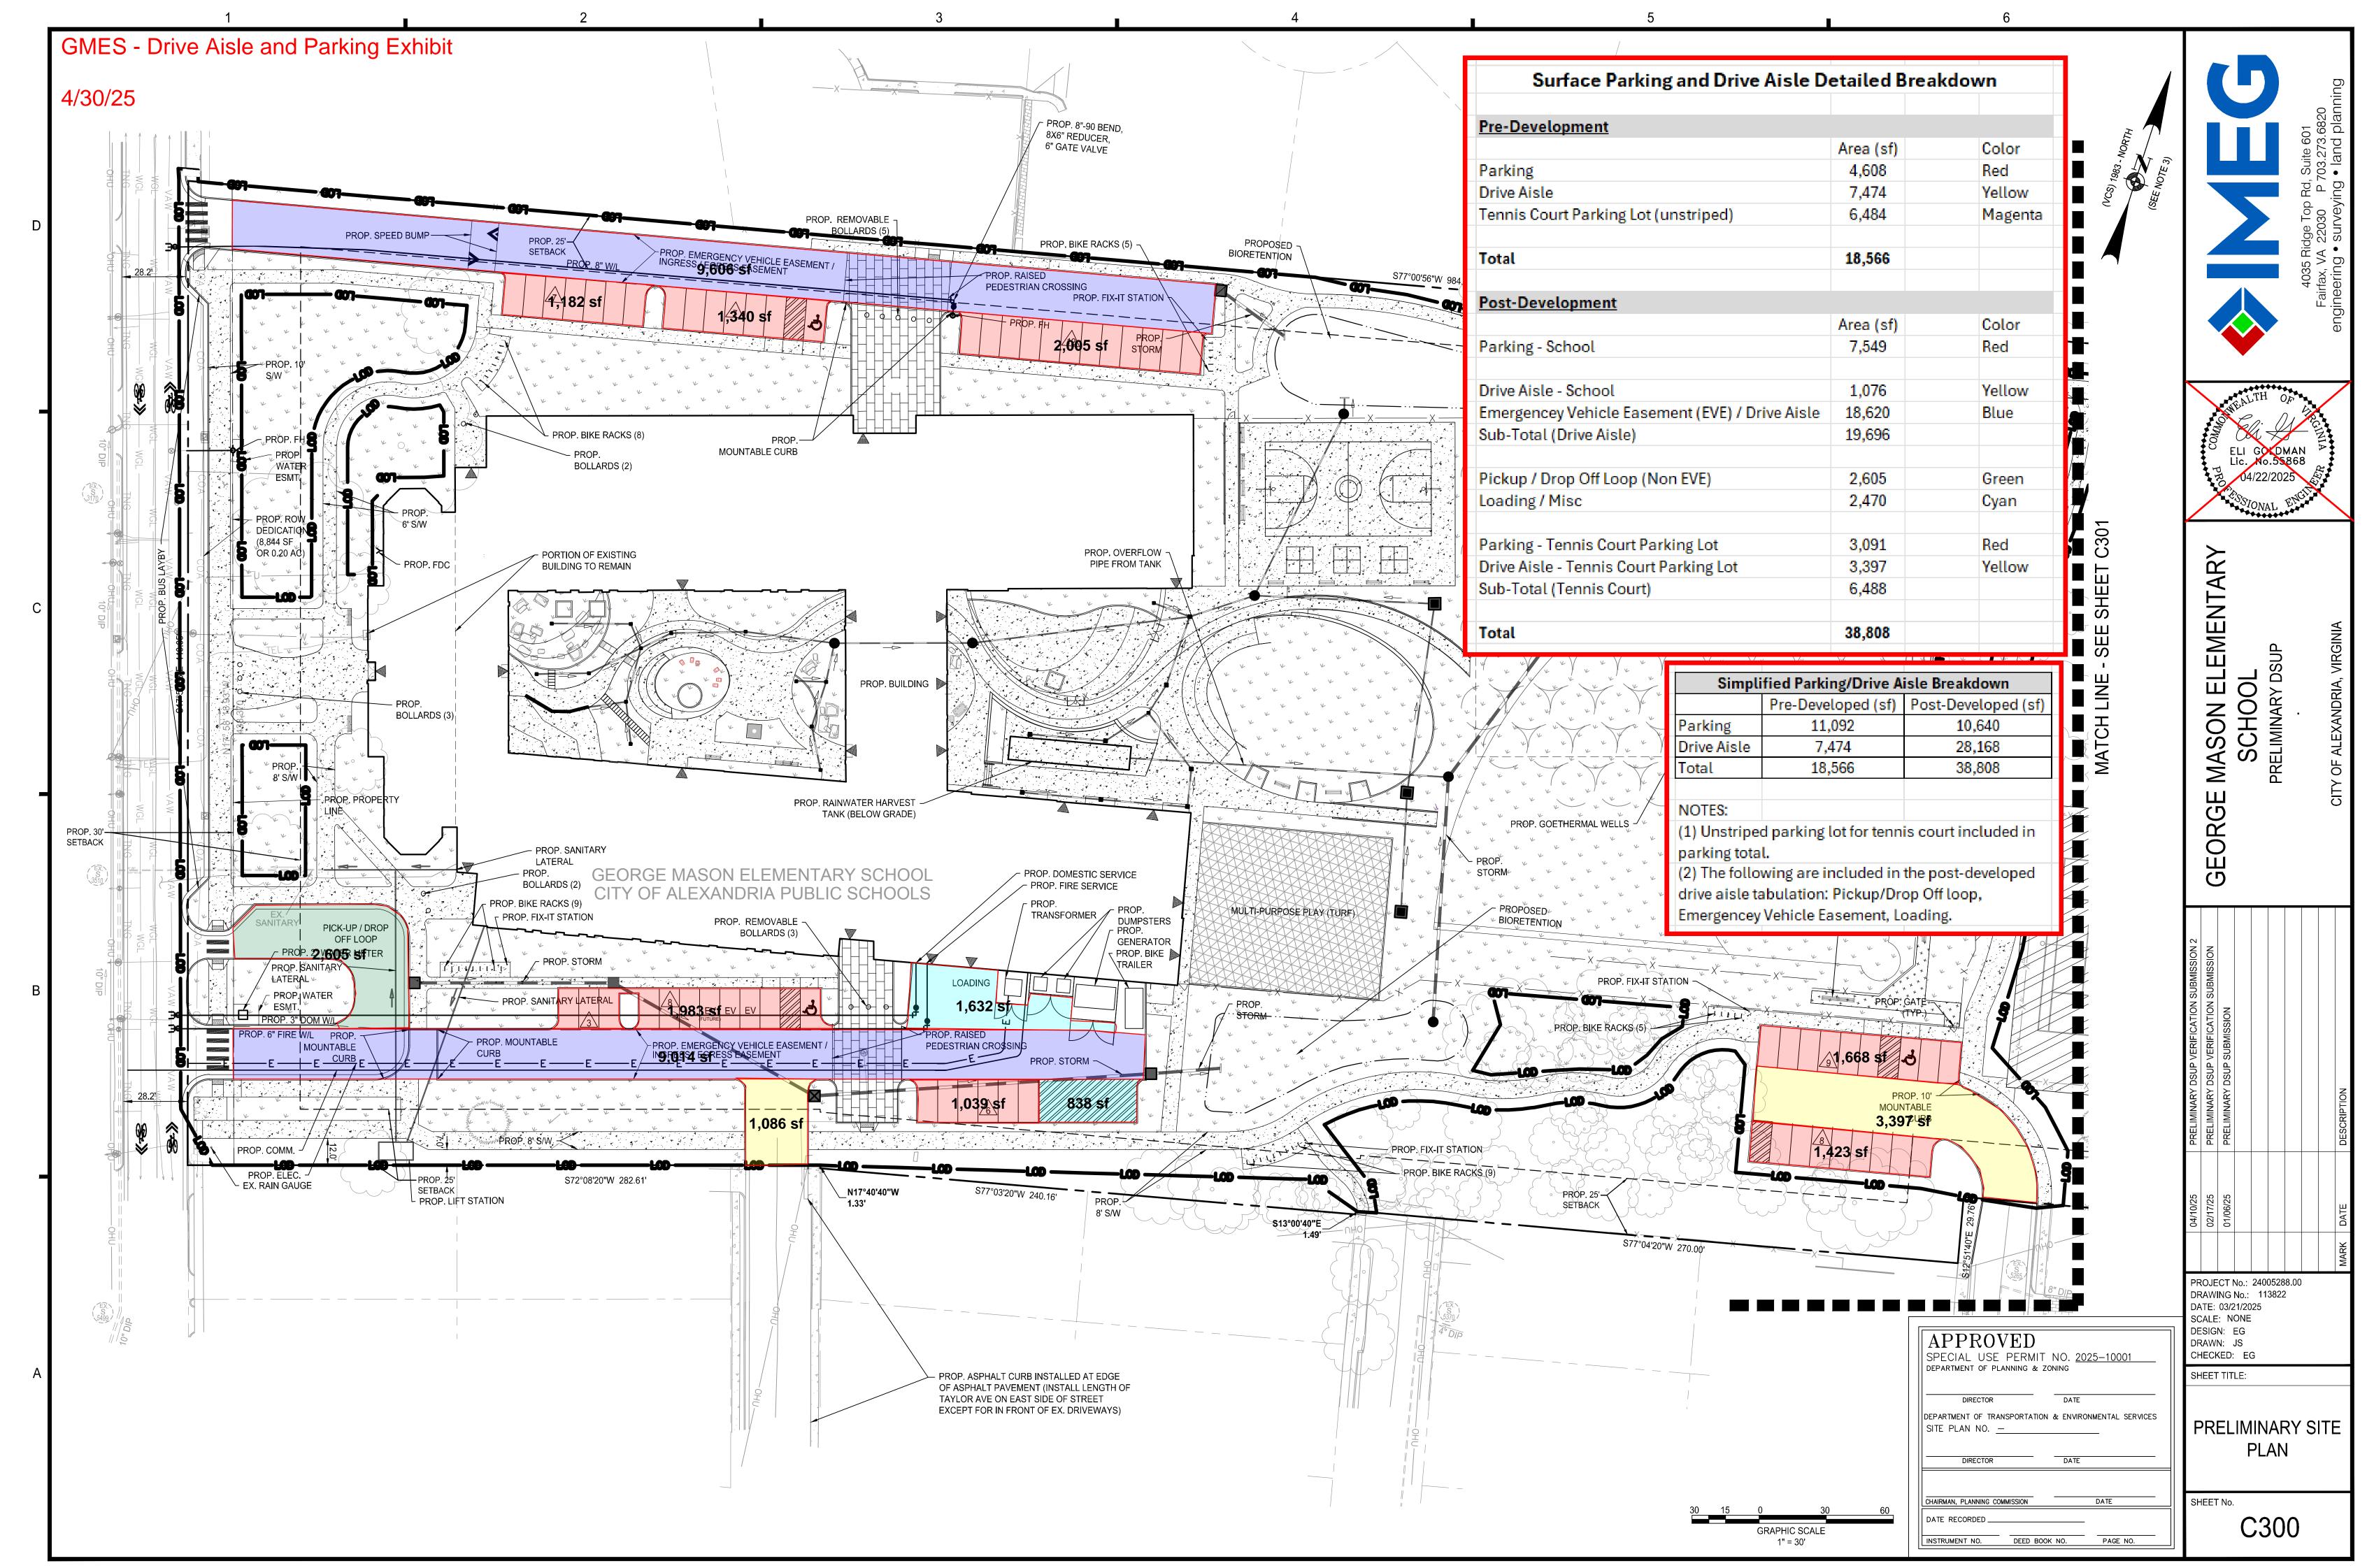
NOTES:

- (1) Unstriped parking lot for tennis court included in parking total.
- (2) The following are included in the post-developed drive aisle tabulation: Pickup/Drop Off loop, Emergencey Vehicle Easement, Loading.

Attached is an exhibit that shows the areas dedicated to surface parking and drive aisles. There is a detailed breakdown provided in addition to a simplified breakdown to help show why there is an increase in impervious area for parking/access. As shown in the exhibit, a lot of the impervious area proposed is needed to facilitate the emergency access for fire trucks around the school. The emergency access to the south and east of the current school barely meets requirements, especially when the parking lot is in use. Access to the north east section of the school is through a green space that has been deemed adequate to support fire truck access and does not count as an impervious area.

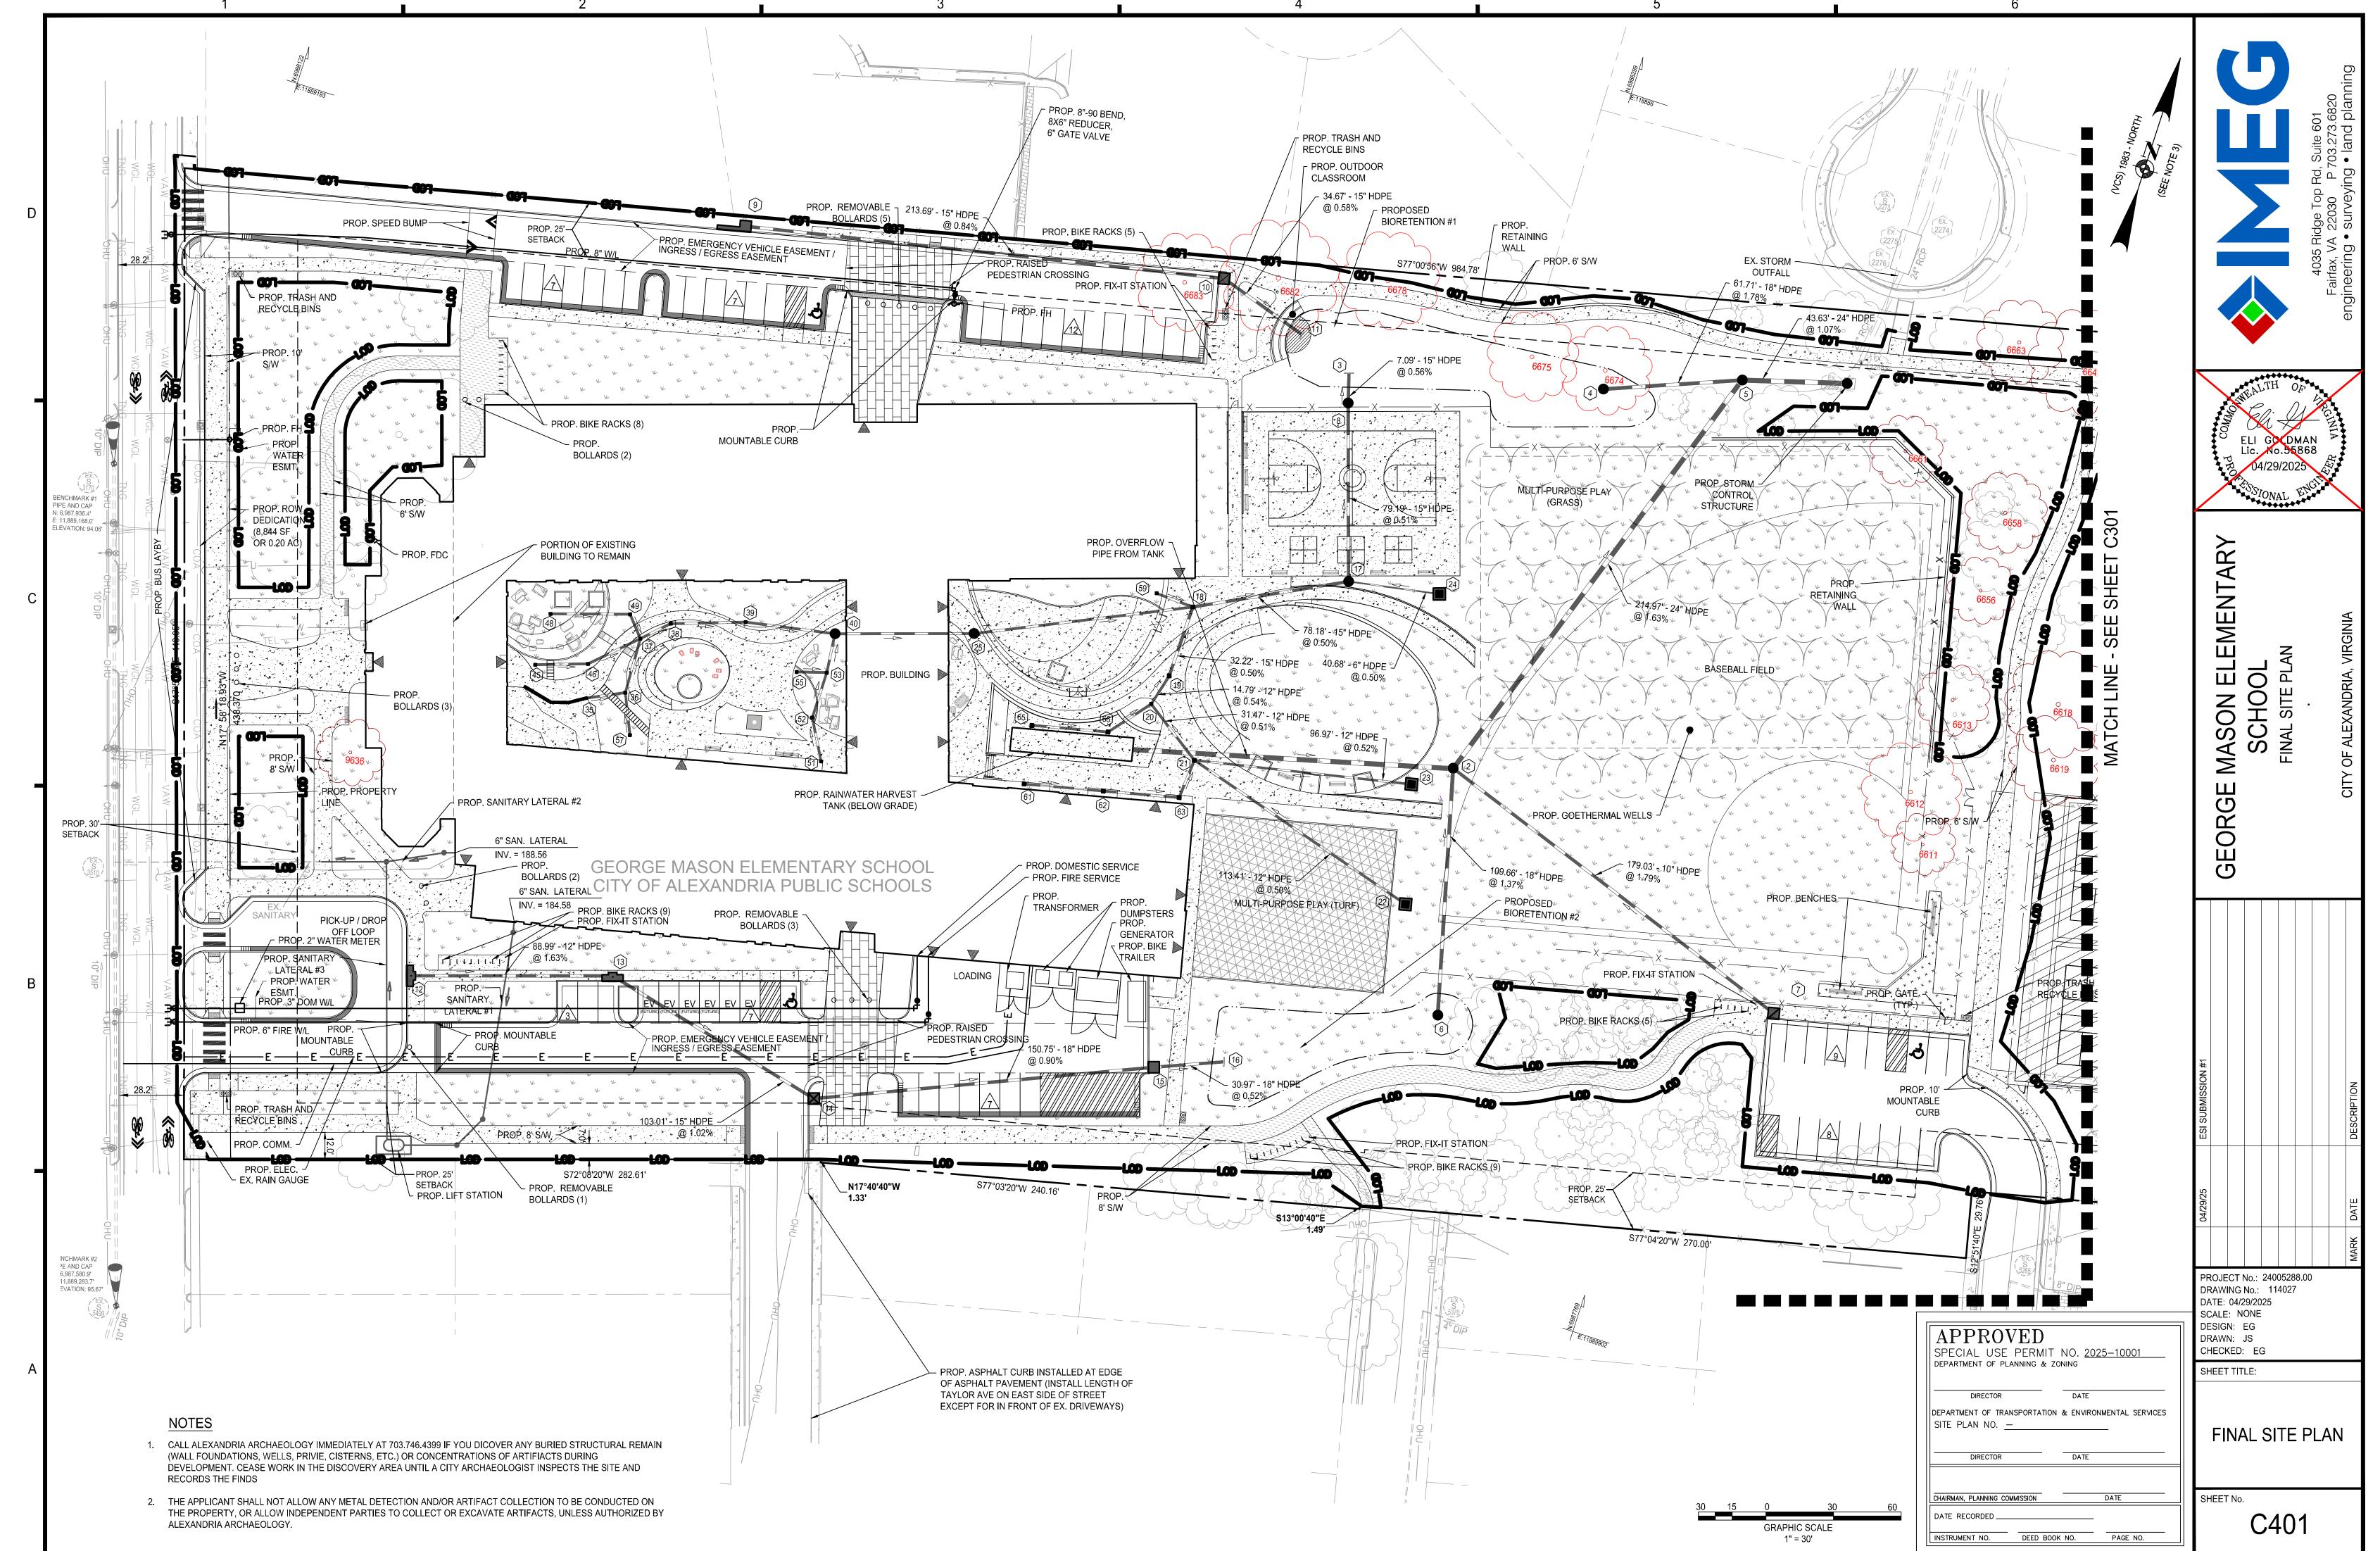
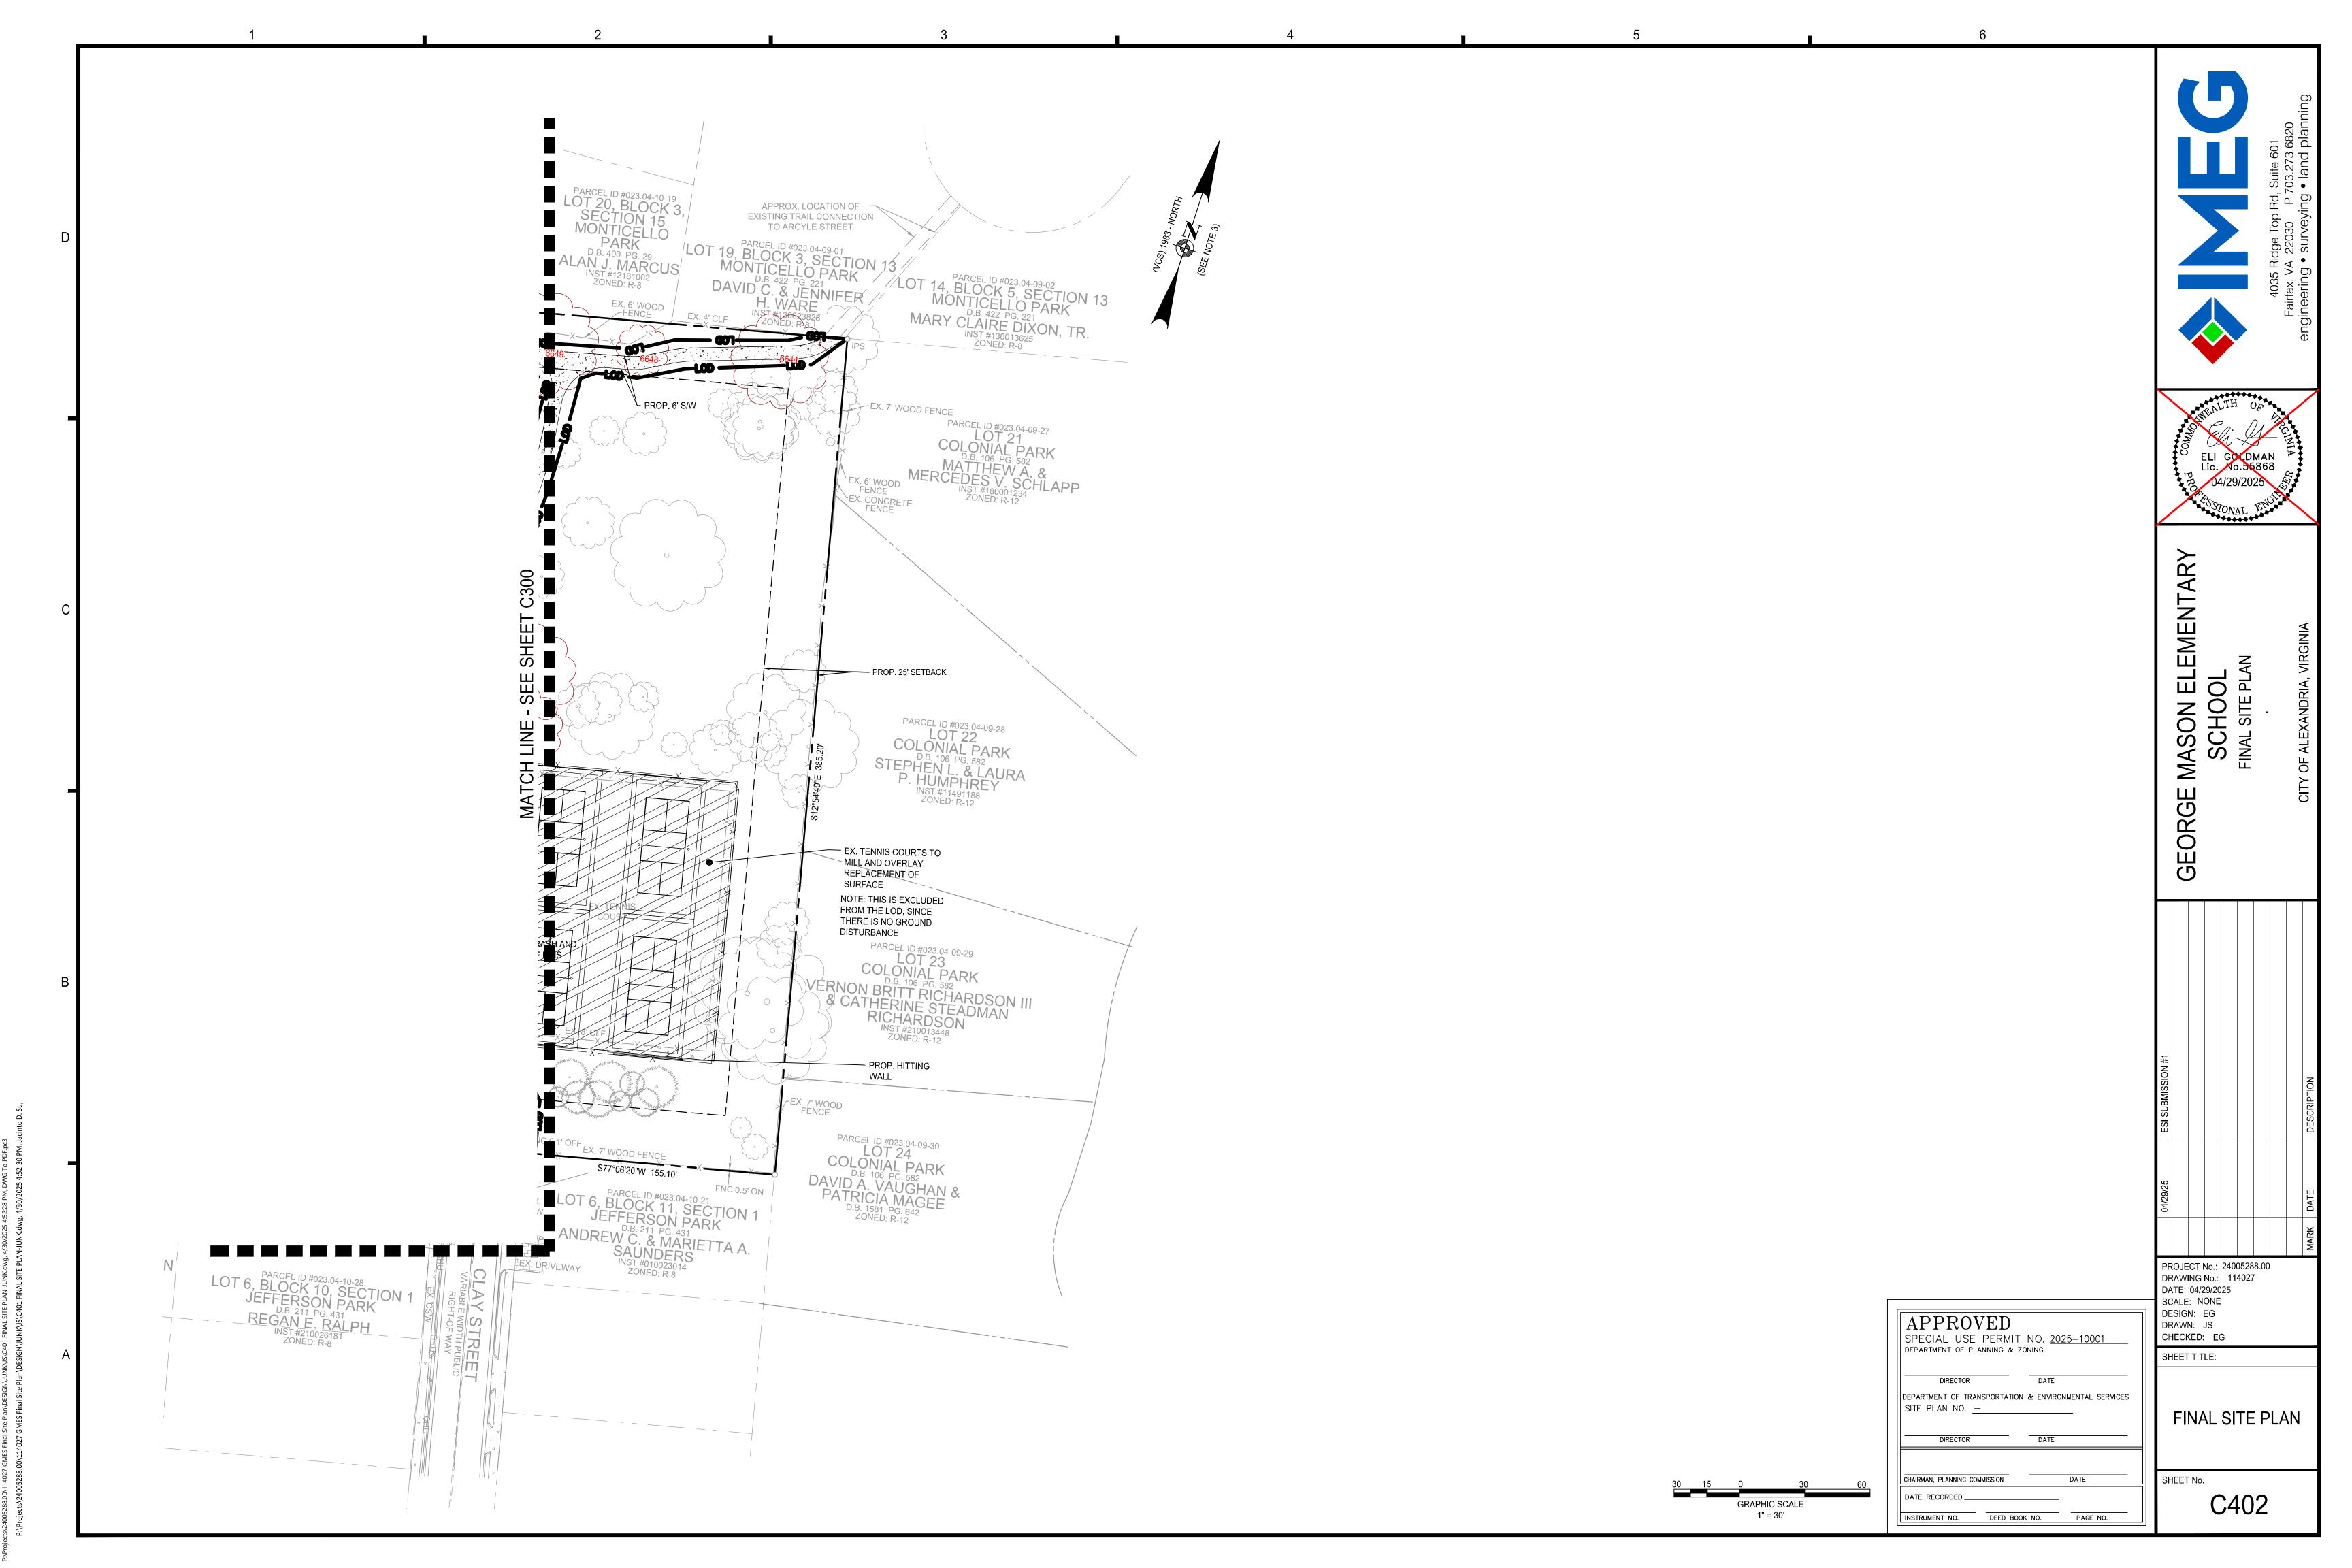
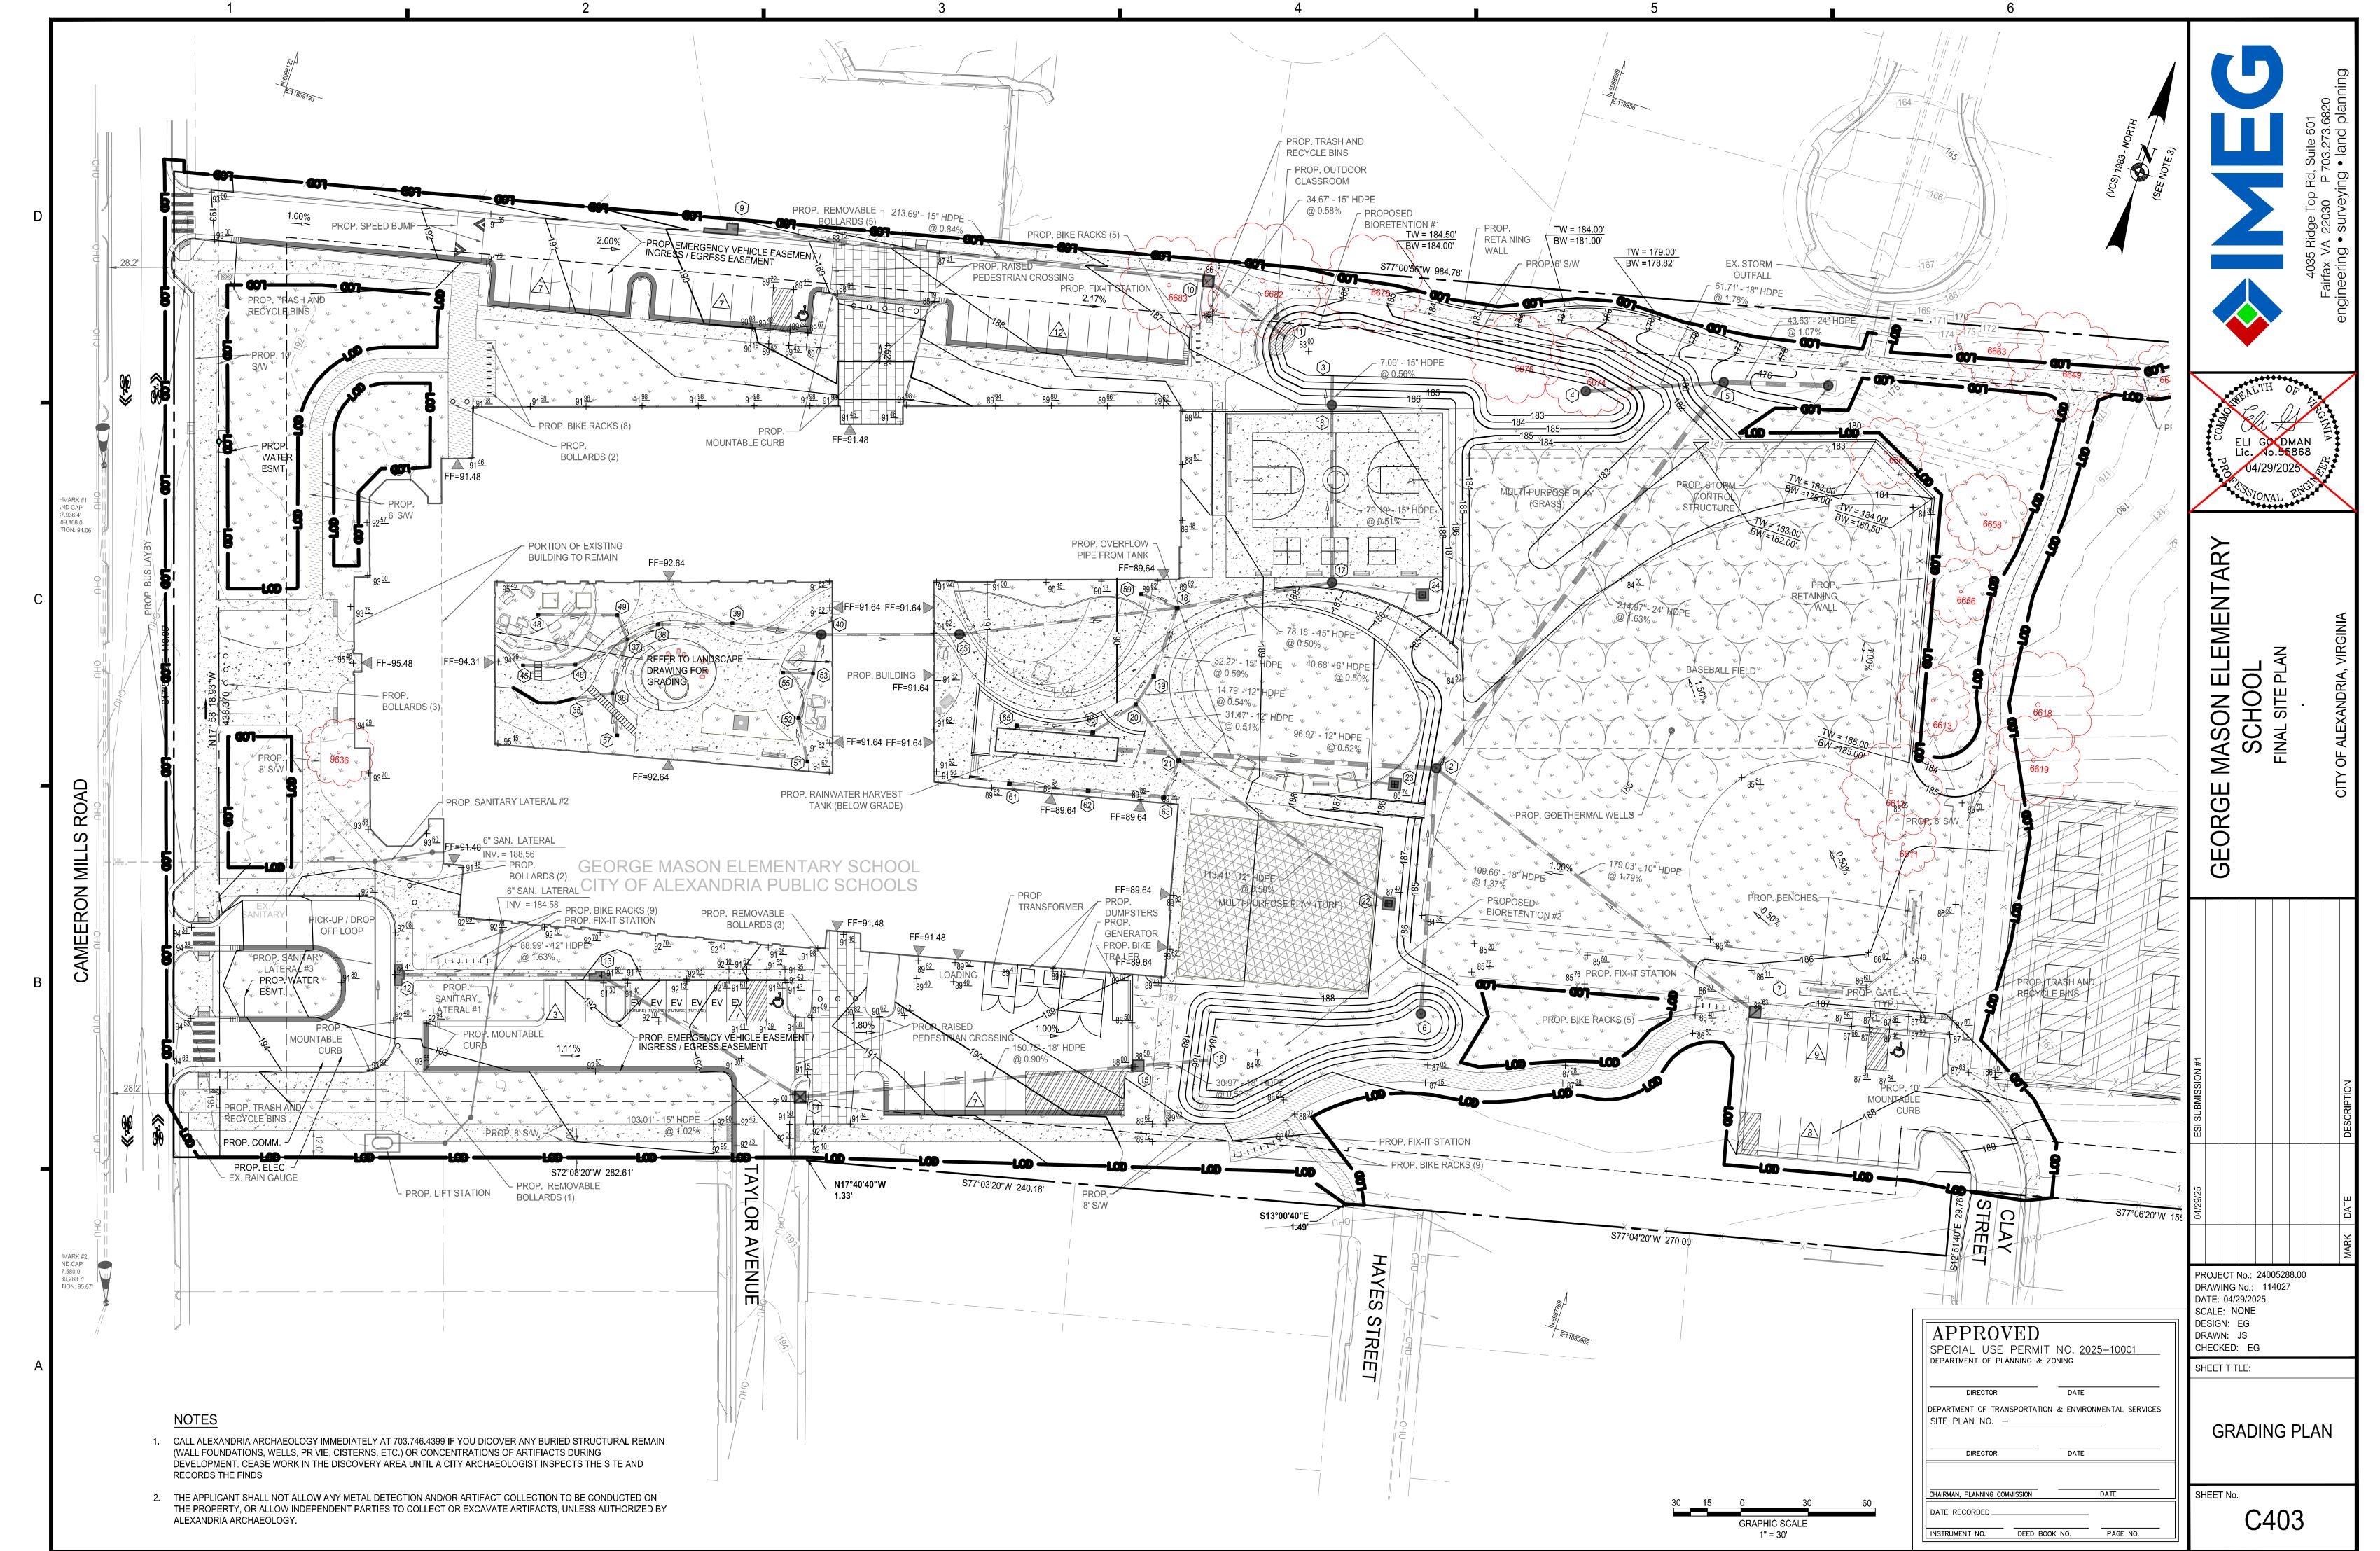
\Projects\z4u0s288.00\ 1 140z/ GMES Final Site Plan\DESIGN\JUNK\JS\C403 GRADING PLAN-JUNK.dwg, 4/30\z0z5 5:14;z3 PM, DWG P:\Projects\24005288.00\114027 GMES Final Site Plan\DESIGN\JUNK\JS\C403 GRADING PLAN-JUNK.dwg, 4/30/2025 5:1

- 12 of the Identified trees in question (#9636, #6683, #6682, #6678, #6674, #6661,# 6649, #6648, #6644, #6612, and #6661) as seen on the associated GMES Tree Mark up 2025-05-01, are located inside the Limits of disturbance. This means that these trees will experience 100% CRZ and SRZ disturbance due to grading, internal road improvements, increased parking, storm water management improvements, installation of geothermal wells, and park pathway improvements. The level of disturbance these trees will experience is not survivable and they will need to be removed

- Tree # 6613 is 28" White Oak (Quercus Alba). Tree 6613 is proposed to be removed due to the level
 disturbance of its root zone from proposed grading and the installation of geothermal wells on the eastern
 half of the property. These site improvements are calculated to remove 58% of the CRZ and 25% of SRZ.
 Even with tree protection measures, such as tree protection fencing or root pruning, the level of impact to
 the CRZ and SRZ is so severe that tree #6613 would not survive the development and should be removed.

- Tree # 6618 is a 45" Black Oak (Quercus Velutina). Tree #6618 is proposed to be removed due to the level of disturbance to it's CRZ and SRZ from the pathway improvements on the western side of the property. The removal of the existing pathway as well as the regrading and installation of the new pathway would remove 44% of Tree #6618's CRZ and 20% of it's SRZ. Even with protection measures, such as tree

- Tree# 6619 is a 36" Black Oak (Quercus Velutina). Tree #6619 is proposed to be removed due to the high level of disturbance to it's CRZ and SRZ from the park pathway improvement on the eastern side of the property. The removal of the existing pathway as well as the regrading and installation of the new pathway would remove 43% of tree #6619's CRZ and 27% of it's SRZ. Even with tree protection measures, such as tree protection fencing or root pruning, the level of impact to the CRZ and SRZ is so severe that tree #6619 would not survive and should be removed.

- Tree #6658 is a 32" White Oak (Quercus Alba). Tree #6658 is proposed to be removed due to the high level of disturbance to the CRZ due to grading improvements and the installation of the geothermal wells on east side of the tree and the park pathway improvements to the west. These improvements are proposed to remove 45% of the trees CRZ. This is well above the 30% disturbance threshold and this level of disturbance to the CRZ is so severe that tree #6658 would not survive the development and should be removed.

- Tree #6663 is 34" Pignut Hickory (Carya Glabra). Tree #6663 is proposed to be removed due to a high level of disturbance to it's CRZ and SRZ from the park pathway improvements on the western side of the property. The removal of the existing pathway as well as the regrading and installation of the new pathway would remove 42% of it's CRZ and 26% of it's SRZ. Even with tree protection measures, such as tree protection fencing or root pruning, the level of impact to the CRZ and SRZ is so severe that Tree #6618 would not survive the development and should be removed.
