Alexandria City Hall

South Façade Colonial Revival Detail Restudy Recommendations

BAR Hearing 10/16/25

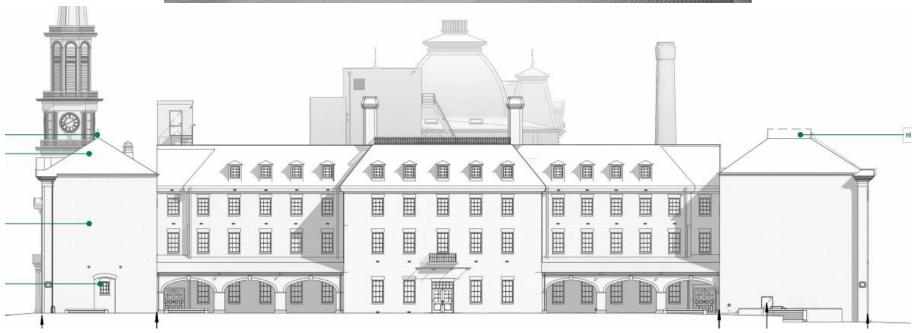
EXISTING SOUTH FAÇADE

The reconstructed Governor's Palace in Williamsburg was the apparent inspiration for the 1960s south façade of the Alexandria City Hall.

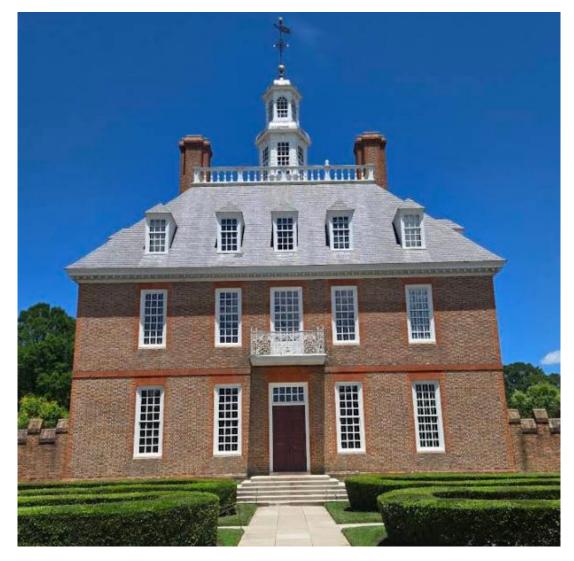
GOVERNOR'S PALACE, WILLIAMSBURG, VA

1706-1710, burned 1781, reconstructed 1930

Hip roof with a simple balustrade flanked by large sculpted chimneys

Rubbed brick quoins, belt course and jack arches above graduated height windows

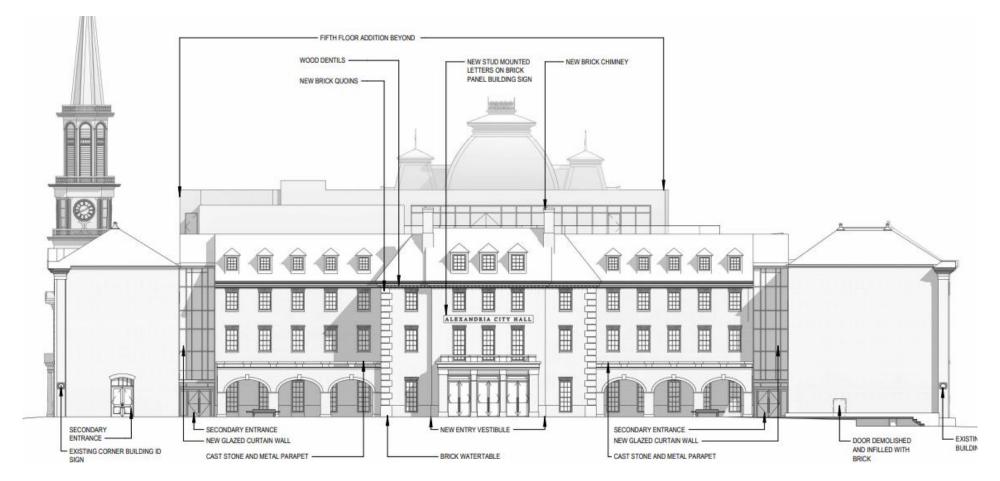
APPLICANT PROPOSAL: ALT 1 MODERNIZATION APPROACH

The raised roof above the new projecting entrance is inappropriate for a Georgian style building and creates unnecessary complexity in the traditional hip roof form. The new chimneys are in an awkward and untraditional location. The windows, and particularly the dormers, on the wings of the main block are visually crowded. The pilasters flanking the entry doors do not have classical proportions and appear to extend thru the entablature to the cornice. The quoins should have greater difference in widths, as shown on the Carlyle House and Christ Church. The new brick watertable cuts through the windows, which is not historically appropriate. The arcade makes absolutely no architectural sense on this facade. It will be expensive to construct and is shown with a "green" roof that will be difficult to maintain and visible to very few building occupants and the environmental benefits will be de minimis. While the vertical hyphens separating the 19th and 20th century portions of the building are welcome, why are they glass with a view of the fire stairs? This curtain wall should be something opaque that references other portions of the building, like slate or metal panels.

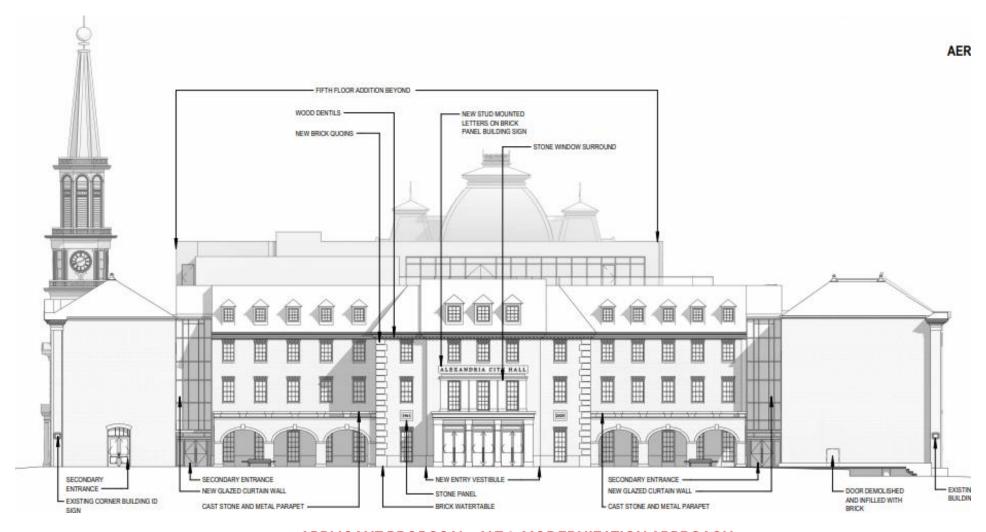
APPLICANT PROPOSAL: ALT 2 MODERNIZATION APPROACH

In addition to the comments in ALT 1, the pilasters of the second-floor stone surround do not have a capital or entablature and do not align with or relate to the first-floor entry vestibule.

The stone panels at the second-floor spandrel are characteristic of the later Adam or Federal style and inappropriate to the Georgian Revival style of this façade.

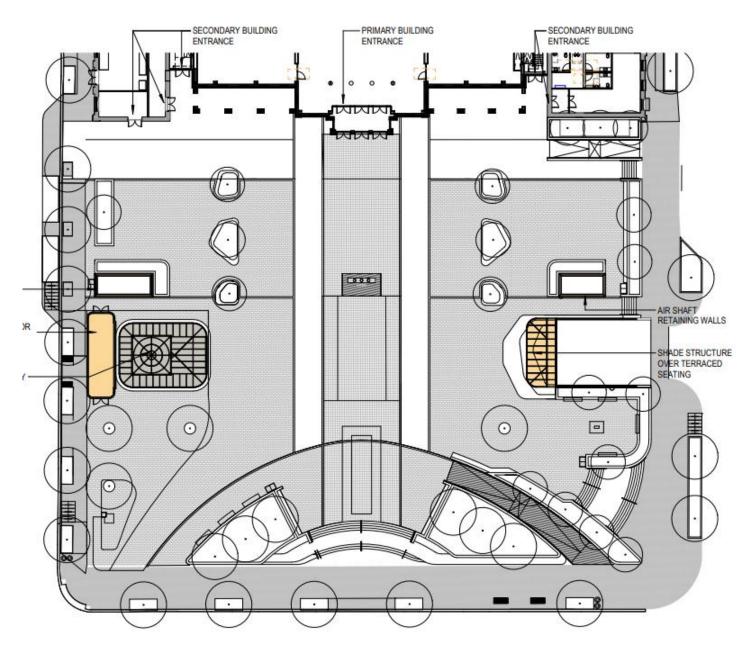
APPLICANT PROPOSAL: MARKET SQUARE

The irregular shape of the six new Mid-century Modern style planters and terraced seating platform are inappropriate to the formal and orthogonal Colonial Revival style of Alexandria.

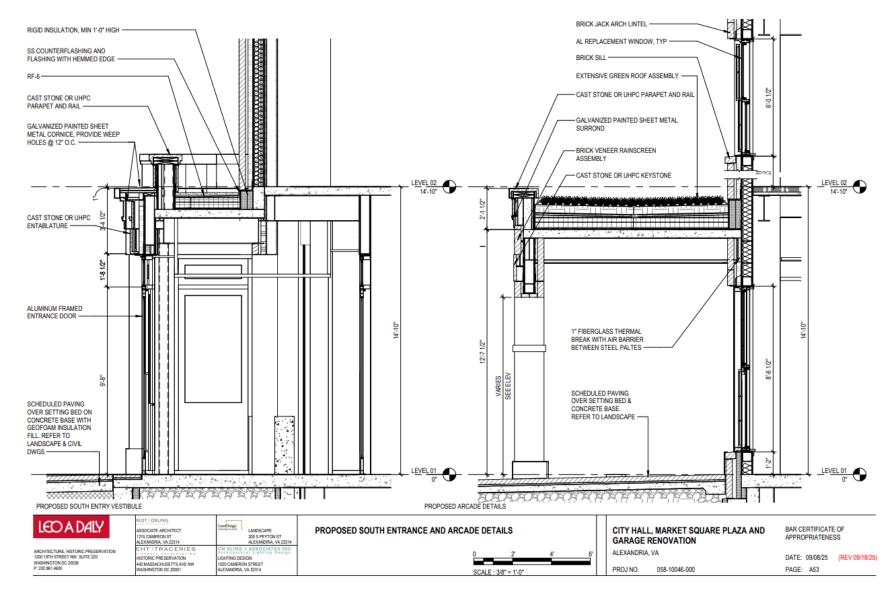
APPLICANT PROPOSAL: ENTRY AND ARCADE SECTIONS

Pilasters at the building entrance extend inappropriately thru the entablature to the cornice and the pilaster base and capital are not correctly detailed.

The "balusters" above the entry are out of scale and lack appropriate detail.

The green roof of the pointless, reconstructed arcades will be expensive and difficult to maintain and are not visible to the public.

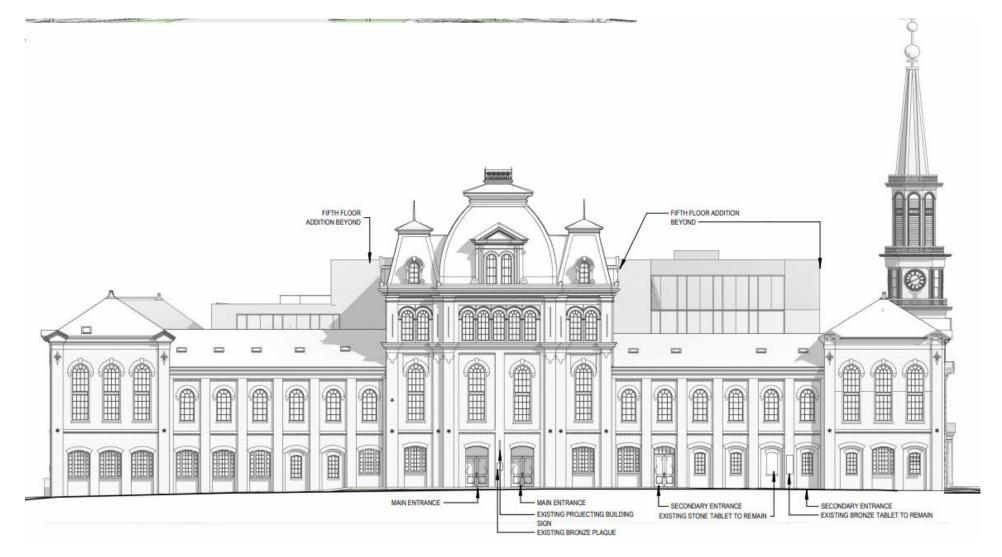
APPLICANT PROPOSAL: CAMERON STREET ELEVATION

The 1879 building has a beautifully clear, symmetrical five-part façade with the focus on the ornate central entry, flanked by less prominent hipped roof corner pavilions connected to the main block by simple hyphens. There is a hierarchy of size and ornament that quickly identifies the primary entrance to the public building. This classical hierarchy should be repeated on the south façade.

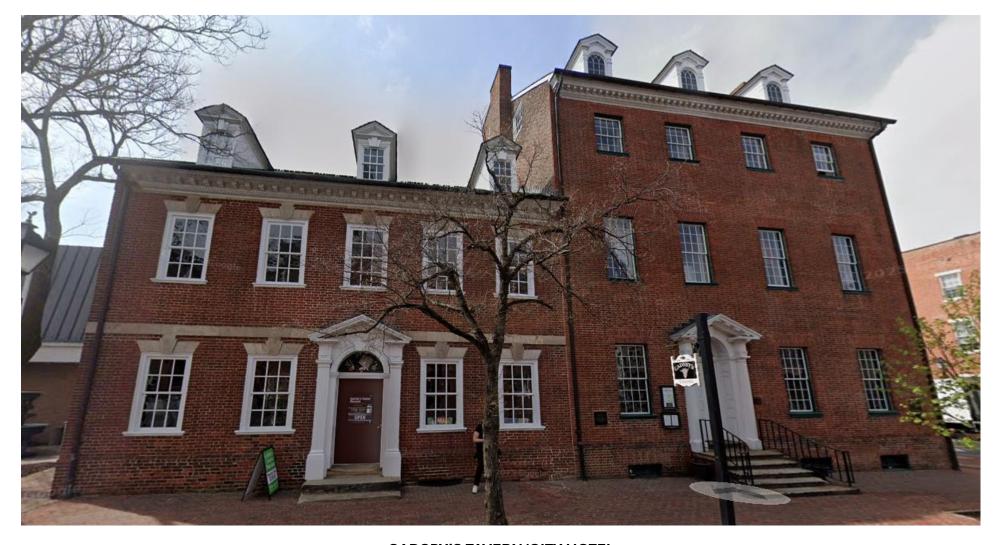
GADSBY'S TAVERN/CITY HOTEL

Acquia stone lintels above windows of the 1785 Tavern building and rubbed brick jack arches above windows in the 1792 City Hotel.

Graduated window sizes -- becoming smaller on the upper floors -- on City Hotel.

Watertable course occurs below windows

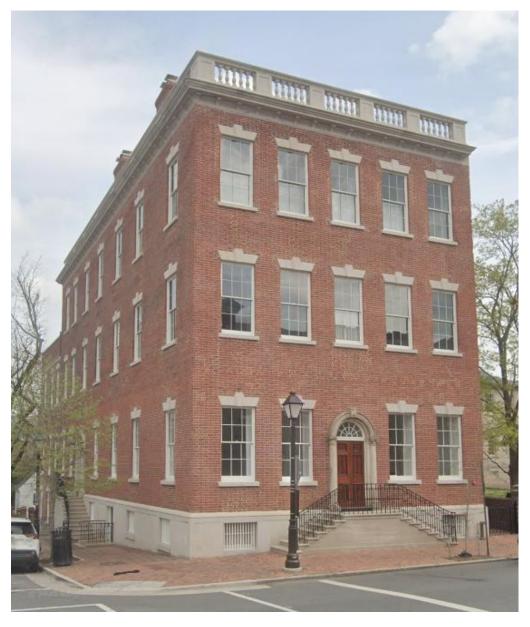
BANK OF ALEXANDRIA

133 N Fairfax St., completed 1807

Acquia stone water table, window lintels and rooftop balustrade

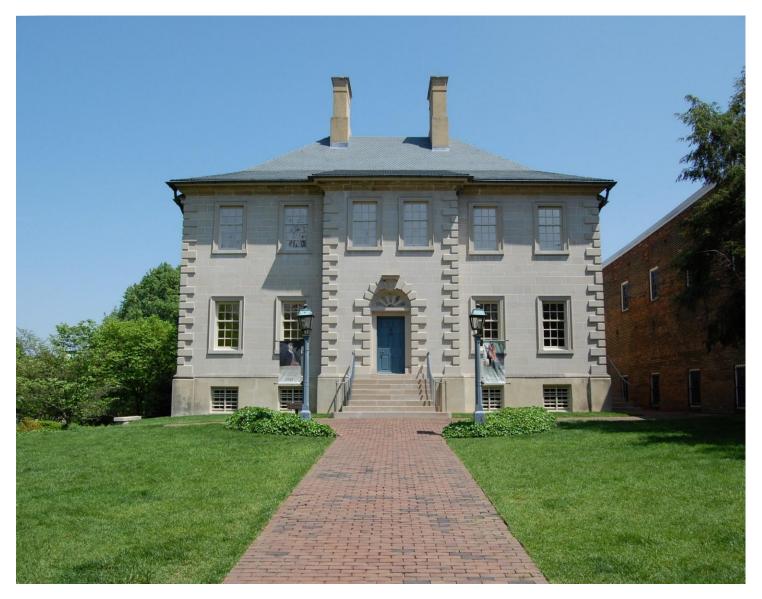
CARLYLE HOUSE

121 N Fairfax St., completed 1753

Hip roof with large chimneys

Stone façade with quoins and projecting watertable at the first floor level, below the windows

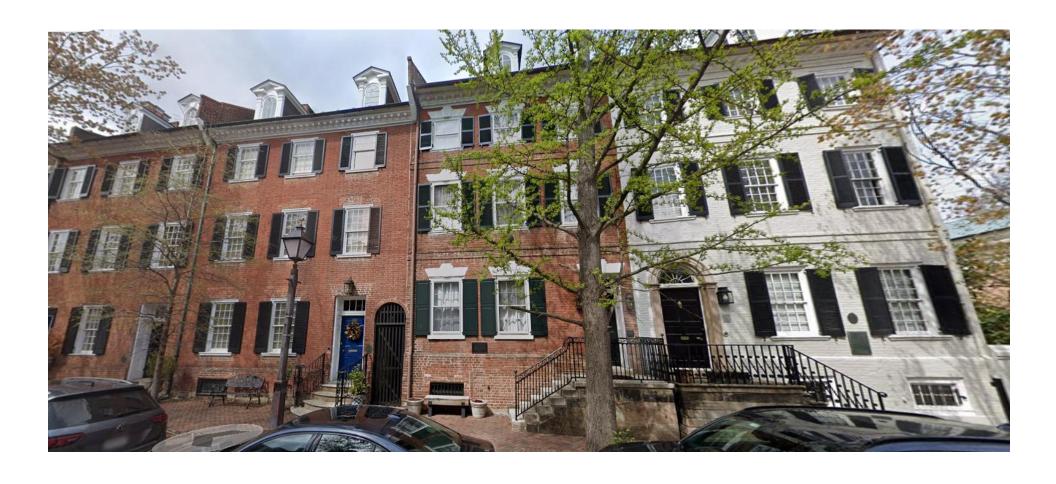
GENTRY ROW TOWNHOUSES

200 Block Prince Street, late 18^{TH} century, Georgian style

Brick belt courses with stone lintels and brick jack arches

Decorative cornice with modilions

Watertable course occurs below windows

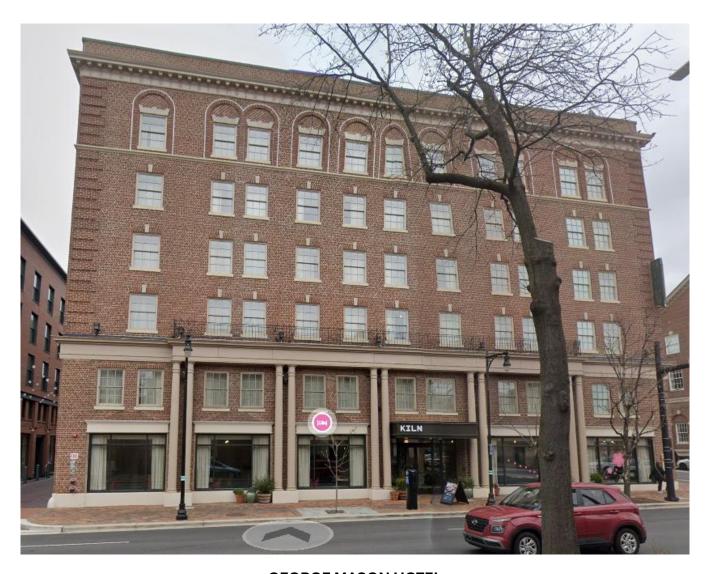
GEORGE MASON HOTEL

130 S Washington St., 1929, Colonial Revival style

Projecting colonnade emphasizes entrance location

Brick jack arch above windows with stone keystone

Exaggerated brick quoins

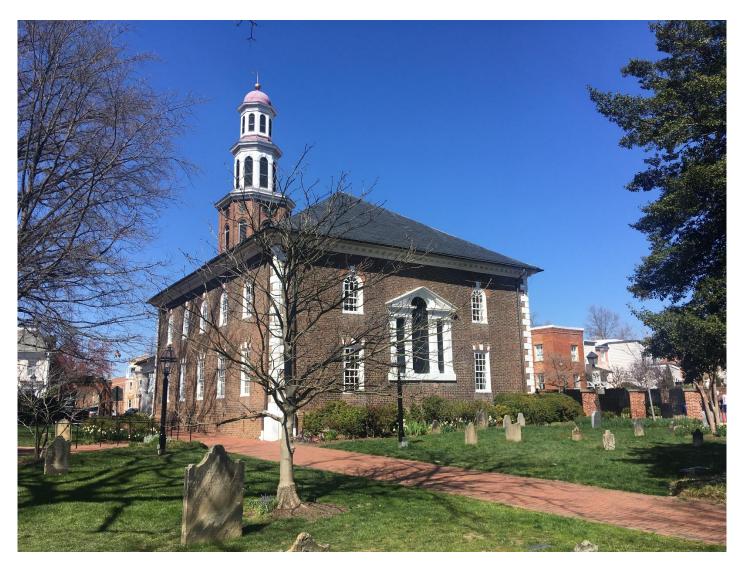
CHRIST CHURCH

1767 – 1773, James Wren, Architect

Acquia stone quoins

Semicircular arched and rectangular windows with brick and stone jack arches

Molded brick watertable course below windows

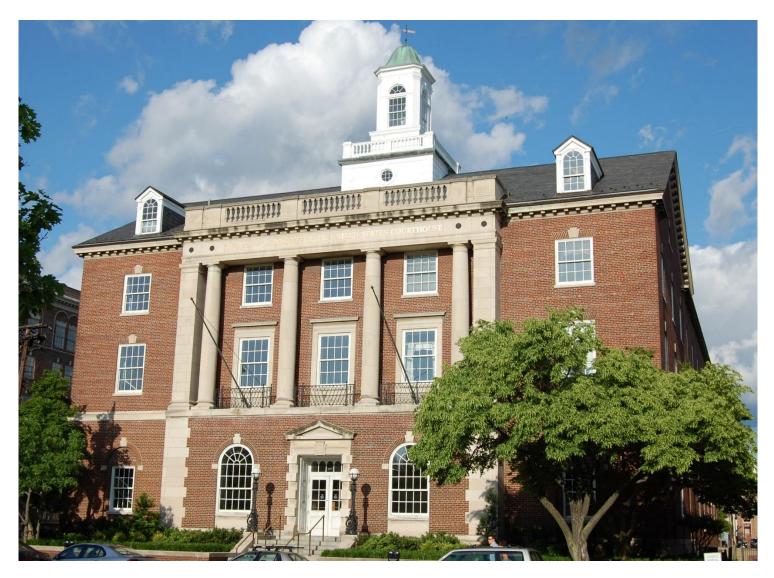
MARTIN BOSTETTER US COURTHOUSE

200 S Washington St., constructed 1930, Colonial Revival style, James S. Wetmore, Architect

Projecting entrance features stone columns and pilasters at the piano noble with quoins below and stone balustrade above.

Arched and rectangular windows with graduated heights and brick and stone lintels.

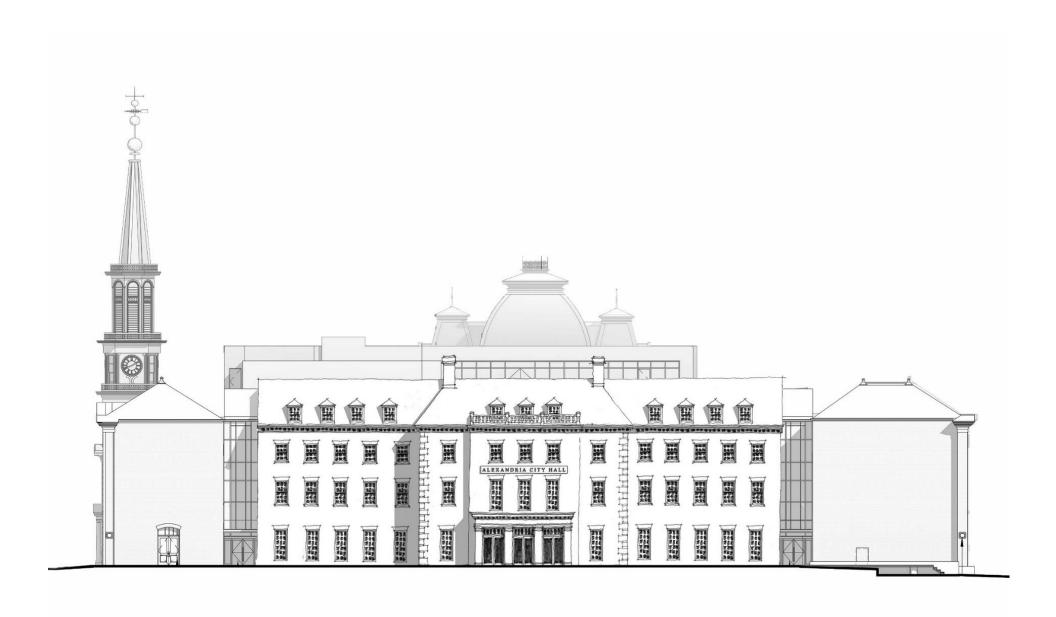
ALTERNATE SOUTH FAÇADE

- 1. Remove the proposed shed roof form from the center of the hip roof and replace it with a flat roof and ornamental railing with plinths on the cornice above the projecting entrance feature.

- 2. Replace the two existing brick chimney forms in the appropriate scale, shape and location on the central hip roof.
- 3. Revise the detailing of the projecting entrance feature to be classically appropriate to the Colonial Revival style found in Alexandria. Refer to Andrea Palladio's Four Books of Architecture (Ware edition 1738); Sebastiano Serlio's Five Books of Architecture (English ed. 1611); or William Ware's The American Vignola (pub. 1903), etc. for the correct classical proportions and details of columns, entablatures, etc.
