# Alexandria City Hall

## South Façade Colonial Revival Detail Restudy Recommendations

BAR Hearing 10/16/25

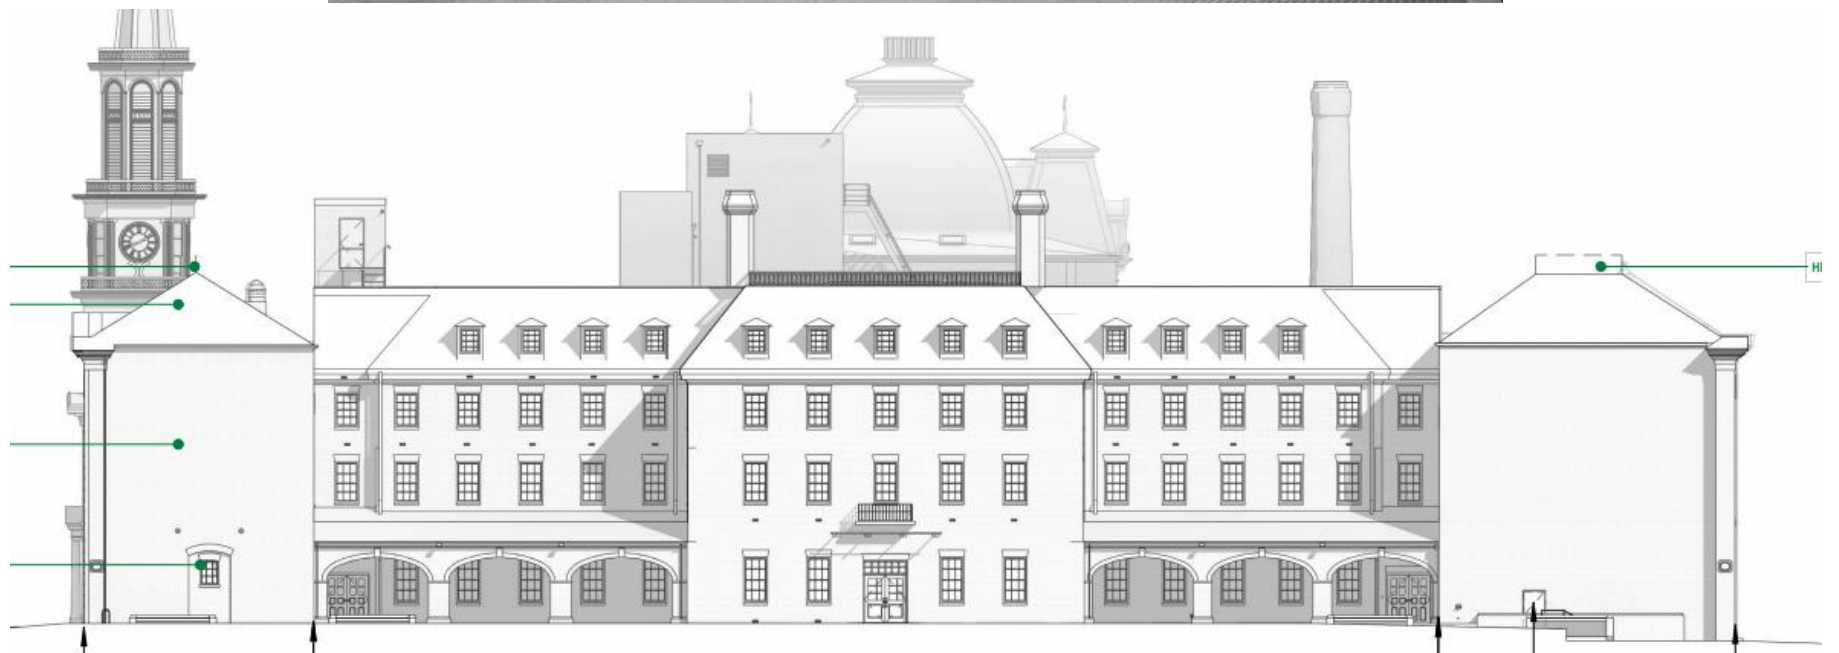
**EXISTING SOUTH FAÇADE**

The reconstructed Governor's Palace in Williamsburg was the apparent inspiration for the 1960s south façade of the Alexandria City Hall.

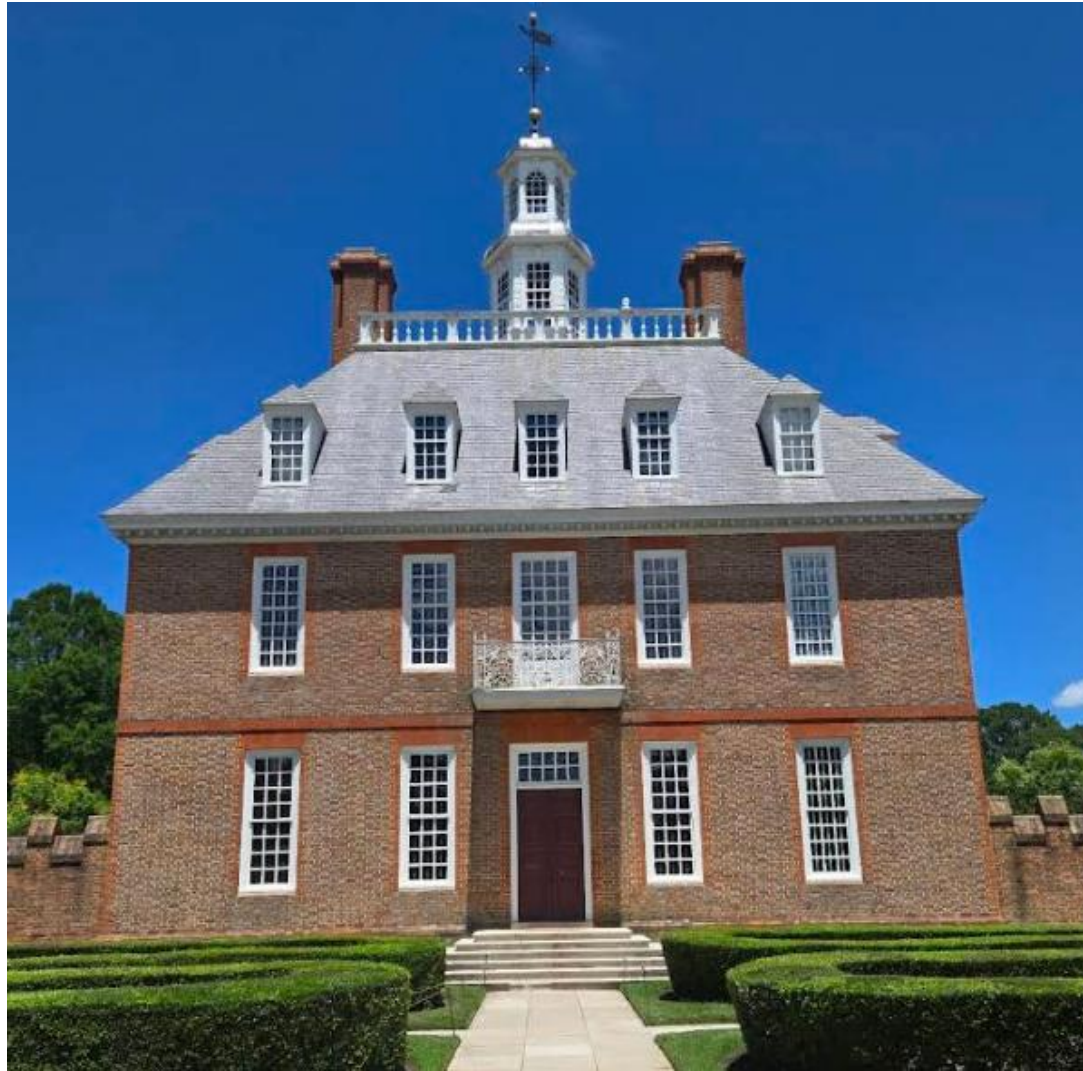
**GOVERNOR'S PALACE, WILLIAMSBURG, VA**

1706-1710, burned 1781, reconstructed 1930

Hip roof with a simple balustrade flanked by large sculpted chimneys

Rubbed brick quoins, belt course and jack arches above graduated height windows

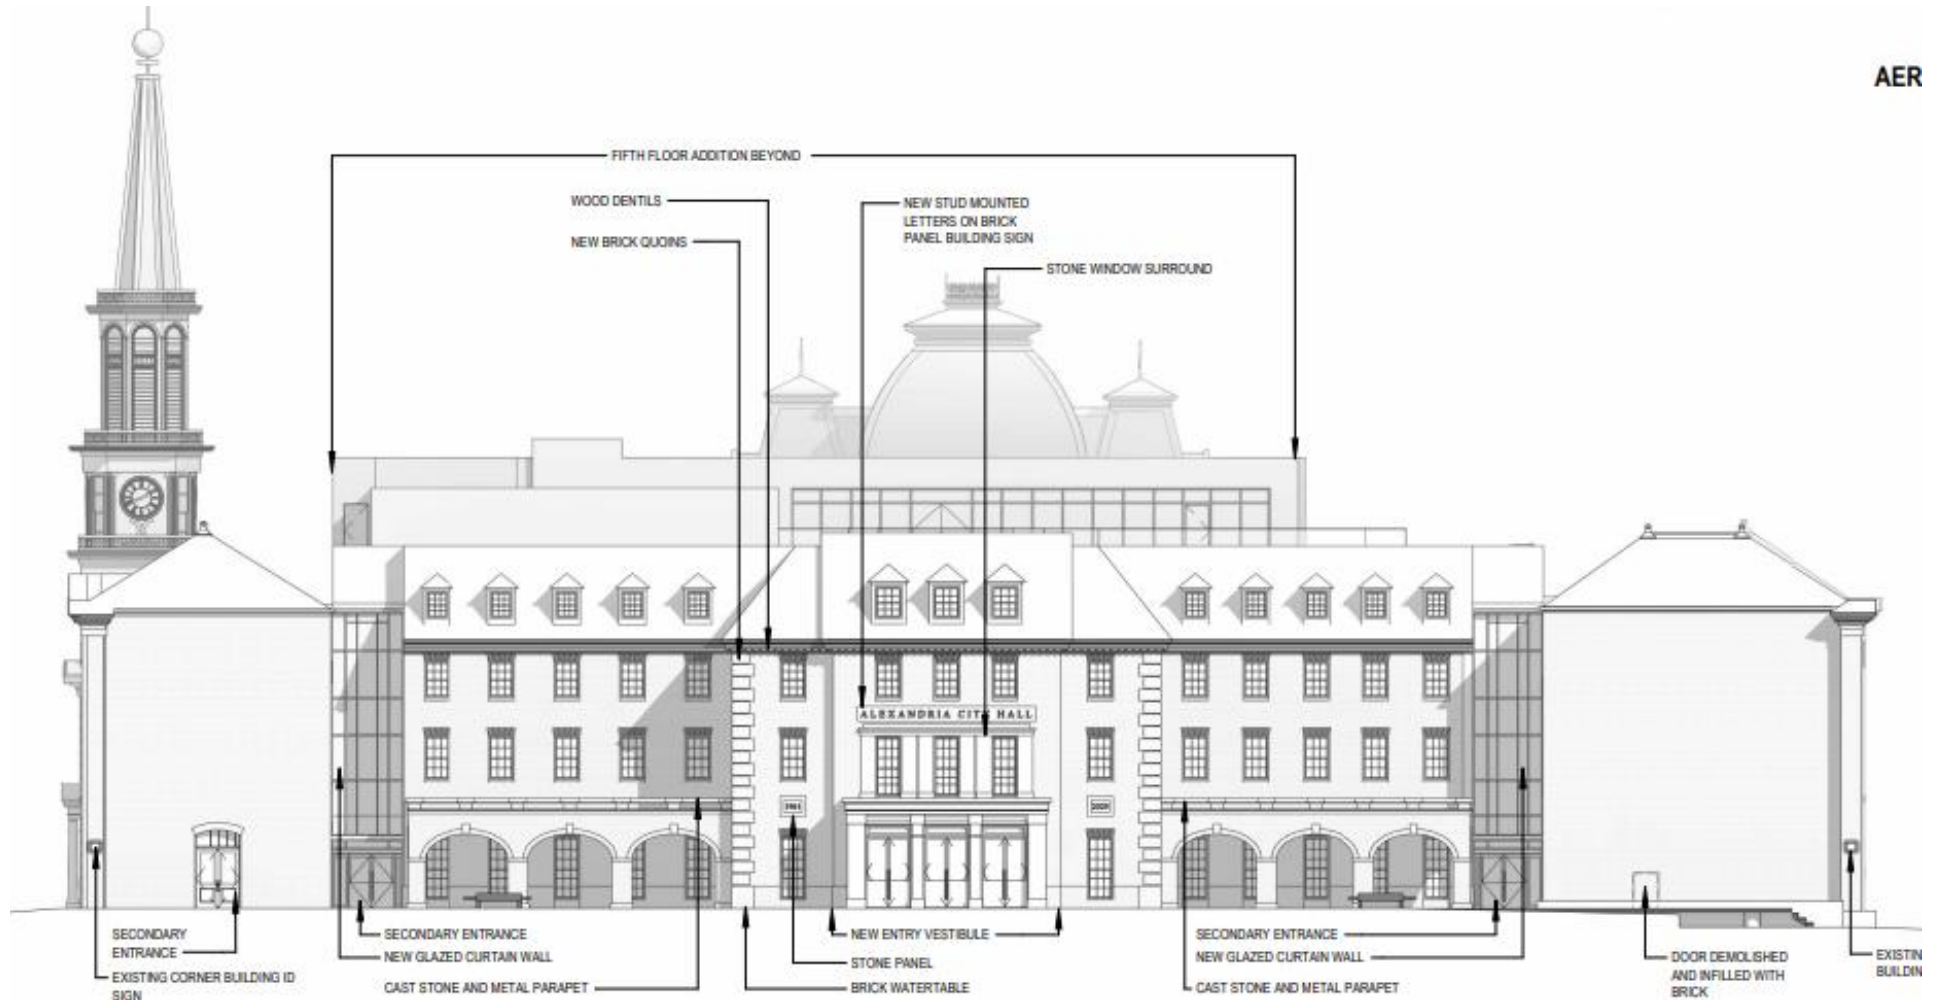
### APPLICANT PROPOSAL: ALT 2 MODERNIZATION APPROACH

In addition to the comments in ALT 1, the pilasters of the second-floor stone surround do not have a capital or entablature and do not align with or relate to the first-floor entry vestibule.

The stone panels at the second-floor spandrel are characteristic of the later Adam or Federal style and inappropriate to the Georgian Revival style of this façade.

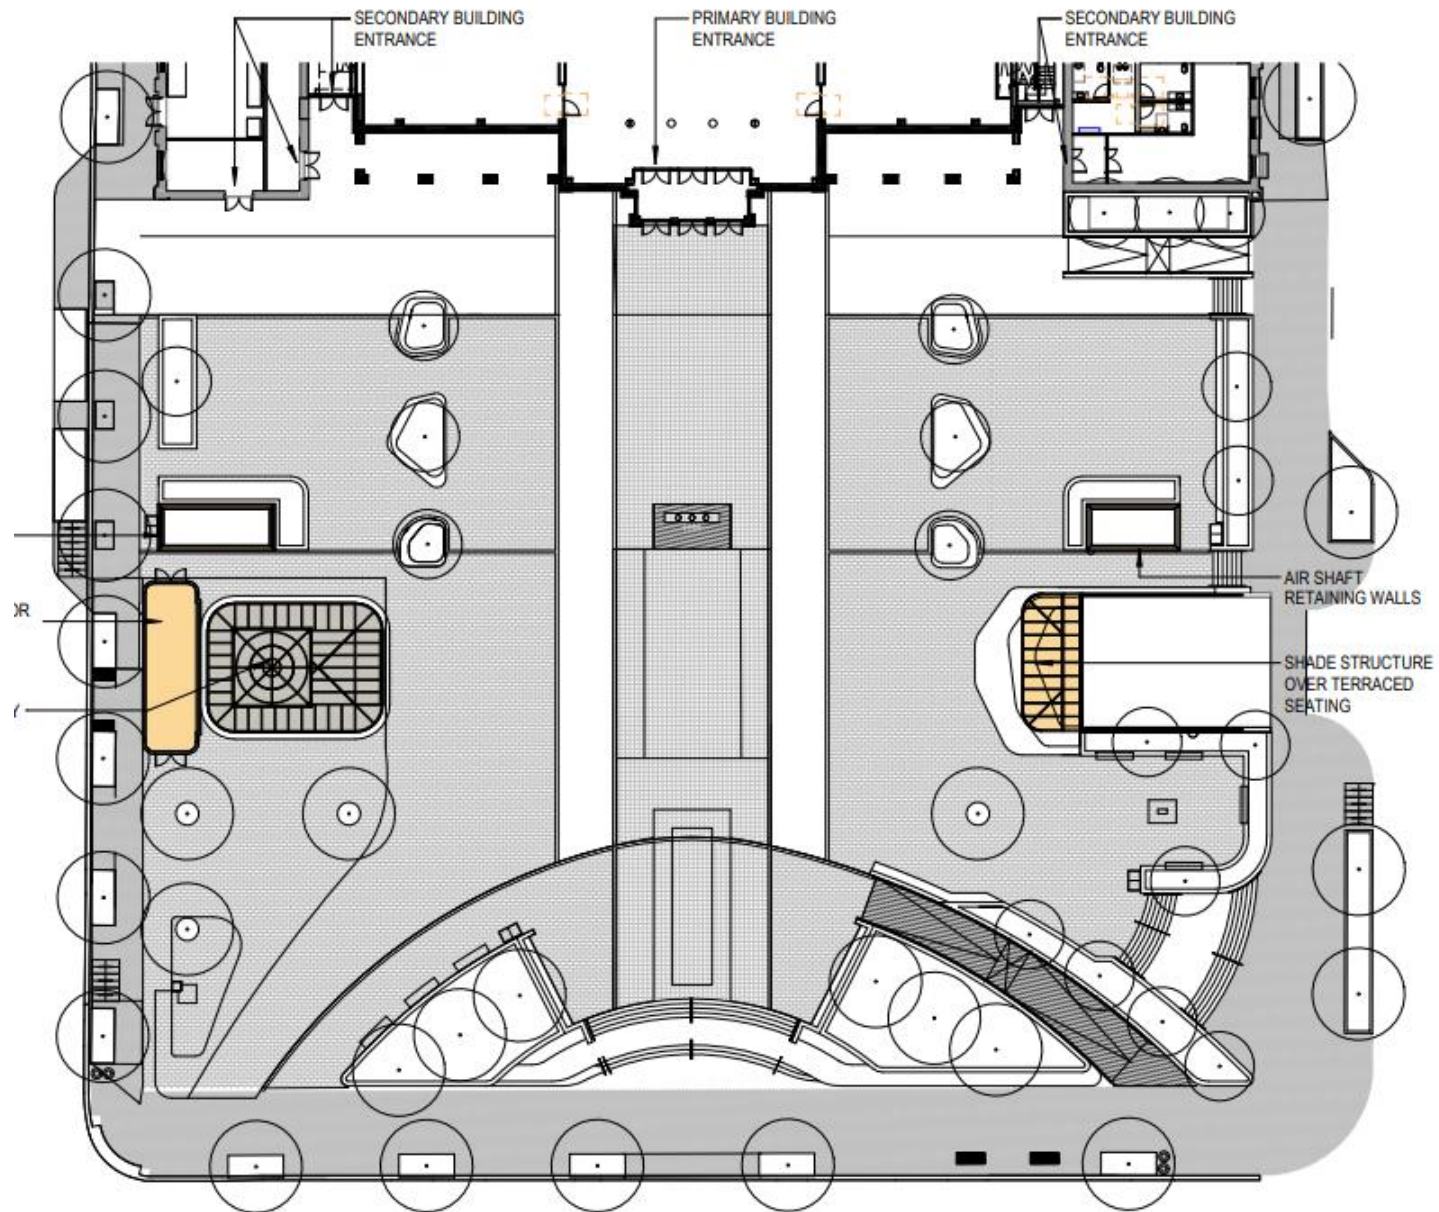
### APPLICANT PROPOSAL: MARKET SQUARE

The irregular shape of the six new Mid-century Modern style planters and terraced seating platform are inappropriate to the formal and orthogonal Colonial Revival style of Alexandria.

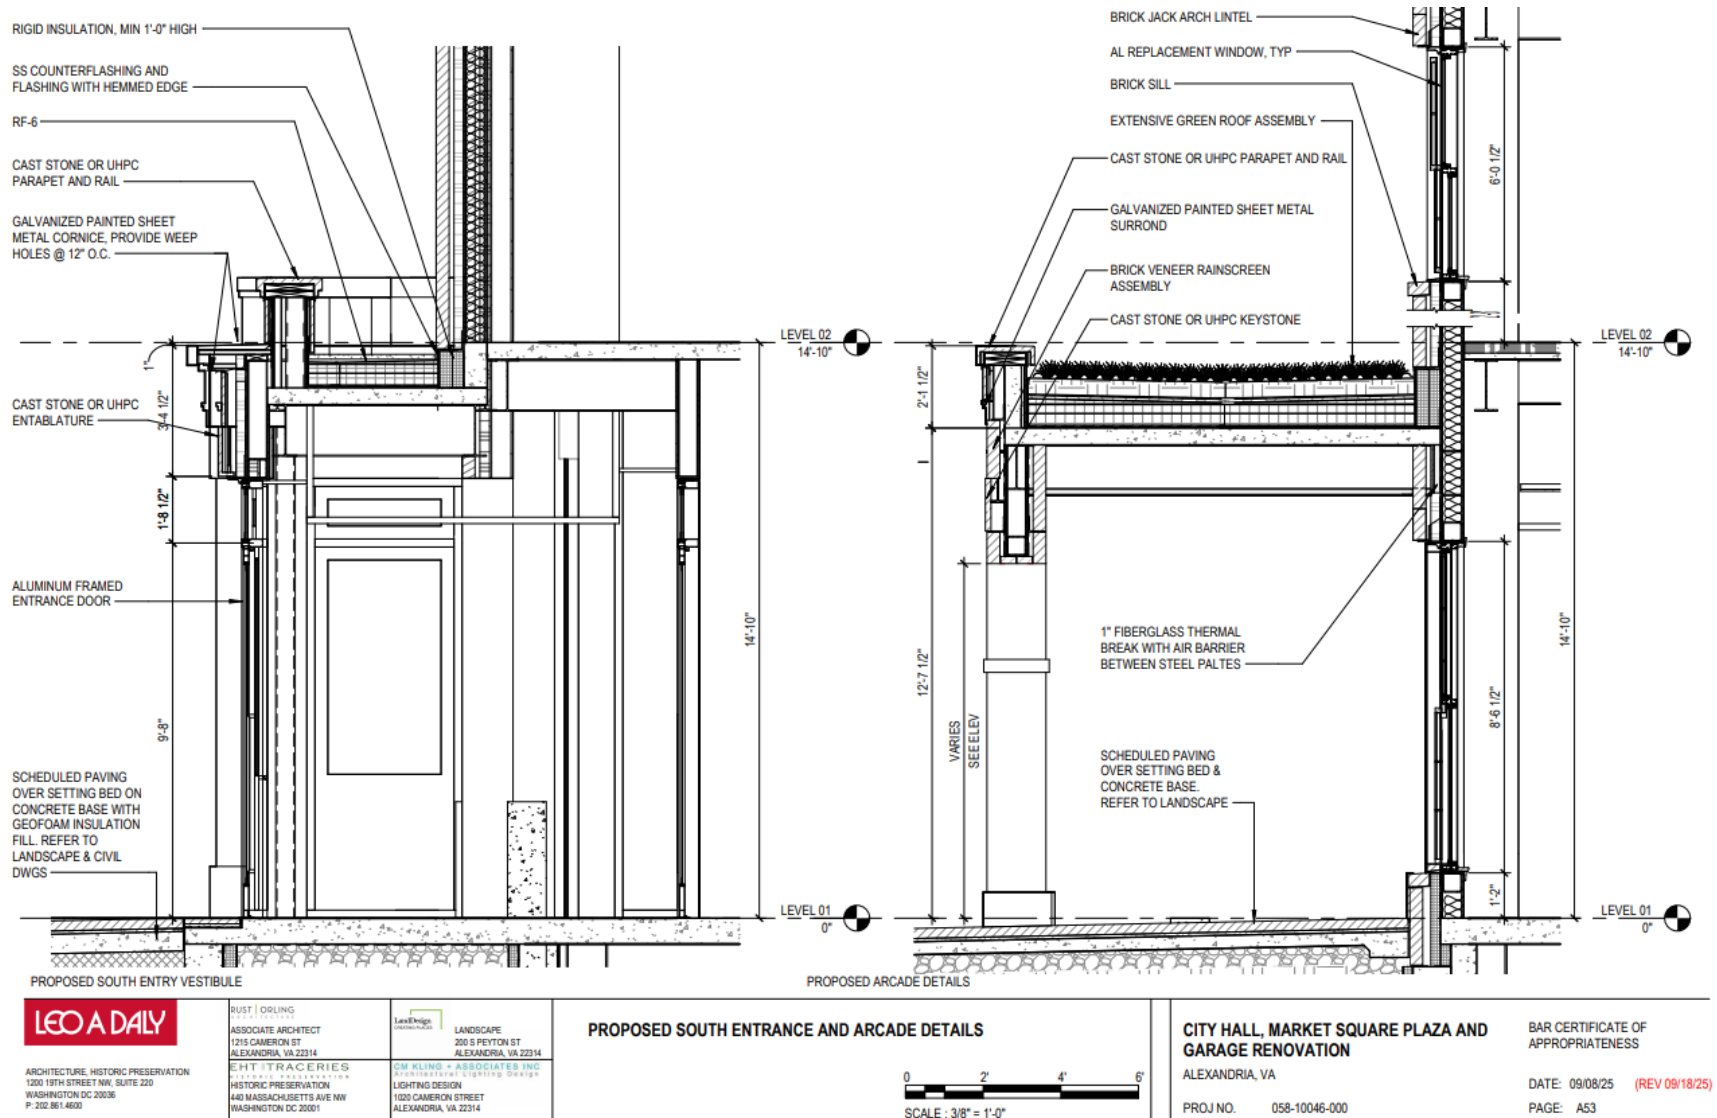
### APPLICANT PROPOSAL: ENTRY AND ARCADE SECTIONS

Pilasters at the building entrance extend inappropriately thru the entablature to the cornice and the pilaster base and capital are not correctly detailed.

The “balusters” above the entry are out of scale and lack appropriate detail.

The green roof of the pointless, reconstructed arcades will be expensive and difficult to maintain and are not visible to the public.

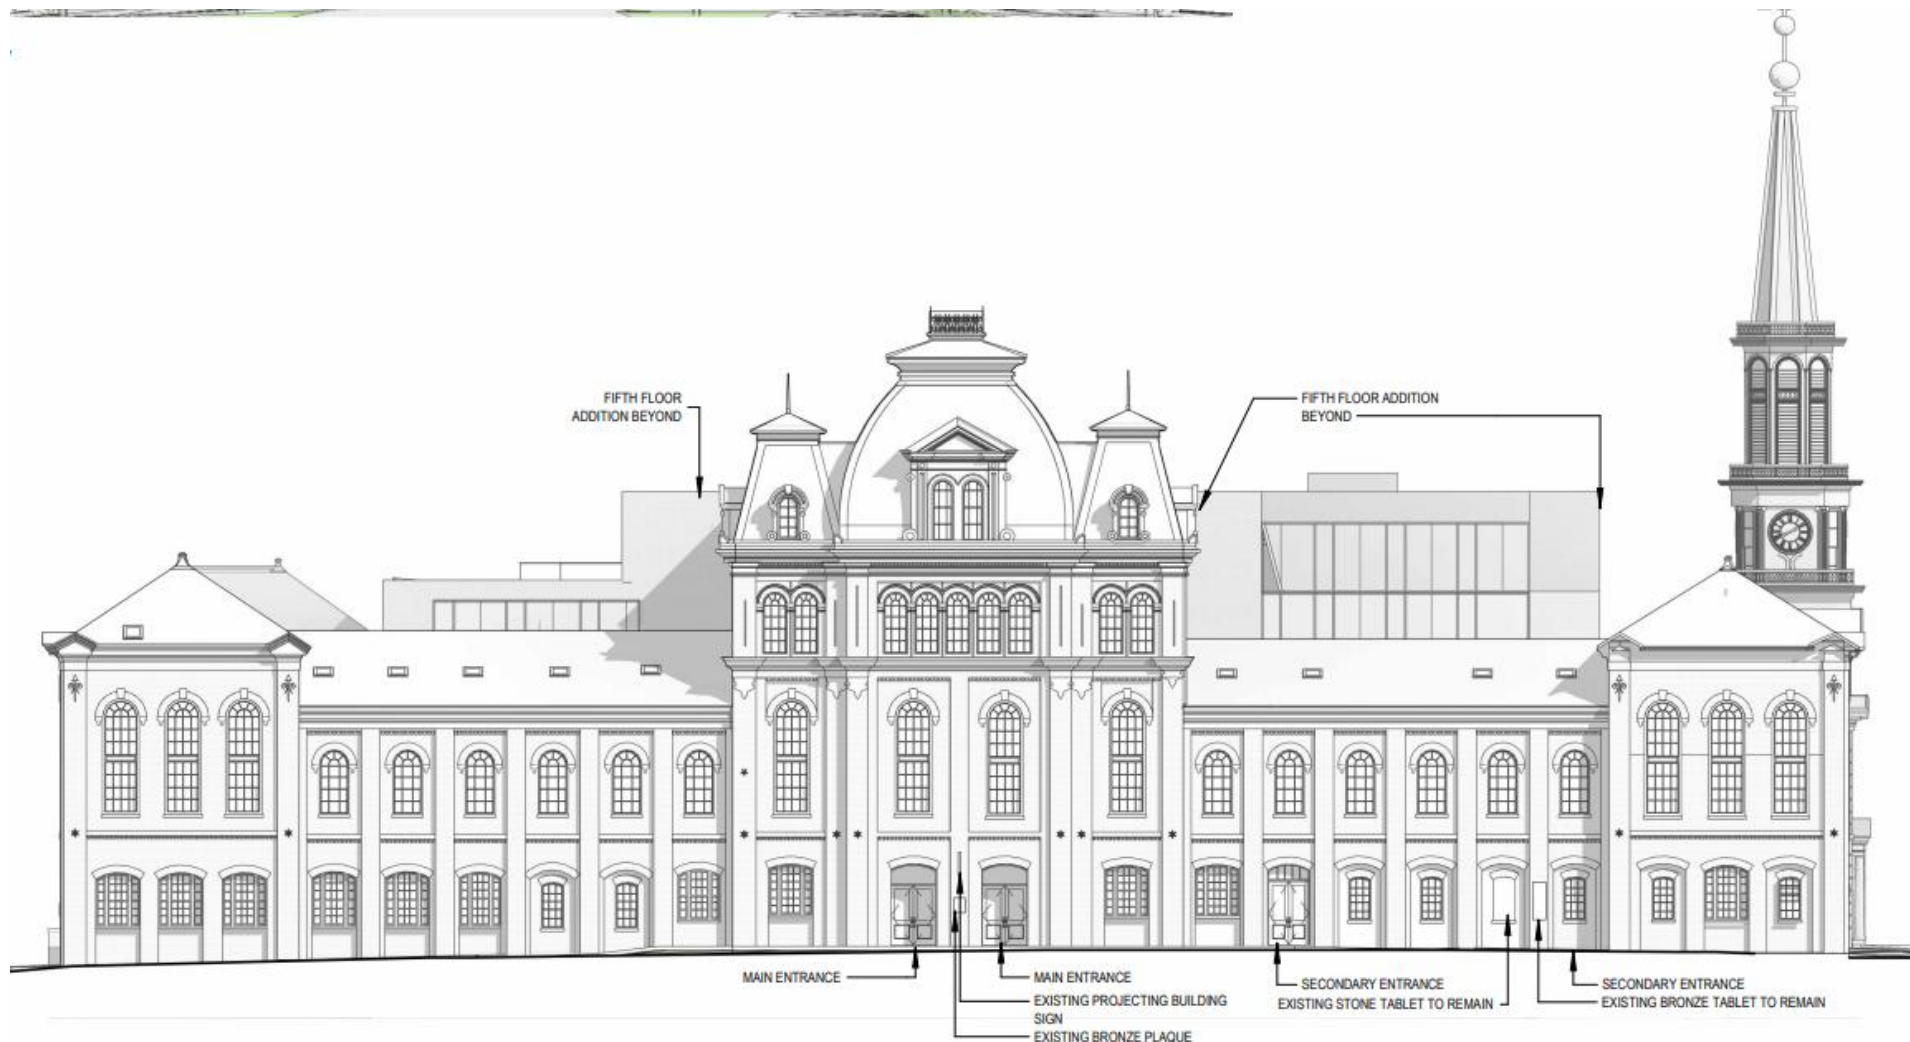
### APPLICANT PROPOSAL: CAMERON STREET ELEVATION

The 1879 building has a beautifully clear, symmetrical five-part façade with the focus on the ornate central entry, flanked by less prominent hipped roof corner pavilions connected to the main block by simple hyphens. There is a hierarchy of size and ornament that quickly identifies the primary entrance to the public building. This classical hierarchy should be repeated on the south façade.

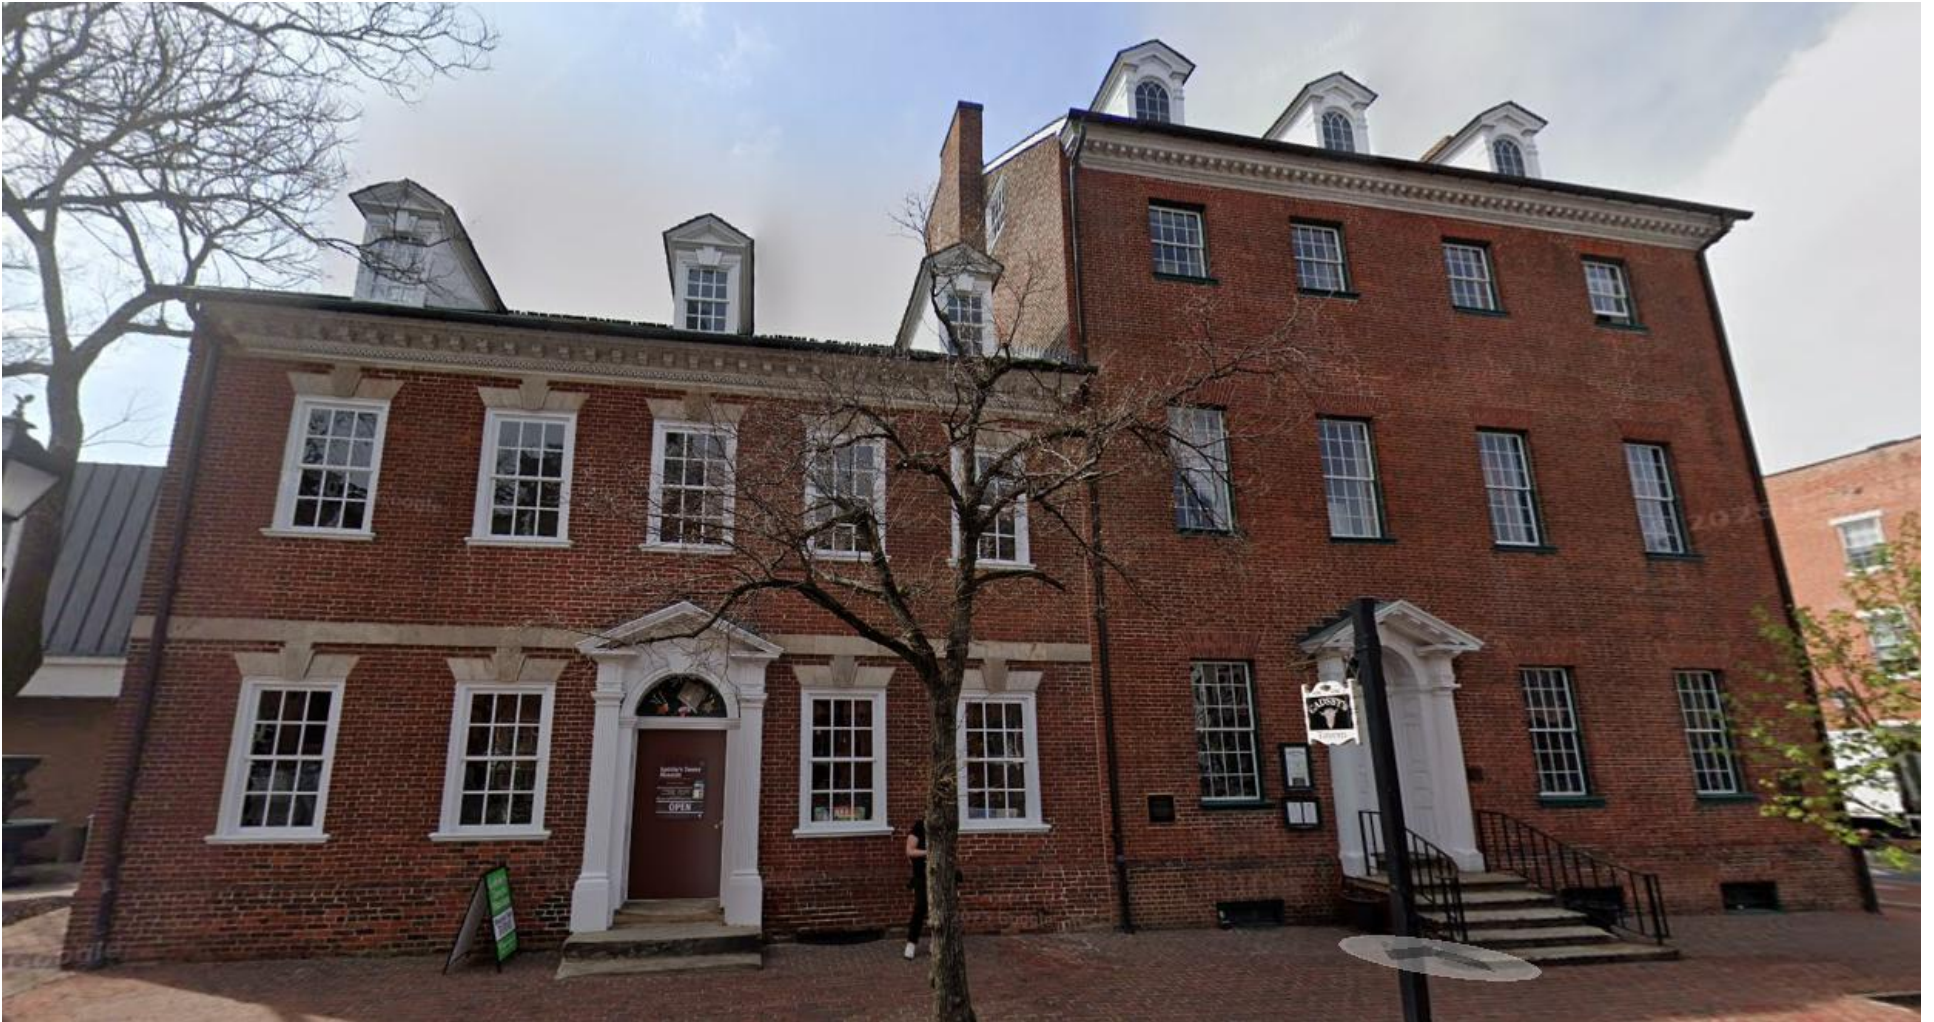
**GADSBY'S TAVERN/CITY HOTEL**

Acquia stone lintels above windows of the 1785 Tavern building and rubbed brick jack arches above windows in the 1792 City Hotel.

Graduated window sizes -- becoming smaller on the upper floors -- on City Hotel.

Watertable course occurs *below* windows

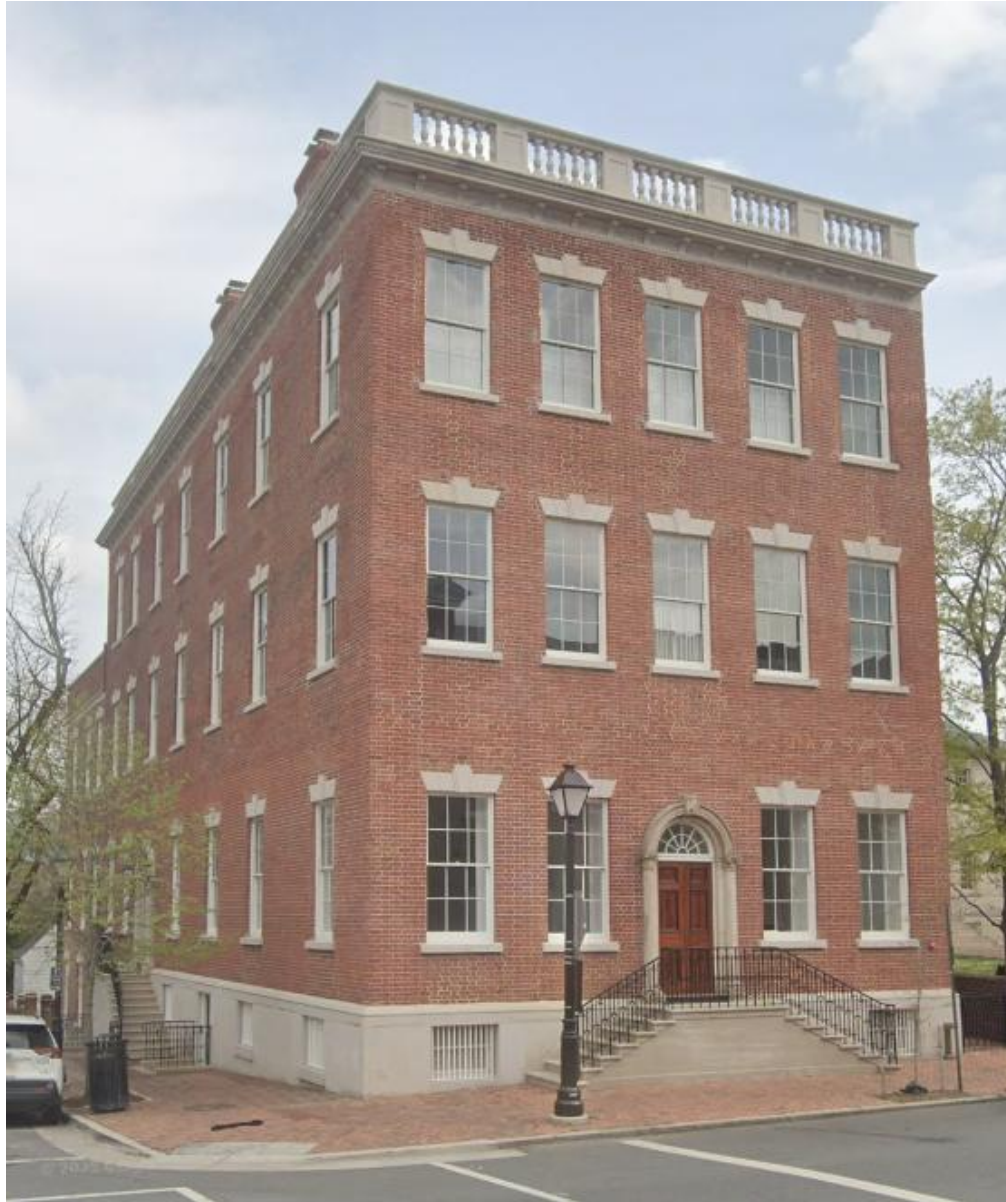
**BANK OF ALEXANDRIA**

133 N Fairfax St., completed 1807

Acquia stone water table, window lintels and rooftop balustrade

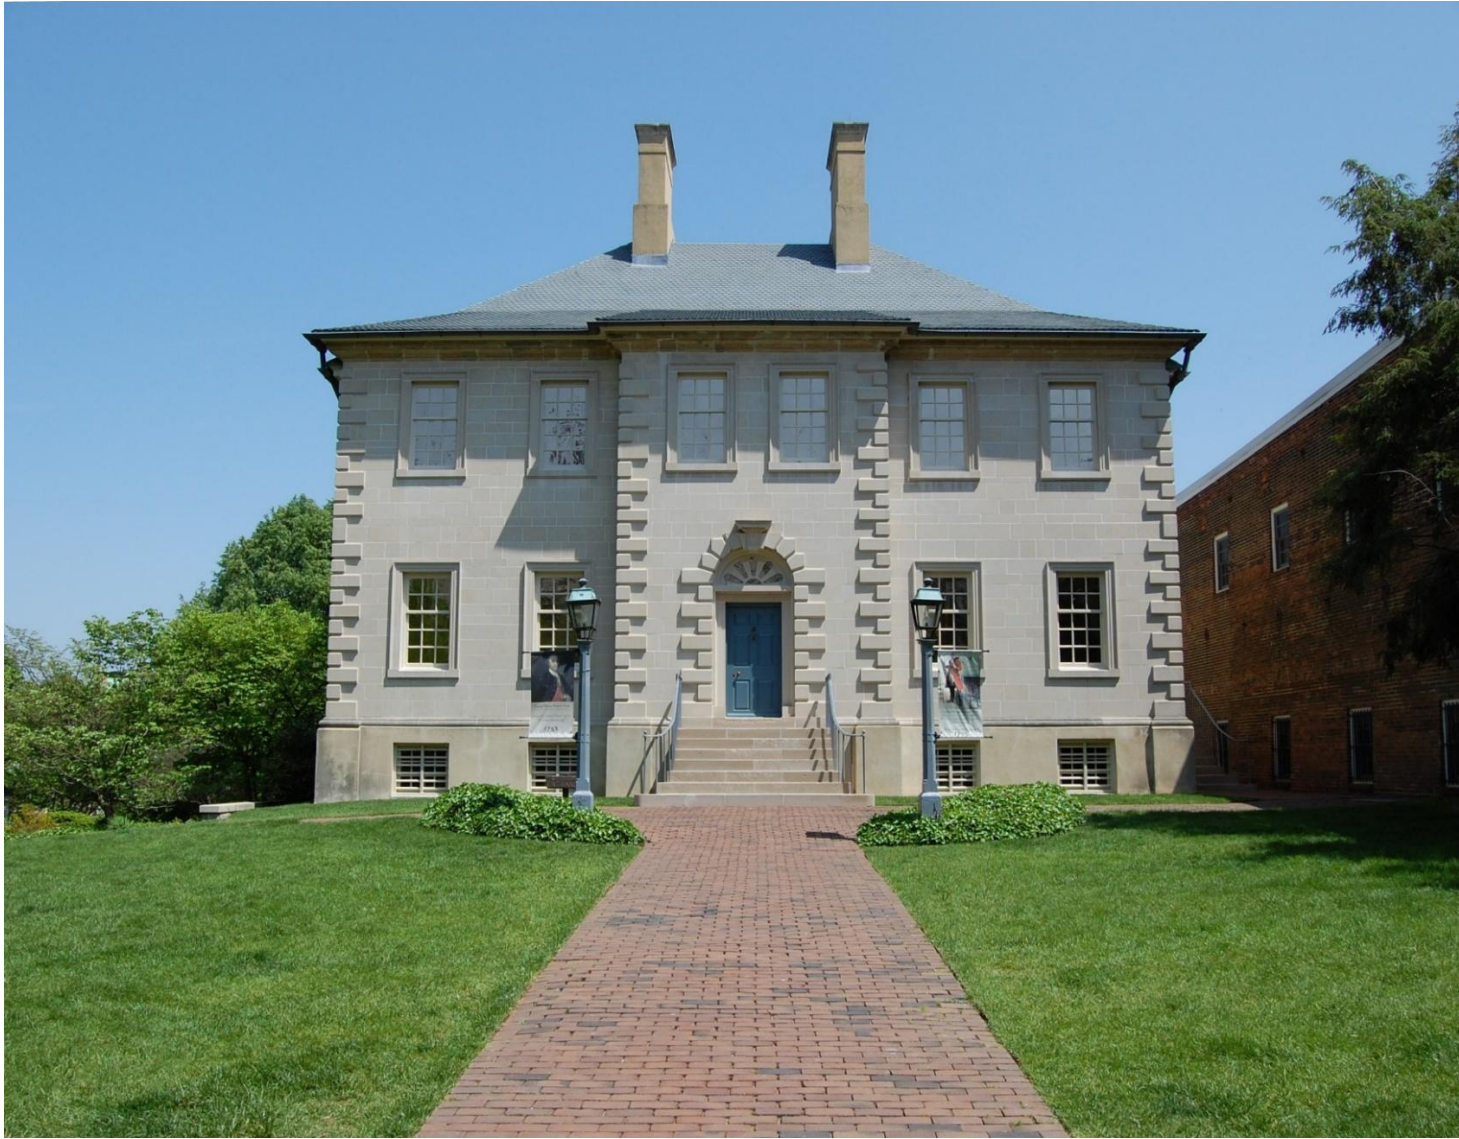
### **CARLYLE HOUSE**

121 N Fairfax St., completed 1753

Hip roof with large chimneys

Stone façade with quoins and projecting watertable at the first floor level, *below* the windows

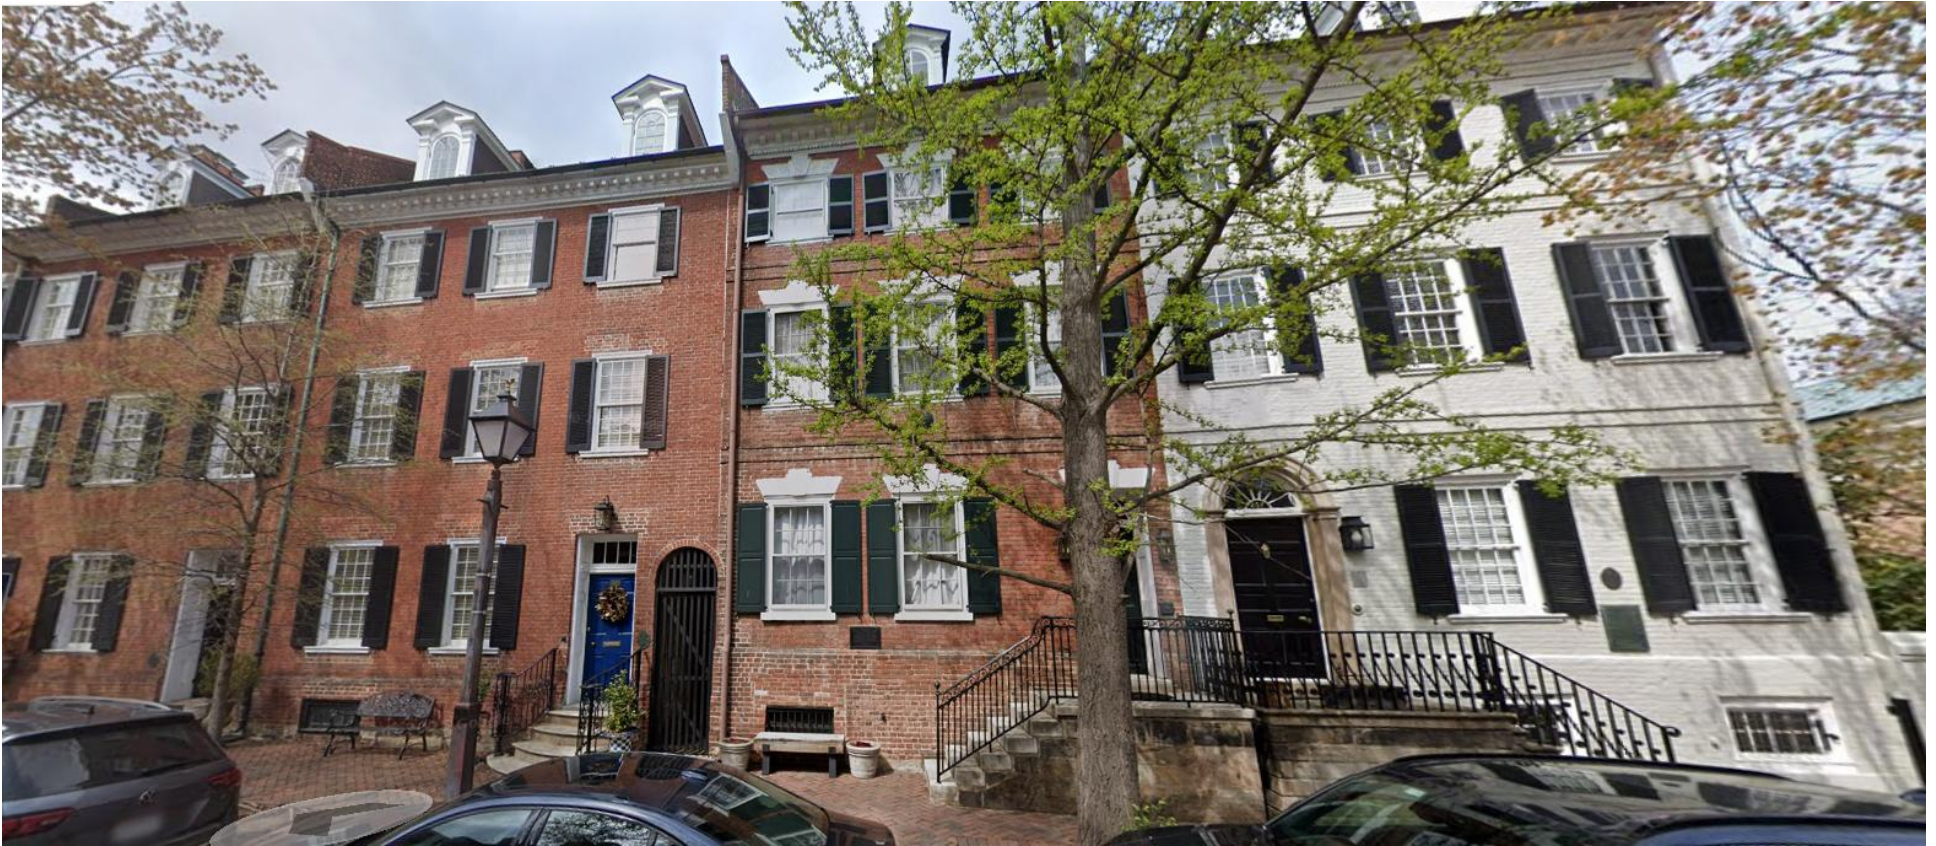
## GENTRY ROW TOWNHOUSES

200 Block Prince Street, late 18<sup>TH</sup> century, Georgian style

Brick belt courses with stone lintels and brick jack arches

Decorative cornice with modillions

Watertable course occurs *below* windows

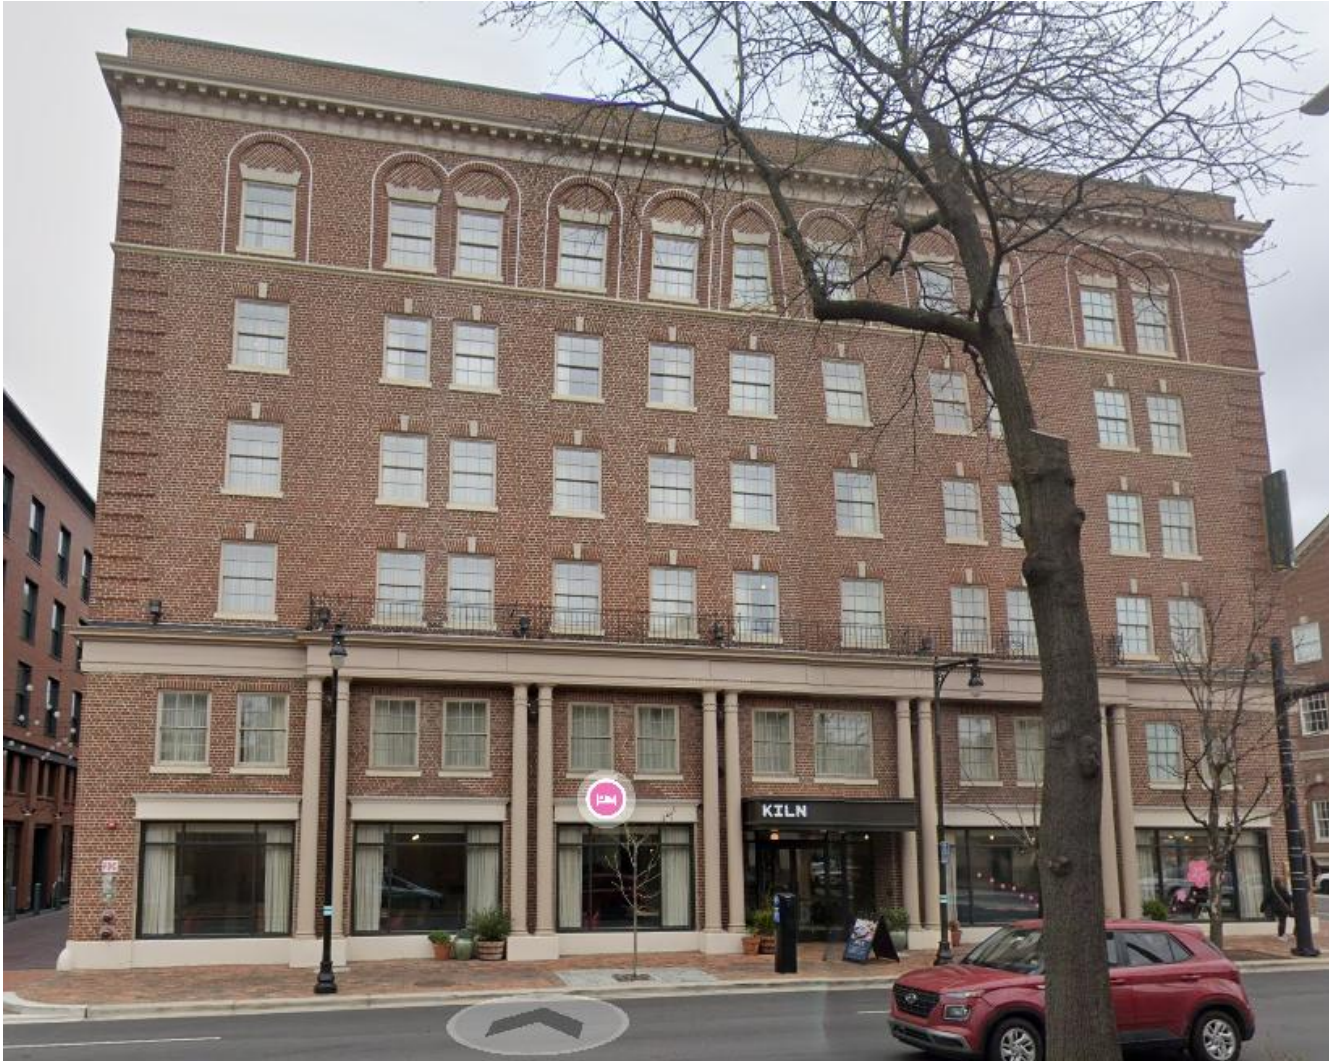
### **GEORGE MASON HOTEL**

130 S Washington St., 1929, Colonial Revival style

Projecting colonnade emphasizes entrance location

Brick jack arch above windows with stone keystone

Exaggerated brick quoins

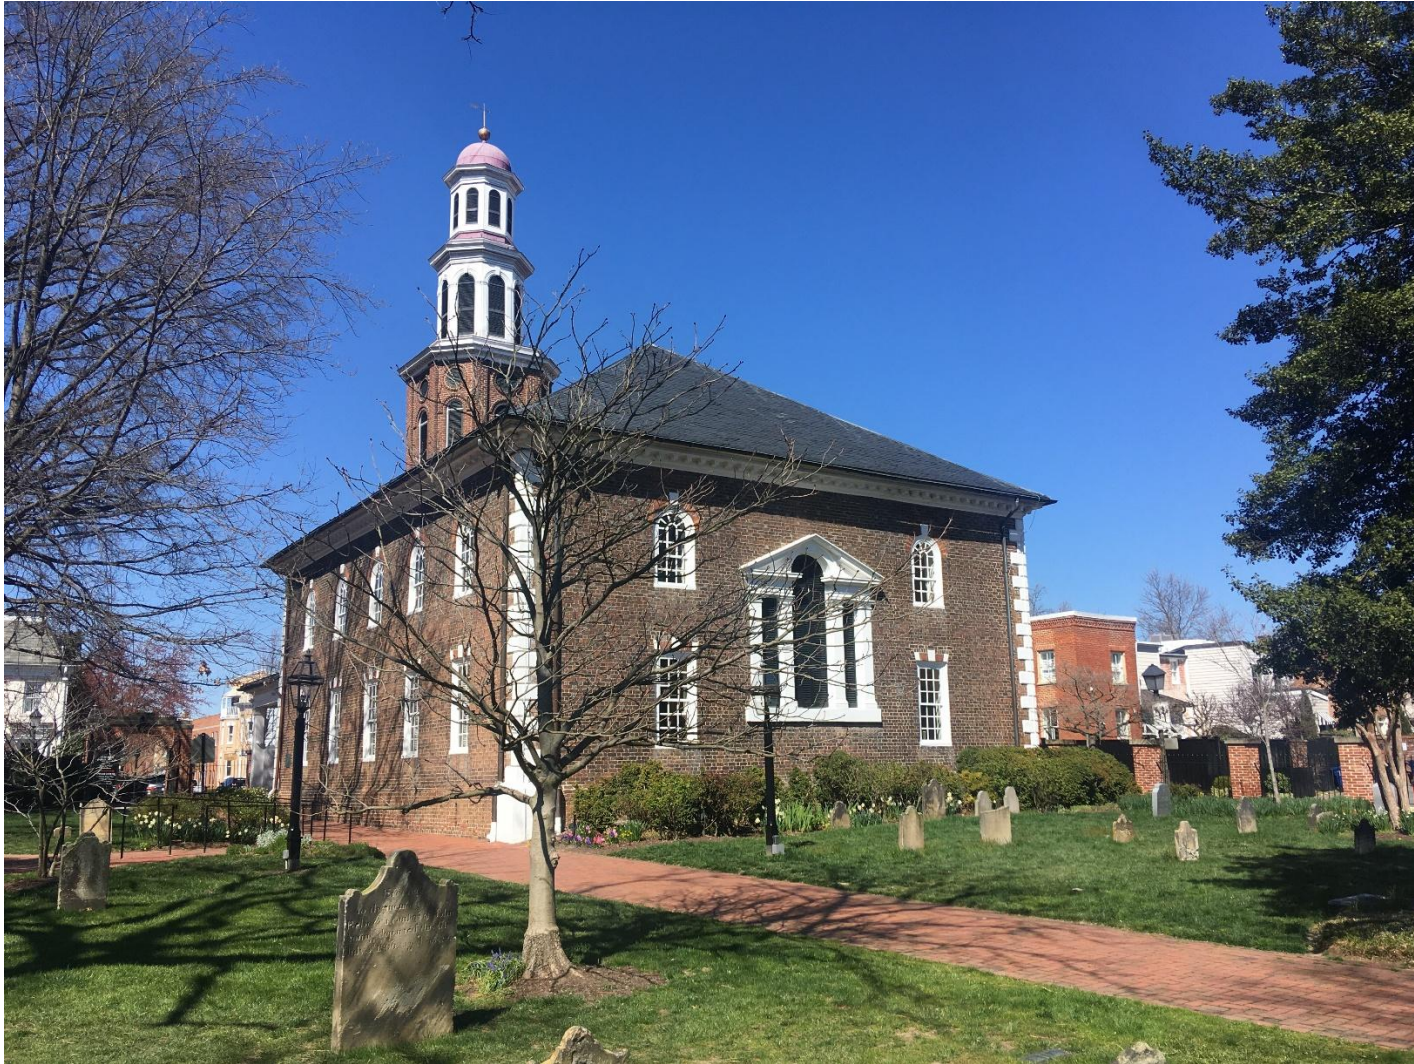
## **CHRIST CHURCH**

1767 – 1773, James Wren, Architect

Acquia stone quoins

Semicircular arched and rectangular windows with brick and stone jack arches

Molded brick watertable course *below* windows

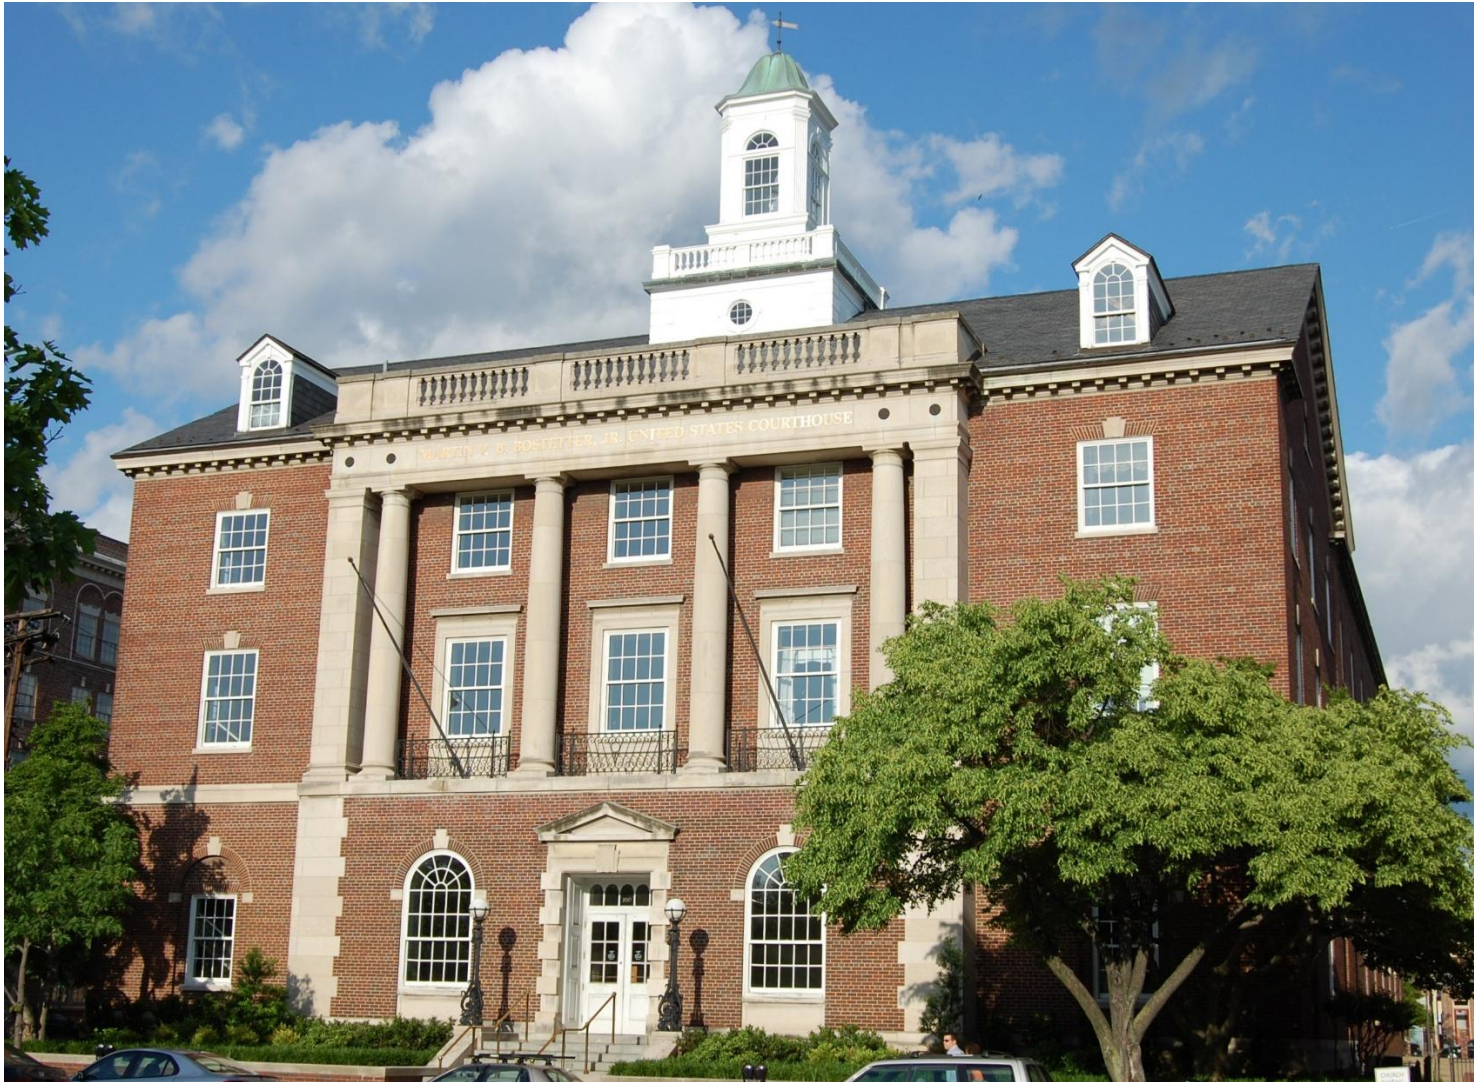
### **MARTIN BOSTETTER US COURTHOUSE**

200 S Washington St., constructed 1930, Colonial Revival style, James S. Wetmore, Architect

Projecting entrance features stone columns and pilasters at the piano noble with quoins below and stone balustrade above.

Arched and rectangular windows with graduated heights and brick and stone lintels.
