# Alexandria City Hall

## South Façade Colonial Revival Detail Restudy Recommendations

BAR Hearing 10/16/25

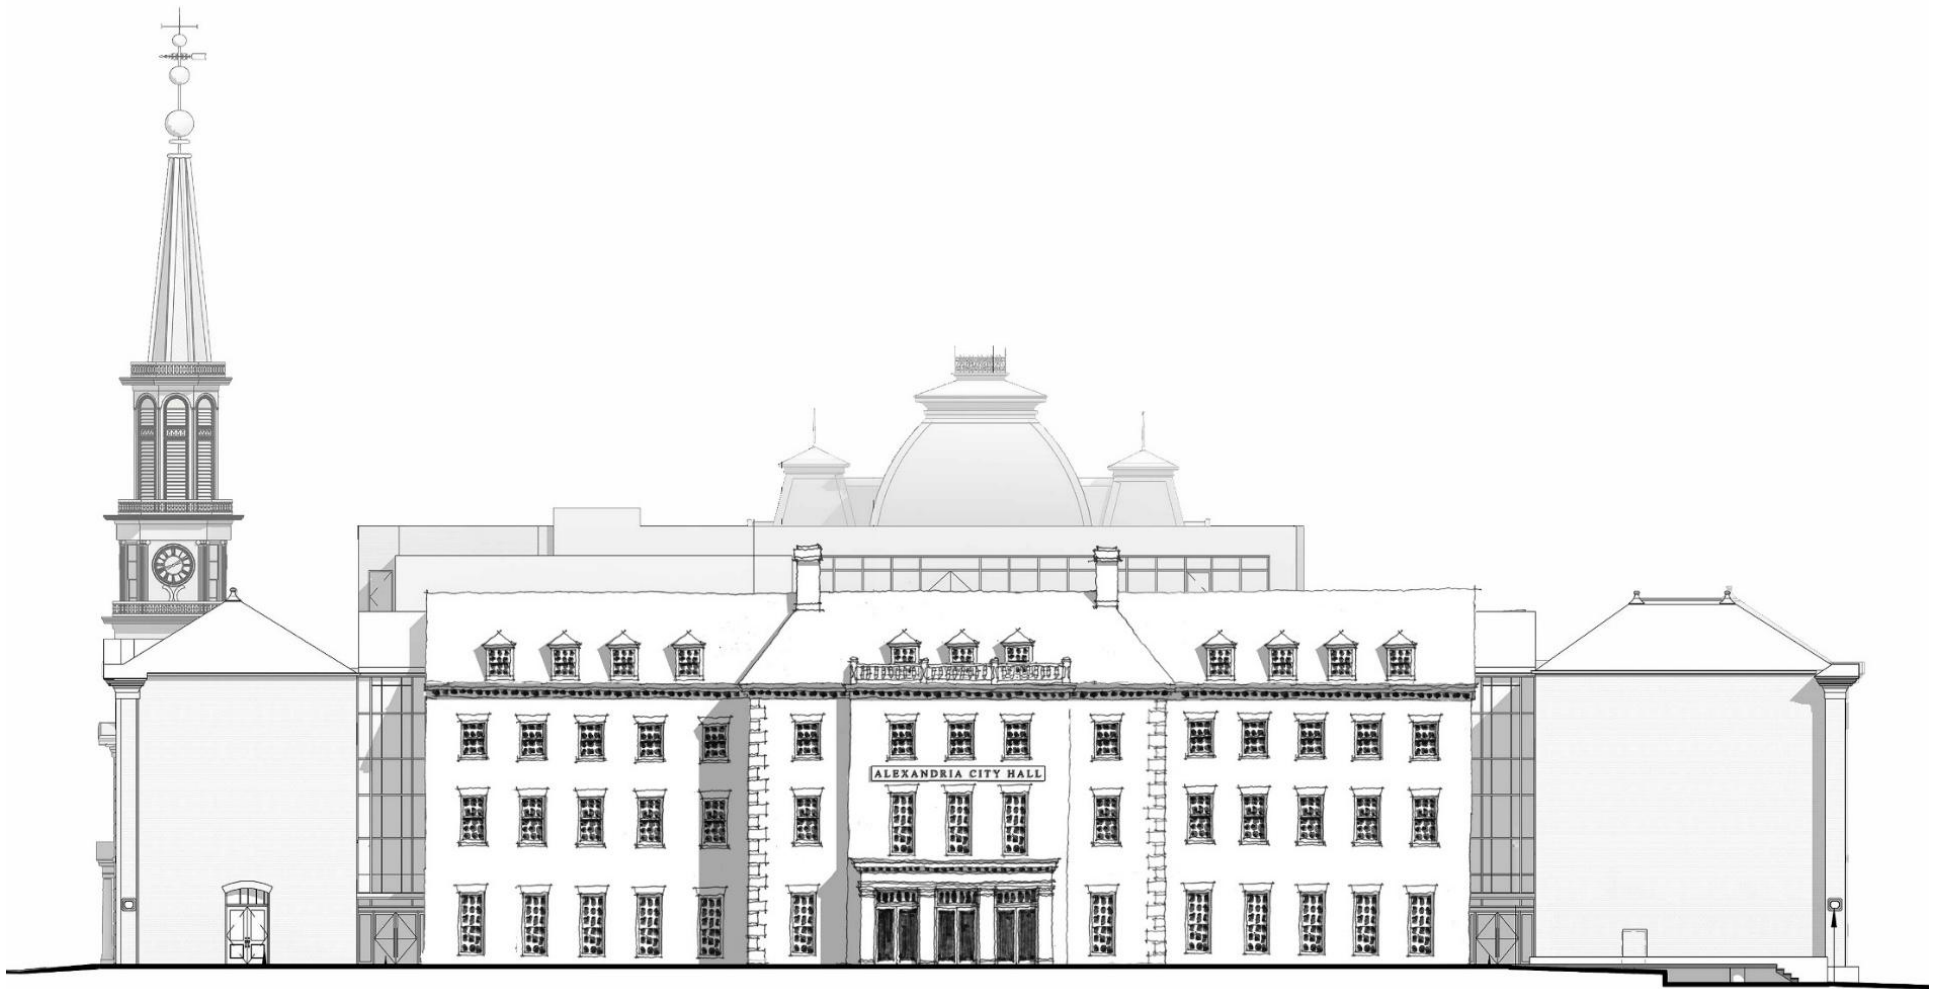
## ALTERNATE SOUTH FAÇADE

Al Cox, FAIA 9/30/25

1. Remove the proposed shed roof form from the center of the hip roof and replace it with a flat roof and ornamental railing with plinths on the cornice above the projecting entrance feature.

2. Replace the two existing brick chimney forms in the appropriate scale, shape and location on the central hip roof.
3. Revise the detailing of the projecting entrance feature to be classically appropriate to the Colonial Revival style found in Alexandria. Refer to [Andrea Palladio's Four Books of Architecture](#) (Ware edition 1738); Sebastiano Serlio's [Five Books of Architecture](#) (English ed. 1611); or William Ware's [The American Vignola](#) (pub. 1903), etc. for the correct classical proportions and details of columns, entablatures, etc.
