# JAMES K. POLK ELEMENTARY SCHOOL WALKABOUT: Existing Conditions, Findings and Recommendations MAY 10, 2016

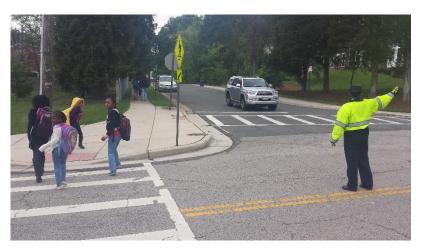
#### N. Pegram Street

- Crossing guard at intersection with Polk Ave (top photo)
- One of two locations with a crossing guard

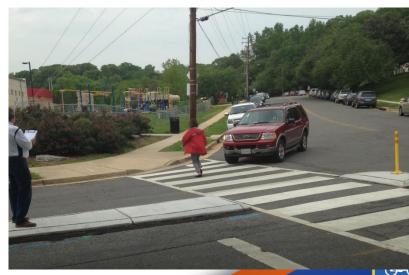
#### N. Pickett Street @ Polk Ave

Parked cars and a crosswalk set back from the corner impair visibility and driver's ability to yield to pedestrians (bottom photo)

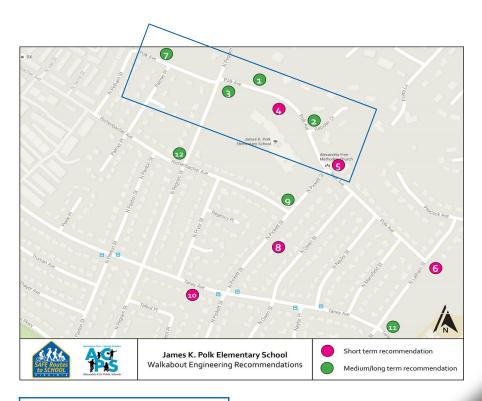
#### **Location 1 – POLK AVENUE**

Map ID	Issue	Recommendation
טו		
1	Speeding and U-turns	Traffic calming, chicanes
2	Gaps in pedestrian network	Complete sidewalks on north side of Polk Ave
3	Unclear school zone	Gateway treatments
4	Impractical parking regulations	Allow parking on north side of Polk Avenue near school

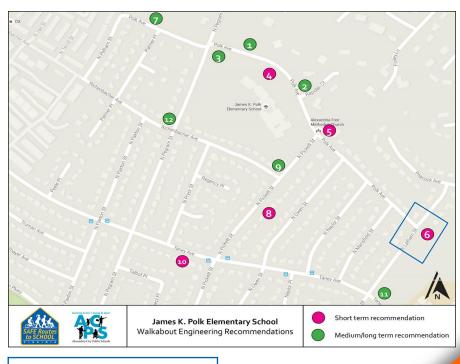
#### **Location 3 – N. LATHAM STREET**

Map ID	Issue	Recommendation	
6	Poor visibility	Trim vegetation and add curb extension	
6	Low visibility crosswalks	Add high visibility crosswalk markings	
6	Curb ramps not accessible	Add / upgrade curb ramps to meet ADA standards
