CONCEPT REVIEW #2 RECEIVED 6/5/2015

PPOPOSED STRUCTURE - SOUTH (REAR) ELEVATION ALEXANDRA 1/16" = 1-0"

HISTORIC STRUCTURE - SOUTH (REAR) ELEVATION ALEXANDRA 1/8" = 1'-0"

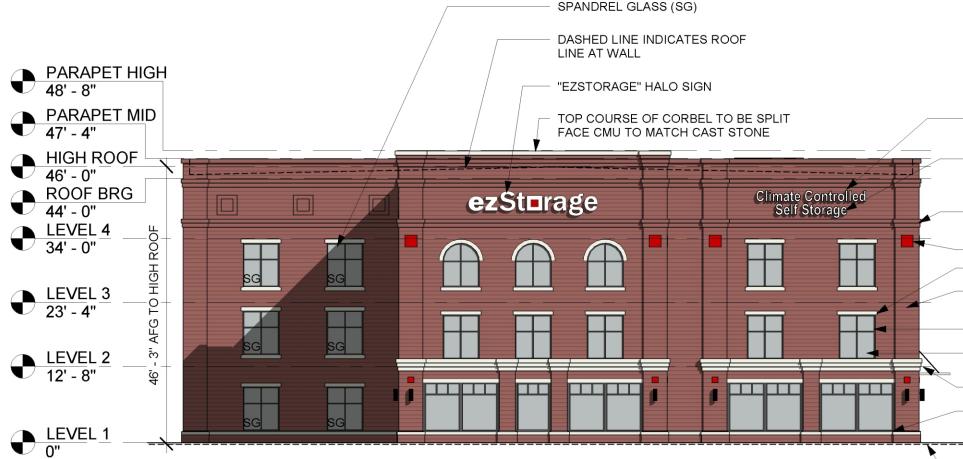
- "CLIMATE CONTROLLED" HALO SIGN
- "SELF STORAGE" HALO SIGN

RED SPLIT FACE CMU - 8" X 16"

CMU BAND TO MATCH CAST STONE

CLEAR ANODIZED ALUMINUM STOREFRONT

- RED SPLIT FACE CMU CORBEL, TYPICAL
- RED GLAZED SQUARE

- CAST STONE HEAD

CLEAR VISION GLASS

CAST STONE SILL

(AFG) - 41.03'

DASHED LINE INDICATES AVERAGE FINISH GRADE

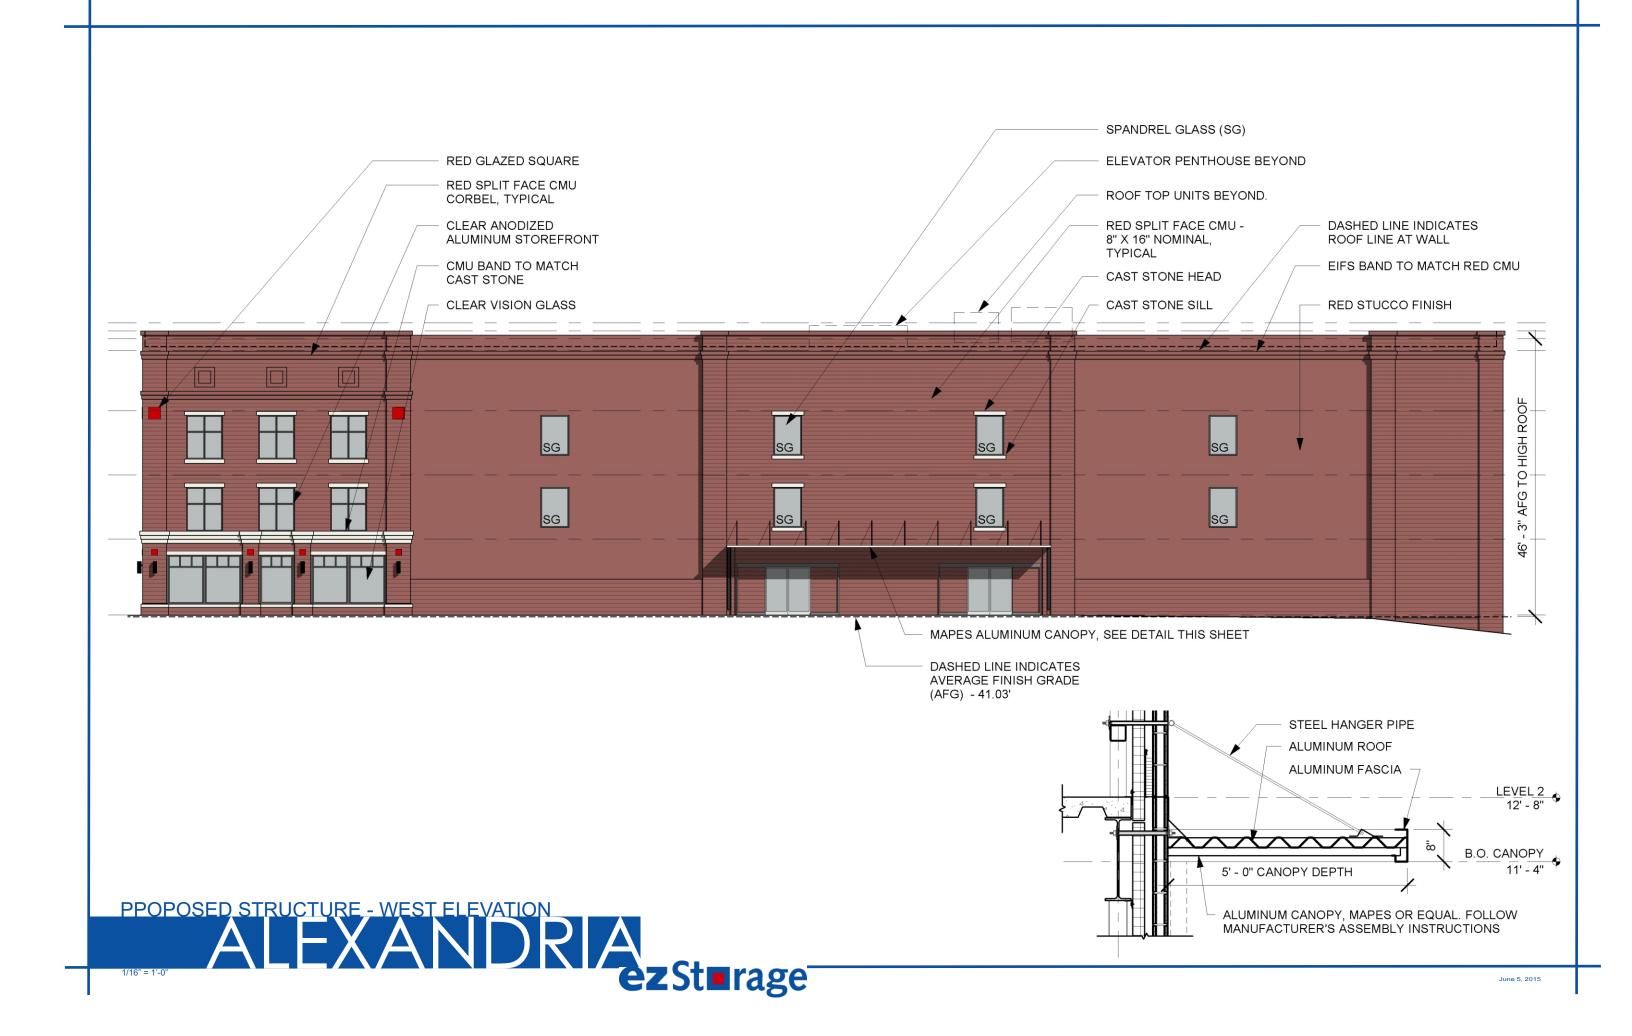
ROOF TOP UNITS BEYOND

DASHED LINE INDICATES AVERAGE FINISH GRADE (AFG) - 41.03'

CLEAR VISION GLASS

CLEAR ANODIZED ALUMINUM STOREFRONT

RED SPLIT FACE CMU - 8" X 16"

EIFS BAND TO MATCH RED CMU

RED SPLIT FACE CMU CORBEL, TYPICAL

DASHED LINE INDICATES ROOF LINE AT WALL

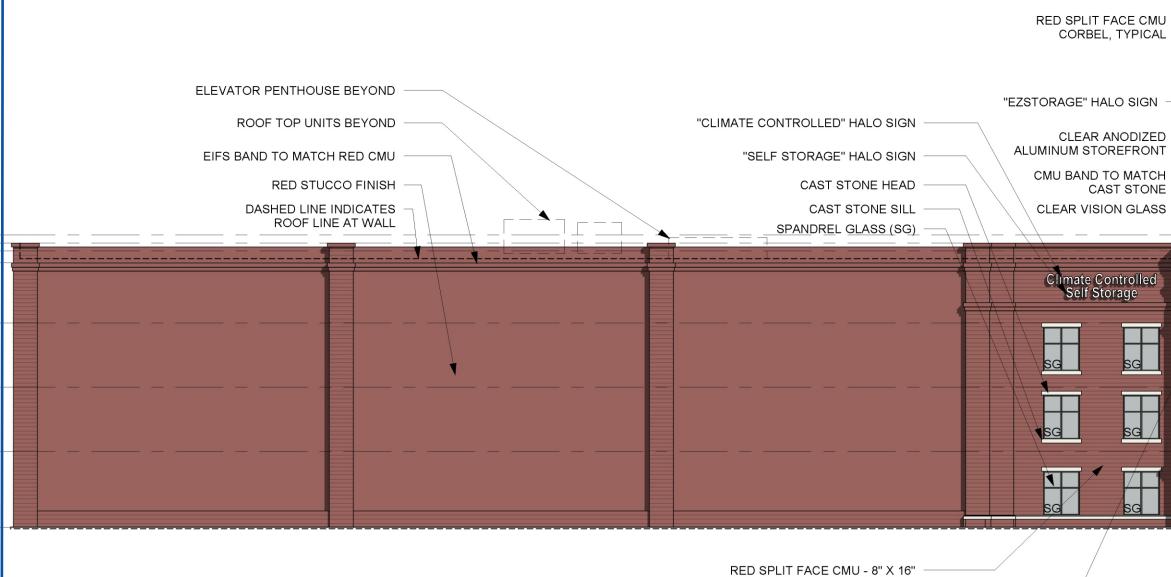
TOP COURSE OF CORBEL TO BE SPLIT FACE CMU TO MATCH CAST STONE

RED GLAZED SQUARE

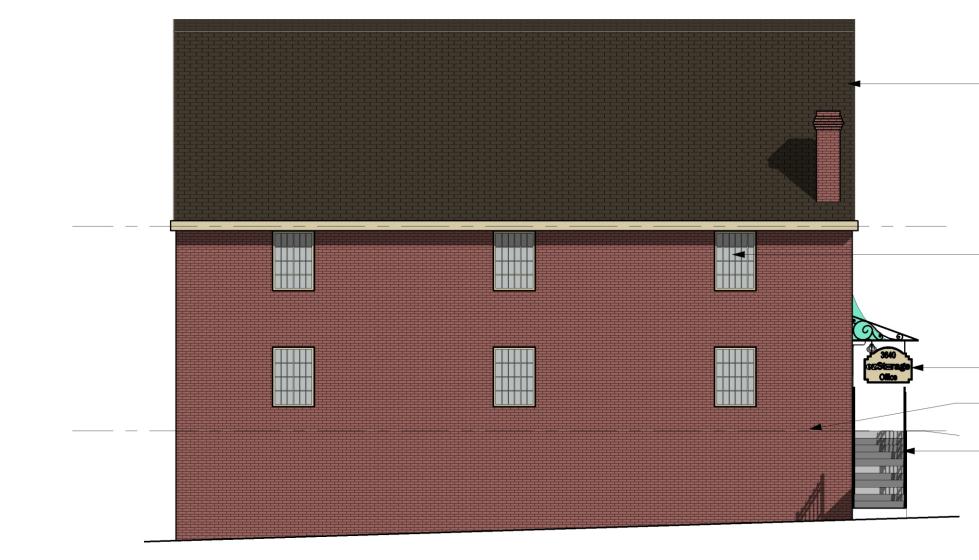
NEW STAIRS

EXISTING WINDOW

IRON AND WOOD

BLADE OFFICE SIGN

CLEAN AND REPAIR EXISTING BRICK

EXISTING SHINGLE ROOF

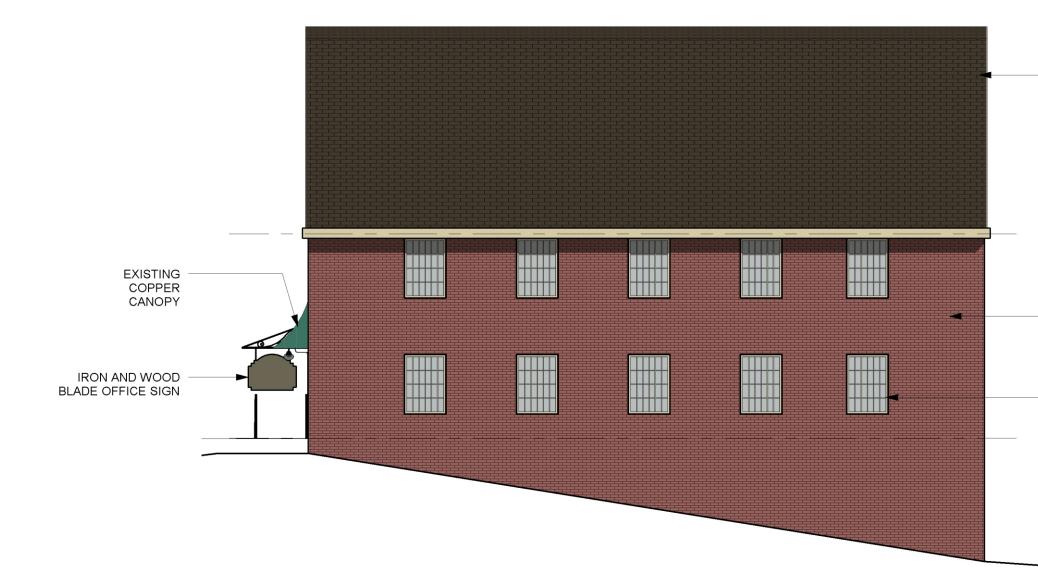
EXISTING SHINGLE ROOF

EXISTING BRICK

EXISTING WINDOW

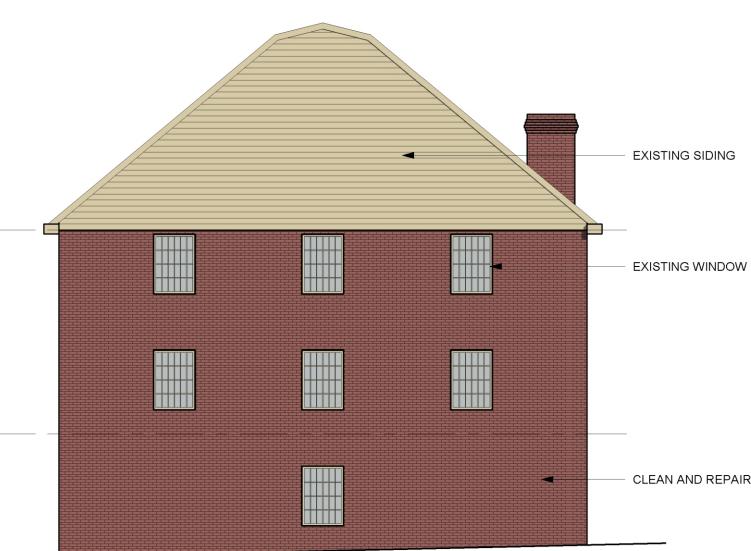
CLEAN AND REPAIR EXISTING BRICK
